# Oakland Elementary School

Humidity Overview and Recommendations

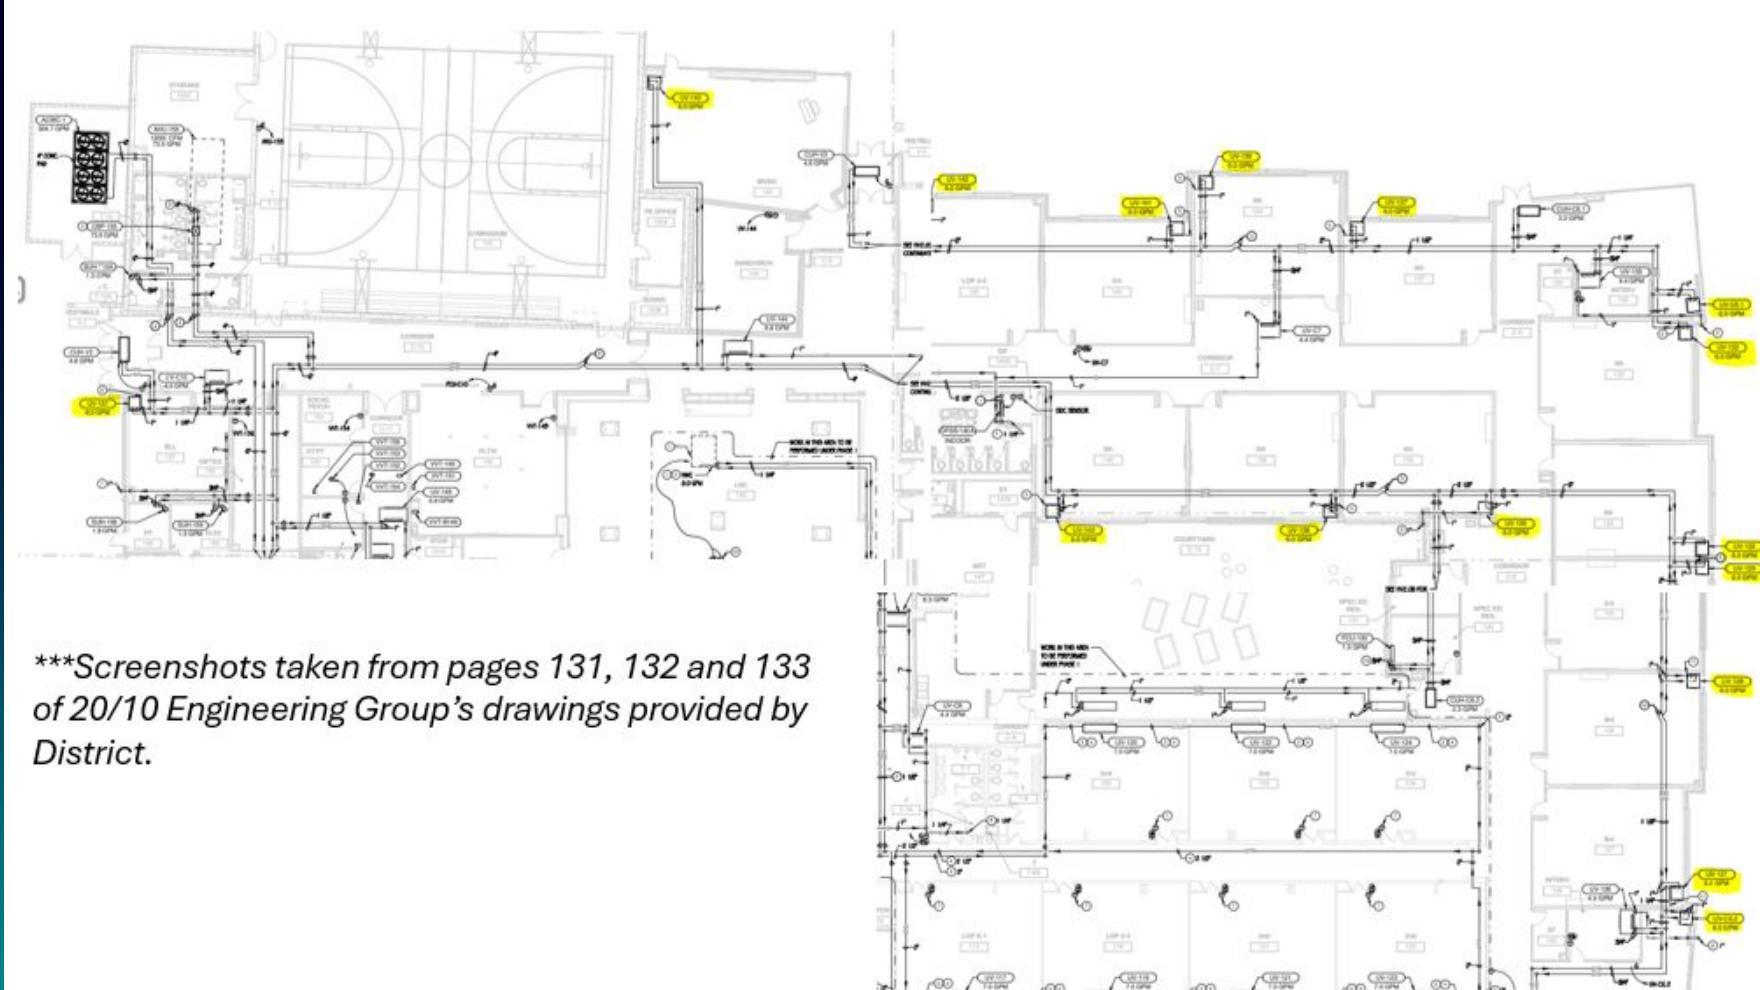
### Site Assessment Overview

- Dehumidification option on the installed vertical unit ventilators is only available for valve-controlled units with a 4-pipe heating and cooling system.
- Existing units have single coil (2-pipe CW/HW changeover)
- Face and bypass dampers are not installed on existing units.

Vertical Unit Ventilators					
	Unit Tag	Classroom				
	UV-127	127 (3rd)				
1	UV-128	128 (3rd)				
	UV-129	129 (3rd)				
	UV-132	132 (4th)				
	UV-133	133 (4th)				
2	UV-136	136 (4th)				
	UV-137	137 (4th)				
	UV-138	138 (5th)				
1	UV-139	139 (5th)				
	UV-140	140 (5th)				
	UV-141	141 (5th)				
	UV-142	142 (LOP 4-5)				
	UV-143	143 (Music)				
	UV-157	157 (ELL)				
	UV.C6.1	Corridor C-6				
	UV.C6.2	Corridor C-6

- Demo existing vertical unit ventilators, modify piping system and install new unit ventilators with appropriate application options.\*
- Modify existing vertical unit ventilators and install 2-3 dedicated outdoor air system (DOAS) units to serve impacted classrooms.\*
- 3) Utilize IAQP design to manage indoor air quality and reduce dependance on outside air.\*

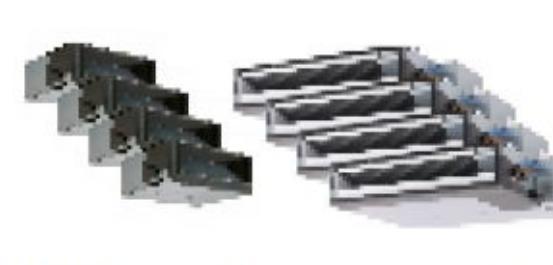
#### **Baseline VRP Design**

(3) 26-Ton Outdoor VRF Heat-pump (24) Indoor VRF FCU

(24) Indoor VRF FCU

(1) VRF DOAS Units

Parameter	VRP Design	IAQP Design	Change	% Change
Gas Phase Air Cleaners	-	6 units 350 ECAg each	6 units 350 ECAg each	
Clean Airflow (ECAg)	-	2,100 CFM	2,100 CFM	
Supply Airflow	40,000 CFM	36,400 CFM	(3,600 CFM)	9% reduced
Outside Airflow	4,500 CFM	900 CFM	(3,600 CFM)	80% reduced
Electric Pre-Heat Power	20 kW	5 kW	(15 kW)	75% reduced
VRF Cooling Load	76.8 tons	55.4 tons	(21.4 tons)	28% reduced
VRF Heating Load	1,128 MBH	839 MBH	(289 MBH)	26% reduced
VRF HP MOCP	660A	440A	(220A)	33% reduced
Refrigerant Charge	138 lbs	92 lbs	(46 lbs)	33% reduced
VRF HP Weight	4,155 lbs	2,956	(1,199 lbs)	29% reduced
DOAS Cost	High	Low	Savings	50-75% cost savings
Air Cleaner Cost	n/a	10-15% of IAQP package	Cost add	10-15% cost add
VRF Unit Cost	High	Low	Savings	20-30% cost savings
Total System Cost	High	Low	Savings	30-40% cost savings
Energy Use	High	Low	Savings	
IAQ	Std 62.1 compliant	Std 62.1 compliant	-

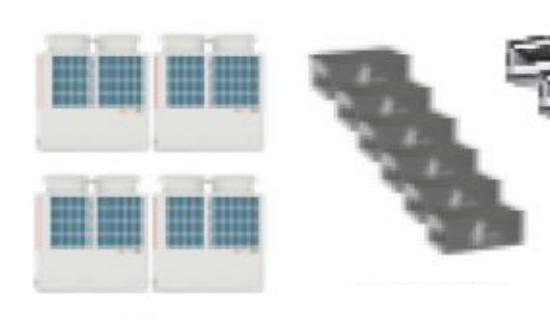
#### **Proposed IAQP Design**

(4) VRF DOAS Units

(2) 28-ton Outdoor VRF Heat-pump

(6) Air-Cleaners
