# Carver Playground Project

Carver Early Childhood Center  
Playground Remodel  
Odessa TX

DRAWING #:  
210643A

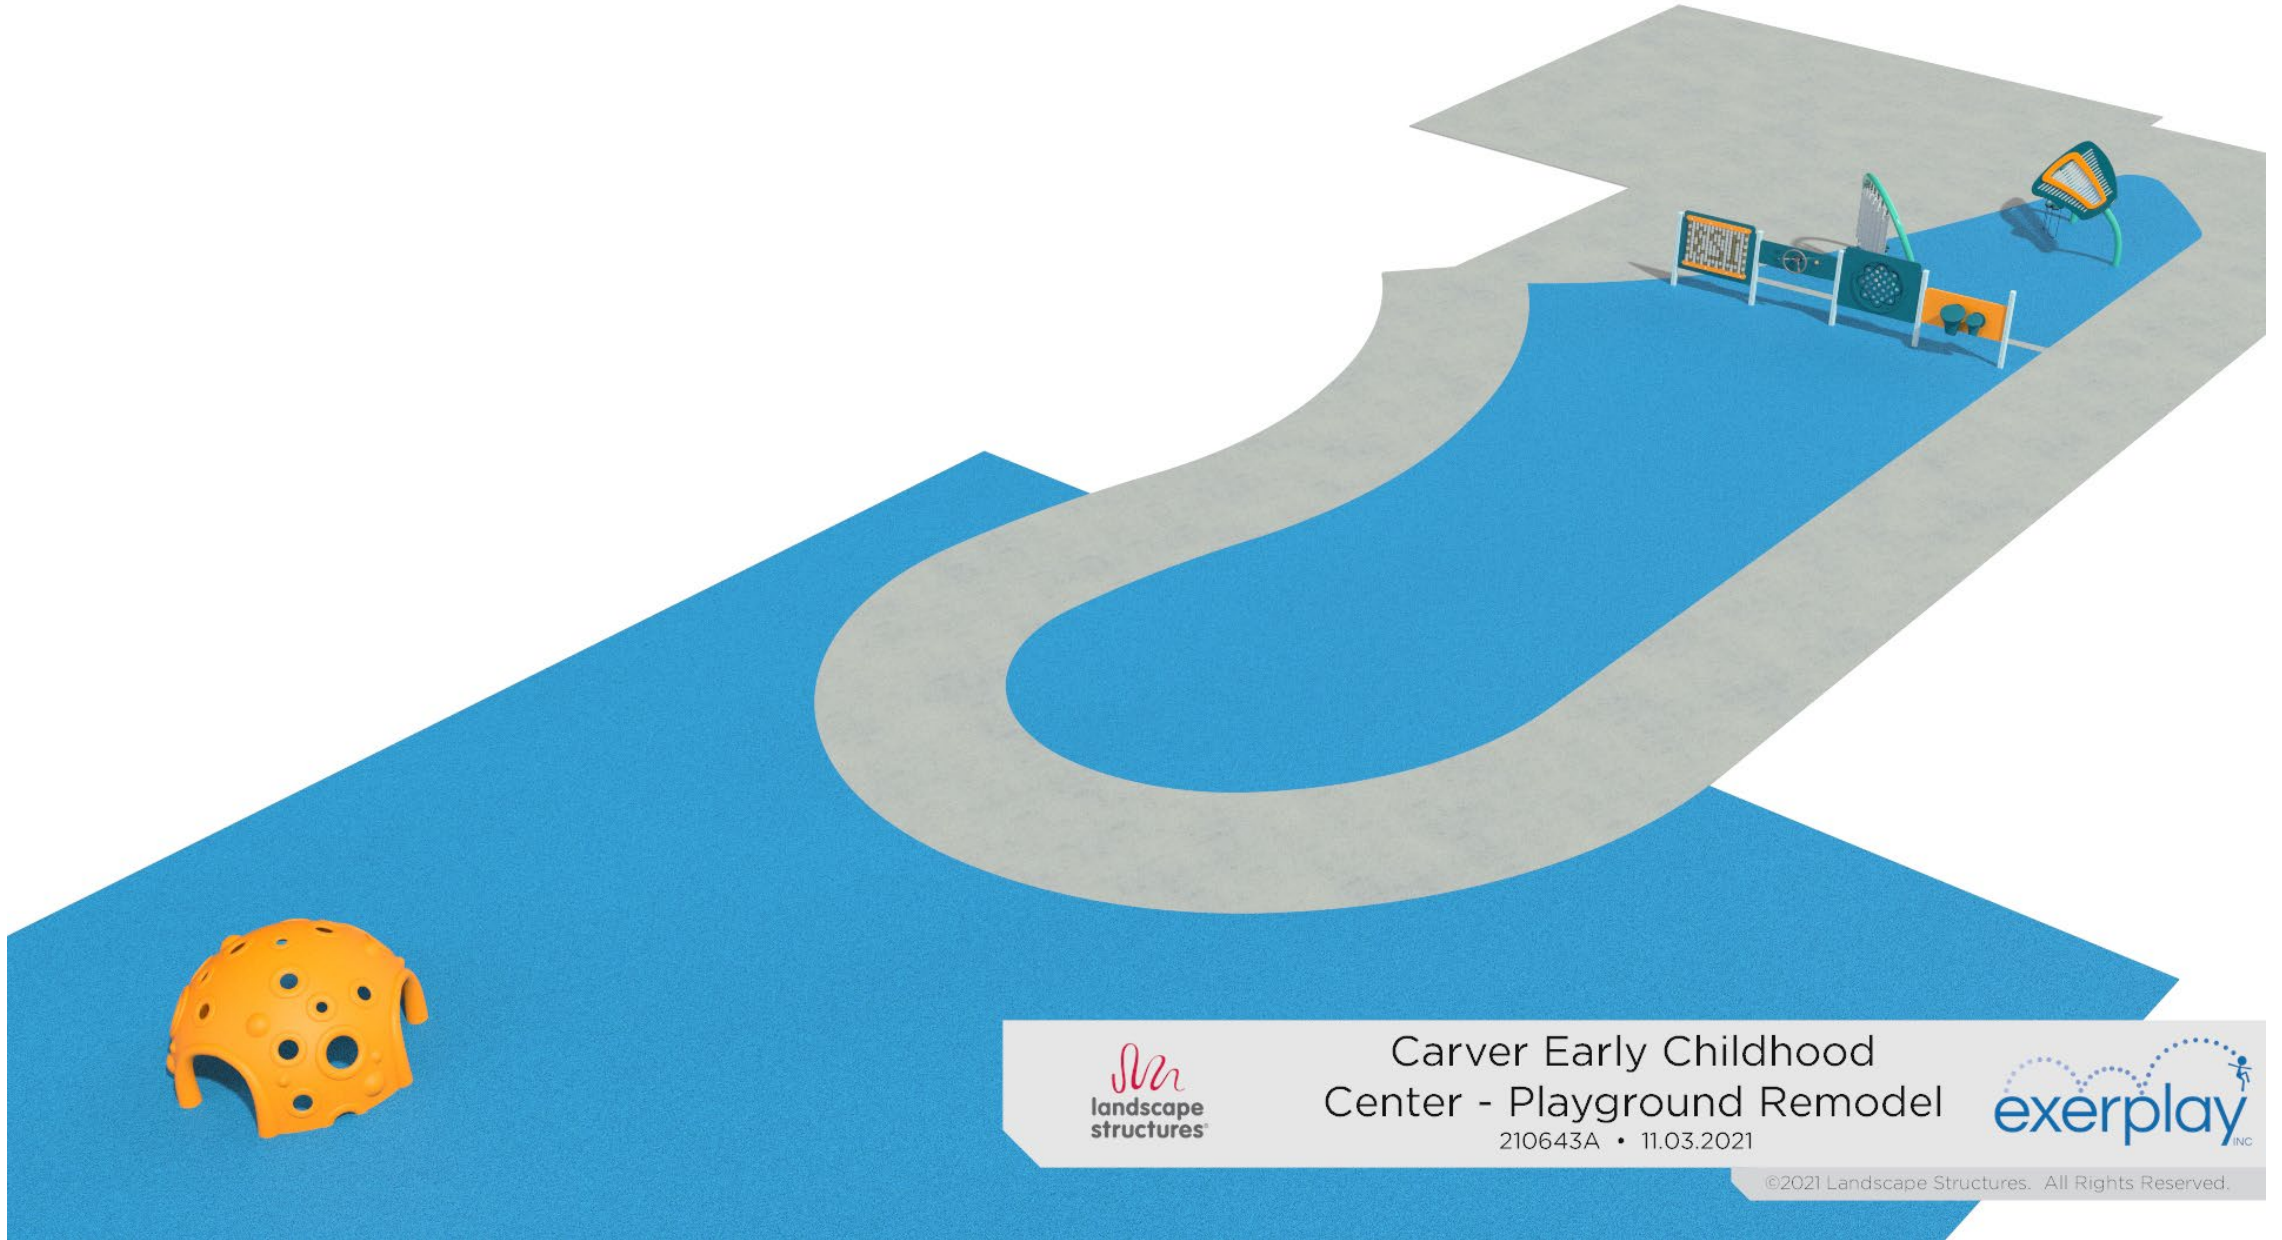
MAXIMUM FALL HEIGHT  
46"

PLAYGROUND SURFACING  
TOTAL AREA 1,683 SF

PLAYGROUND SURFACING  
TOTAL AREA 660 SF

PLAYGROUND SURFACING  
TOTAL AREA 181 SF

2-5 YEARS

TOTAL ELEVATED PLAY COMPONENTS	0		
TOTAL ELEVATED COMPONENTS ACCESSIBLE BY RAMP	0	REQUIRED	0
TOTAL ELEVATED COMPONENTS ACCESSIBLE BY TRANSFER	0	REQUIRED	0
TOTAL ACCESSIBLE GROUND LEVEL COMPONENTS SHOWN	7	REQUIRED	0
TOTAL DIFFERENT TYPES OF GROUND LEVEL COMPONENTS	7	REQUIRED	7
