**THORNE BAY SCHOOL PLAYGROUND UPGRADES
 CONCEPT DESIGN**

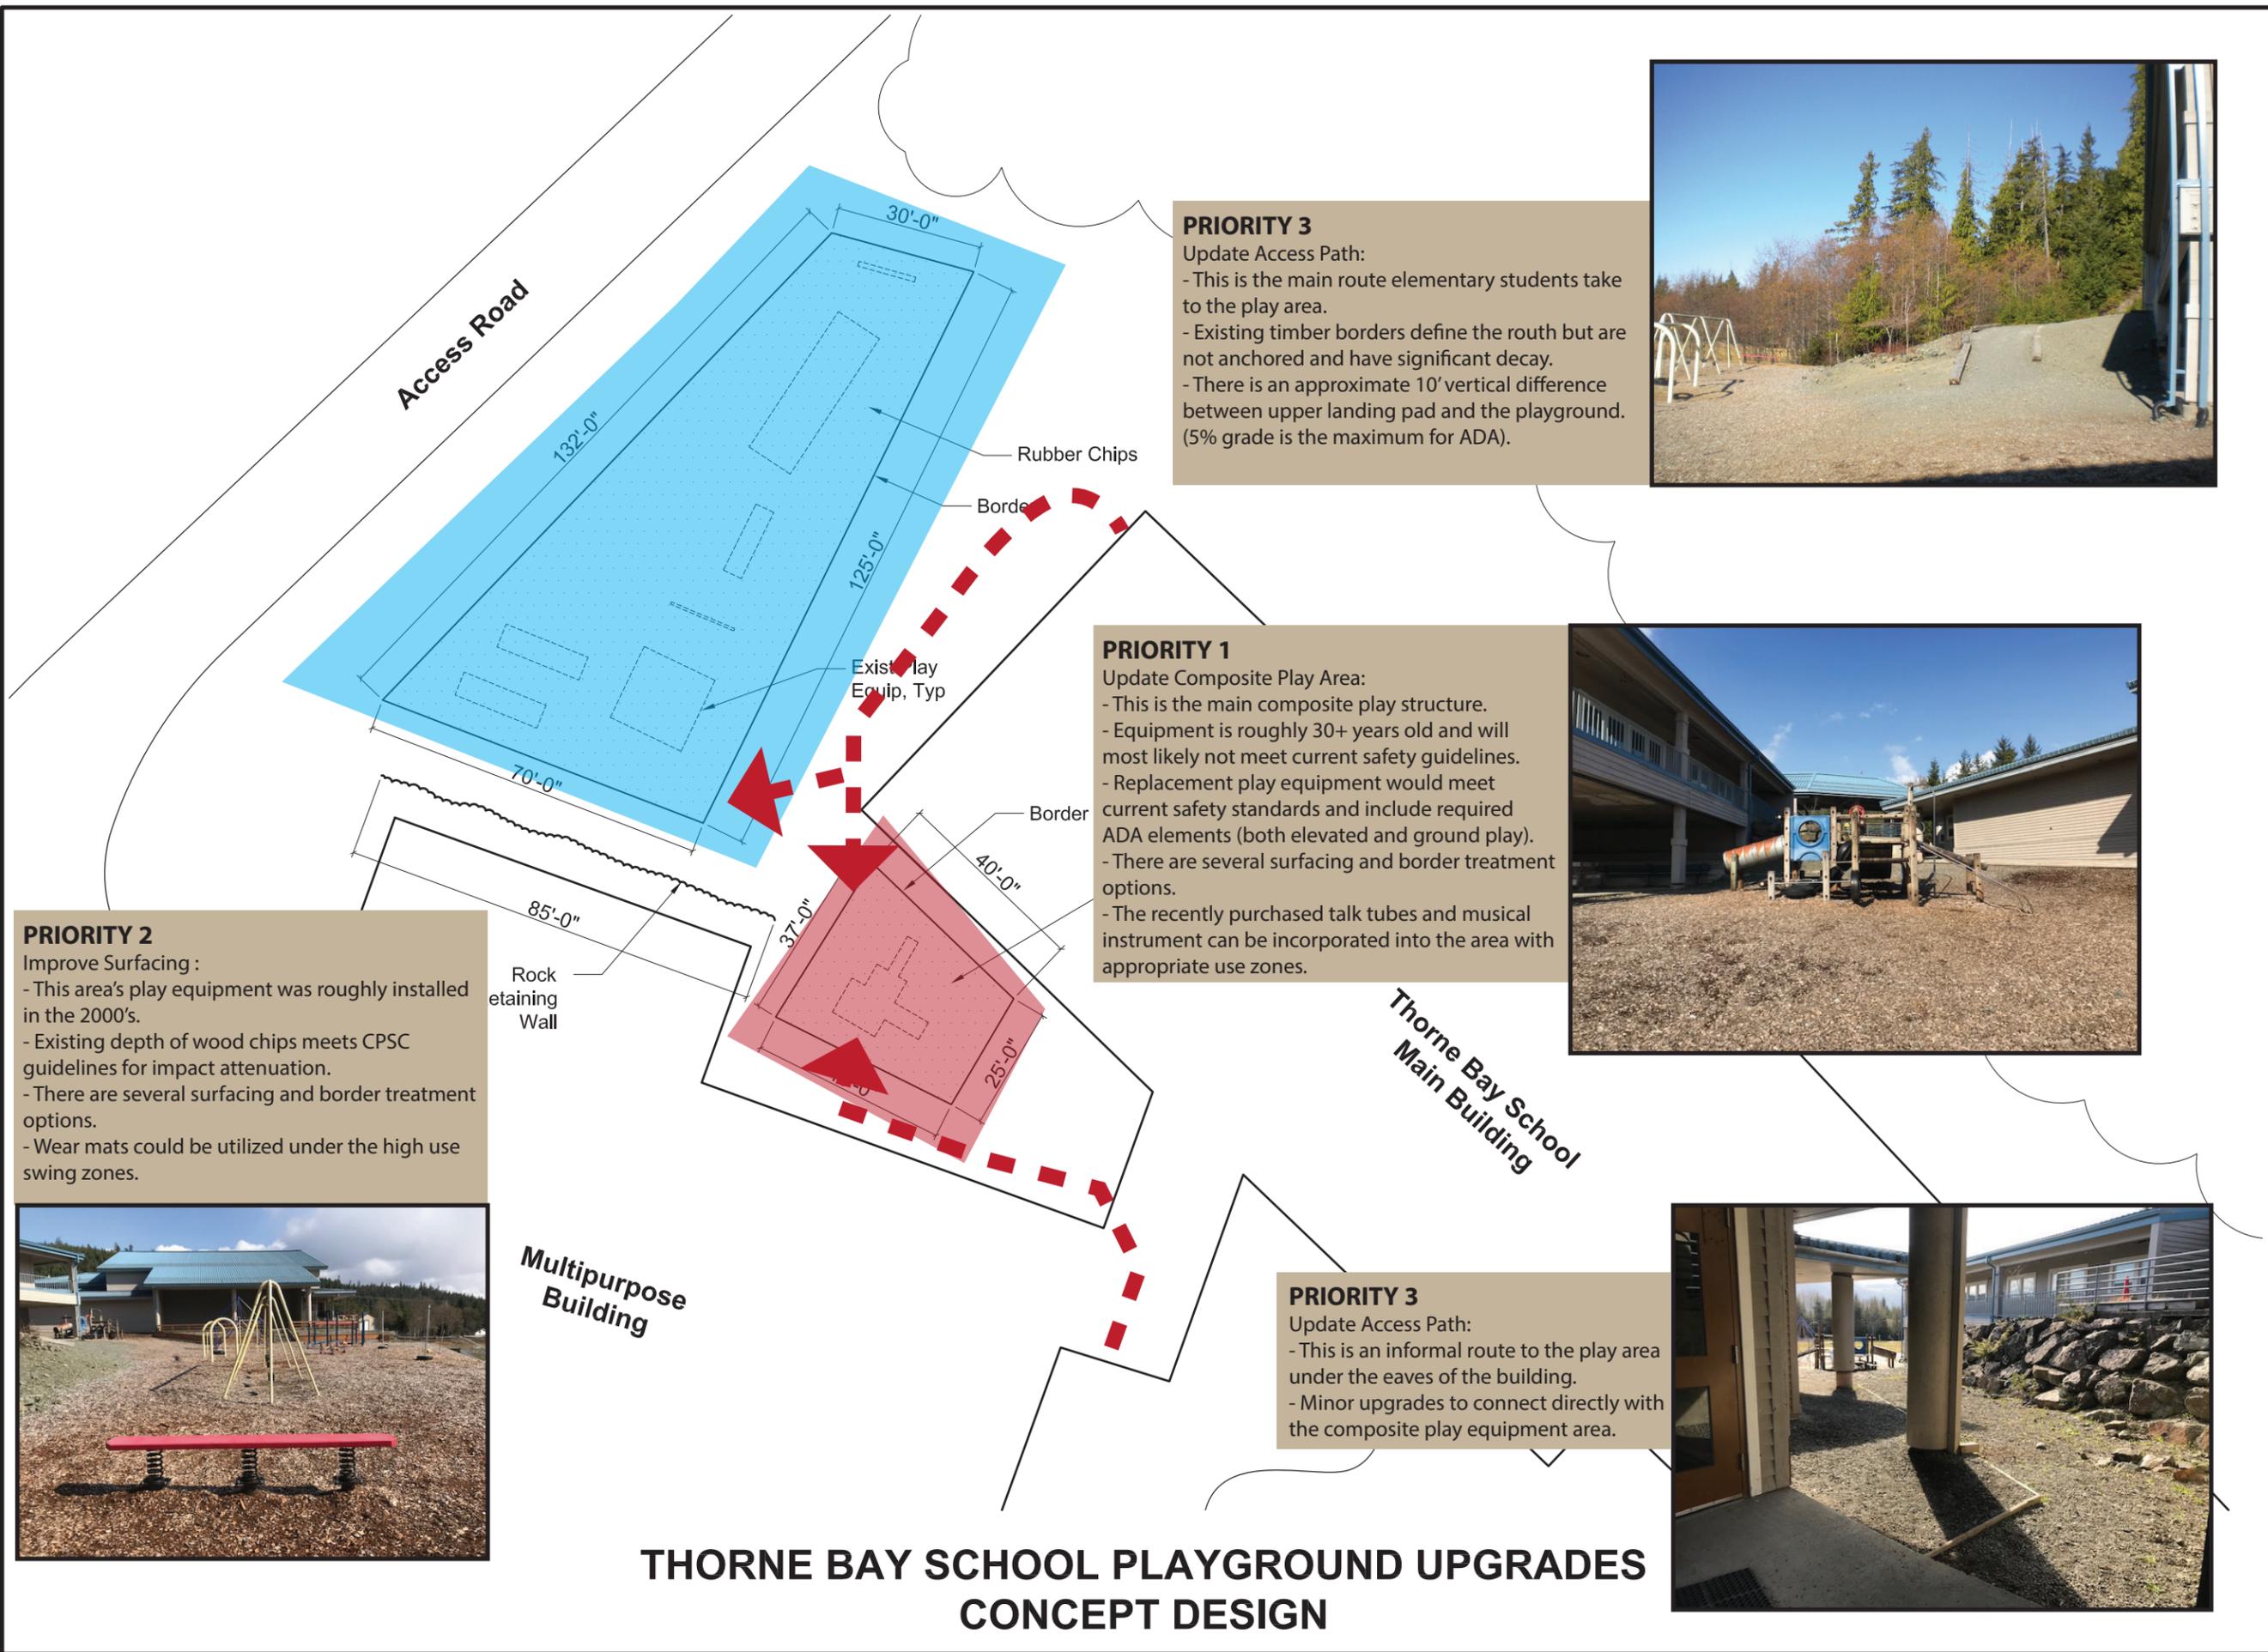
PRIORITY 3
 Update Access Path:
 - This is the main route elementary students take to the play area.
 - Existing timber borders define the route but are not anchored and have significant decay.
 - There is an approximate 10' vertical difference between upper landing pad and the playground. (5% grade is the maximum for ADA).

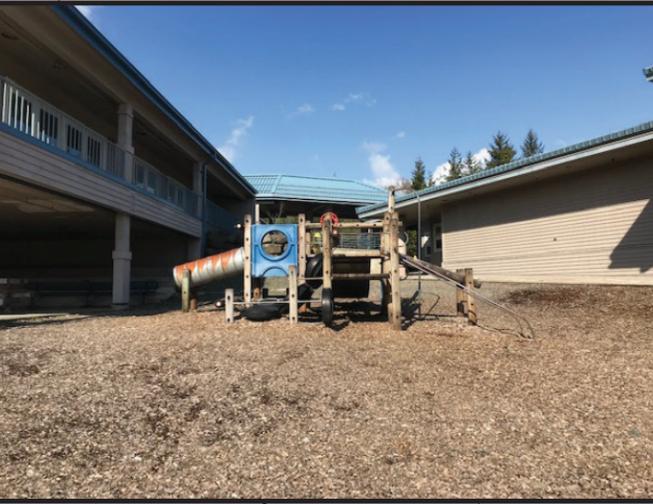
PRIORITY 1
 Update Composite Play Area:
 - This is the main composite play structure.
 - Equipment is roughly 30+ years old and will most likely not meet current safety guidelines.
 - Replacement play equipment would meet current safety standards and include required ADA elements (both elevated and ground play).
 - There are several surfacing and border treatment options.
 - The recently purchased talk tubes and musical instrument can be incorporated into the area with appropriate use zones.

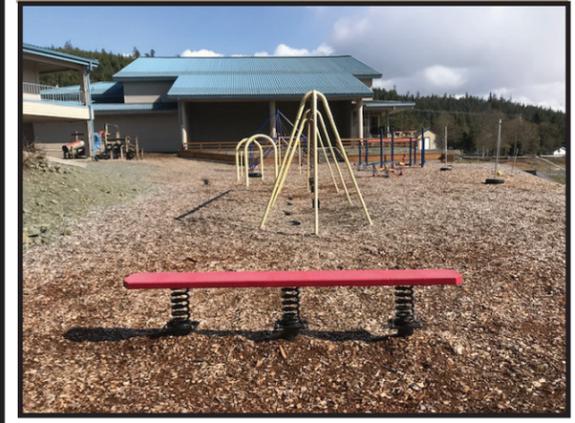
PRIORITY 2
 Improve Surfacing:
 - This area's play equipment was roughly installed in the 2000's.
 - Existing depth of wood chips meets CPSC guidelines for impact attenuation.
 - There are several surfacing and border treatment options.
 - Wear mats could be utilized under the high use swing zones.

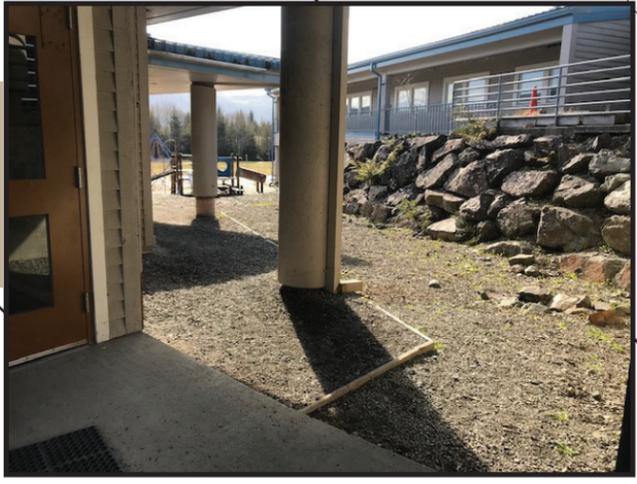
PRIORITY 3
 Update Access Path:
 - This is an informal route to the play area under the eaves of the building.
 - Minor upgrades to connect directly with the composite play equipment area.
