# Aubrey I.S.D Maintenance Department

#### Summer Project Report

A report detailing projects that have been undertaken to improved the quality of facilities district wide.

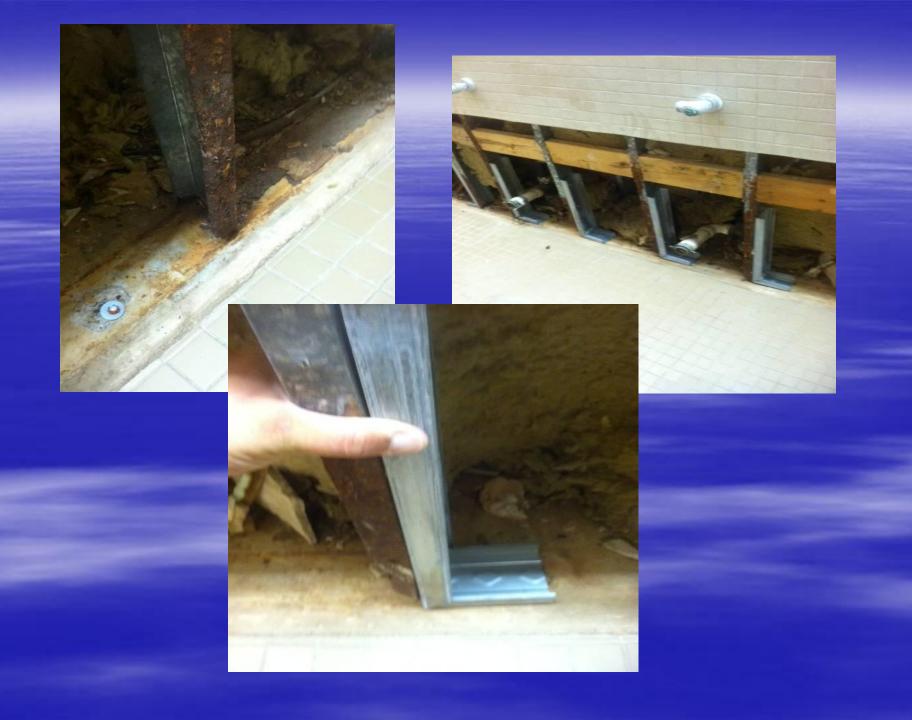
We were forced to deal with walls that had rusted and rotted from years of moisture. The walls were demoed then reattached to the foundation using new metal studs. Drywall was installed to prepare for new tile. All internal plumbing was inspected and prepared for new fixtures.

- The floors and walls were prepared for tile by removing anchors and plumbing hardware.
- Some walls had to be resurfaced to allow for ADA standards.
- New toilets, urinals, and hardware will be installed when tile work has been completed.
- New bathroom stalls will be installed when they arrive.

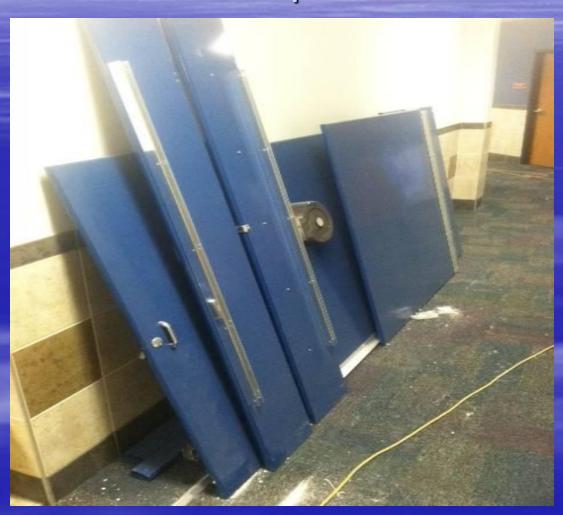
# We were able to save one set of stalls that were new from the previous remodel

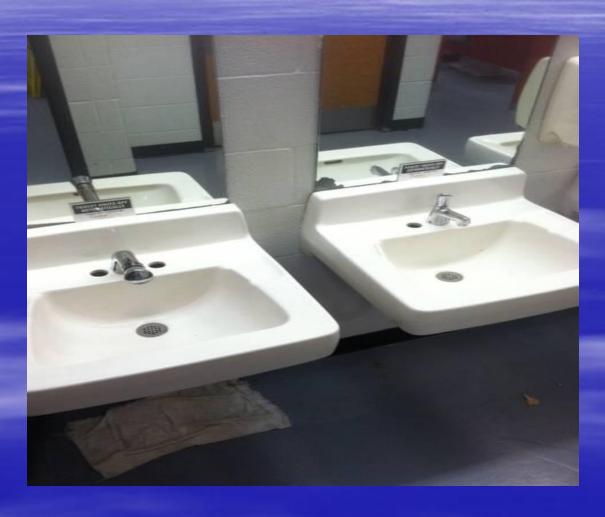
# New metered faucets were installed in the gymnasium bathrooms.

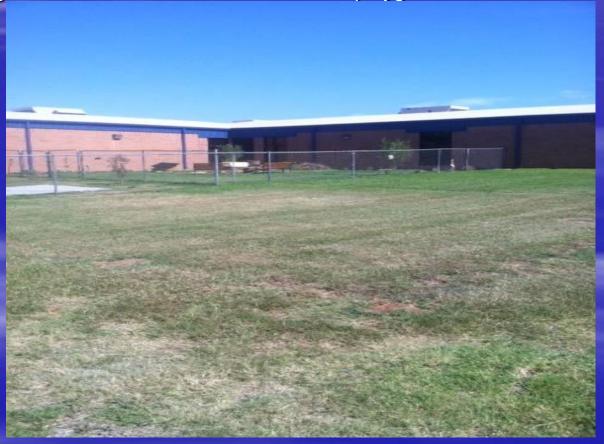
We removed the old fence near the new outdoor learning center and repaired existing chain link gate and fence toward the front of the playground.

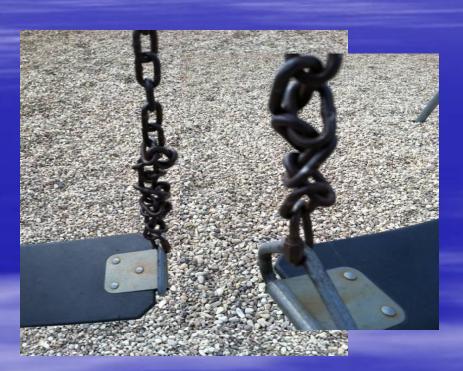
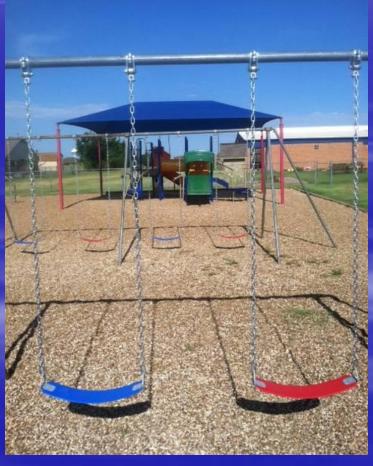
# After some minor incidents last year, we installed all new hardware to existing swings in the front playground area.

(The back playground hardware was replaced last summer)

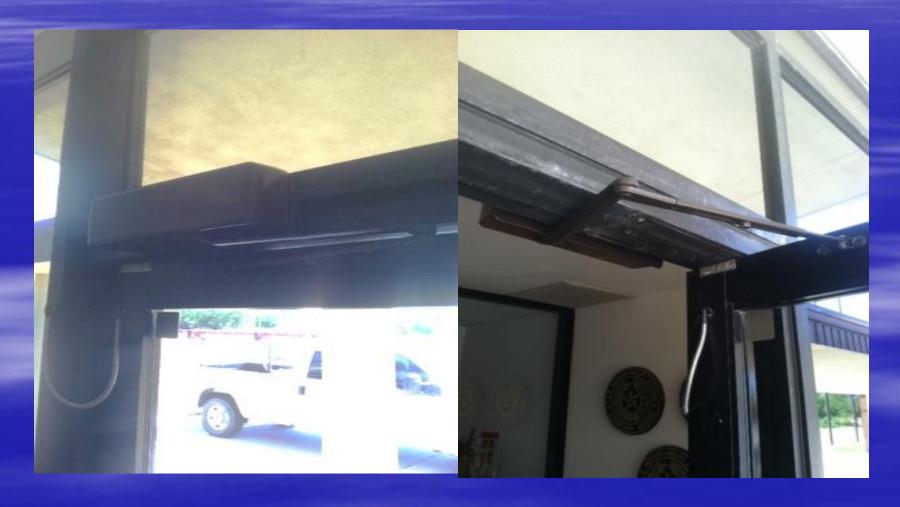
All old door closers for exterior doors were removed due to hazardous operation and an inability to retain adjustment.

All new closers were retrofitted to existing structures creating a much safer and efficient environment for all entry way openings.

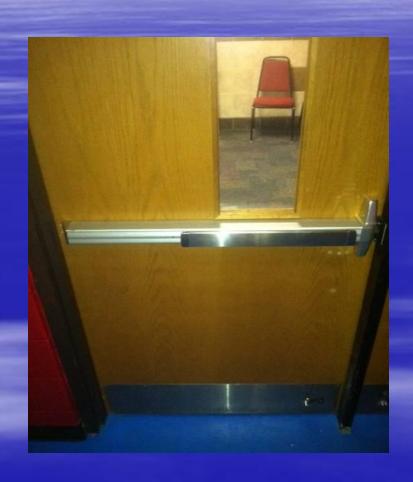
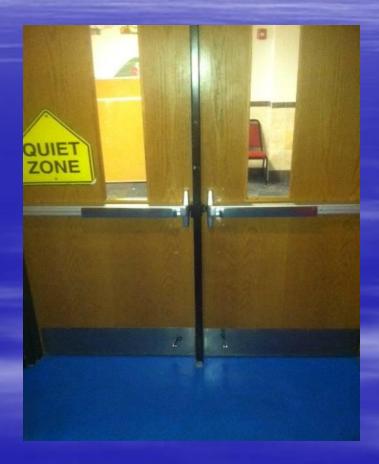
# Gymnasium door panic hardware was replaced to resolve safety issues with old hardware.

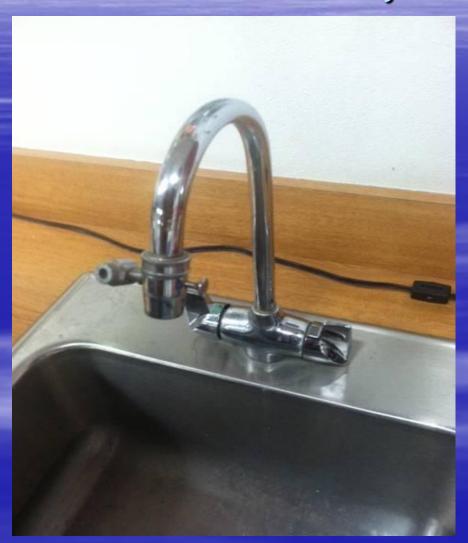
# New faucet seats, stems, and handles were installed on 2<sup>nd</sup>/3<sup>rd</sup> and 4<sup>th</sup>/5<sup>th</sup> hallway faucets

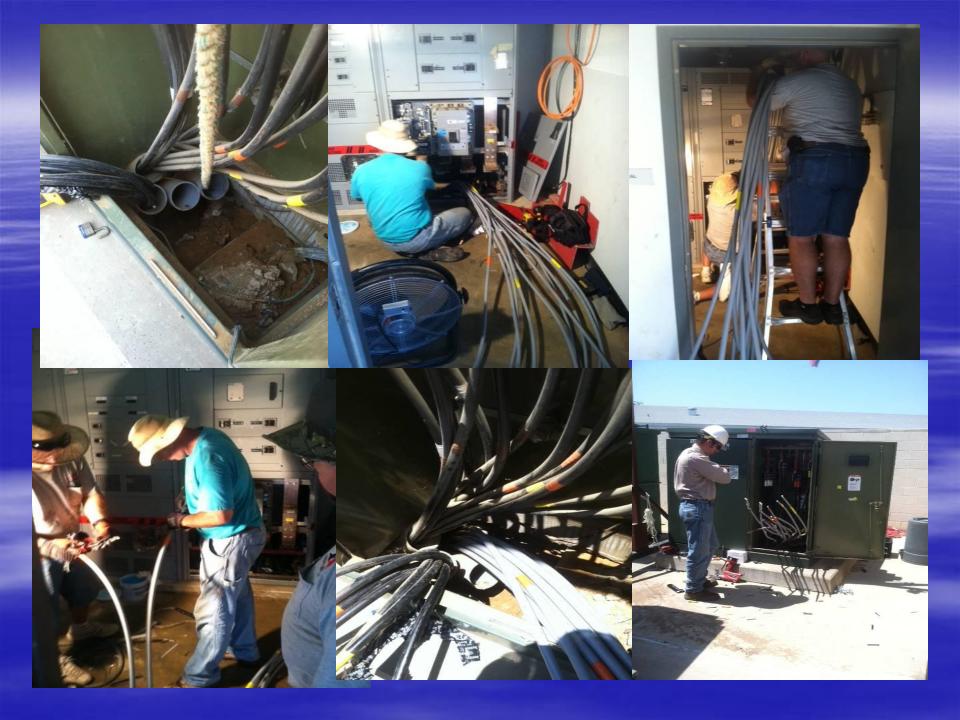
Last year, there was a partial black-out at AMS caused by an underground electrical short in the main line system between the transformer and the main switch gear. The problem was caused by a broken pipe which was damaged during construction.

- Our maintenance team worked with White Electrical service, at a reduced rate, to repair the problem. An attempt was made to remove the old damaged cable but it could not be pulled.
- We utilized existing extra conduit to run 11 more electrical lines from the transformer to the main switch gear at the rear of the school. These lines will accommodate any future electrical needs at AMS.

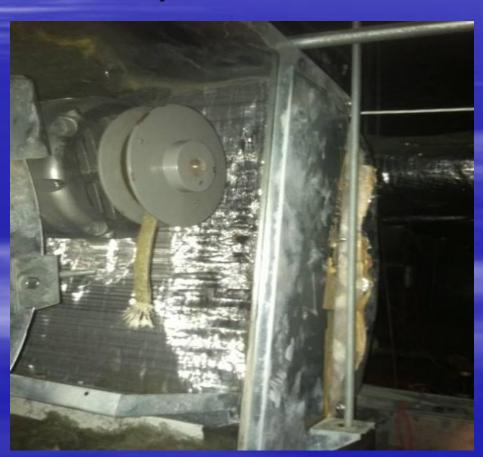
## Damaged HVAC unit

Mrs. Jones began hearing a intermittent noise in the hallway that prompted her to call the Maintenance Department. After an exhaustive search, we found that a HVAC unit had thrown a belt. The unit only came on when the energy management system called for cooling at the unoccupied set point. Upon inspection we discovered that the broken belt had not released from the pulley and had destroyed a sizable portion of the coils.

- We contacted Berger Engineering who has given us prices for both repair and replacement of the unit.
- Berger Engineering is pursuing an inquiry into the cause of the belt breakage which had been replaced during Berger's preventative maintenance schedule only 6 months earlier.
