Oak Park Elementary School District 97

Julian Middle School
Home of the Jayhawks

Site Improvements

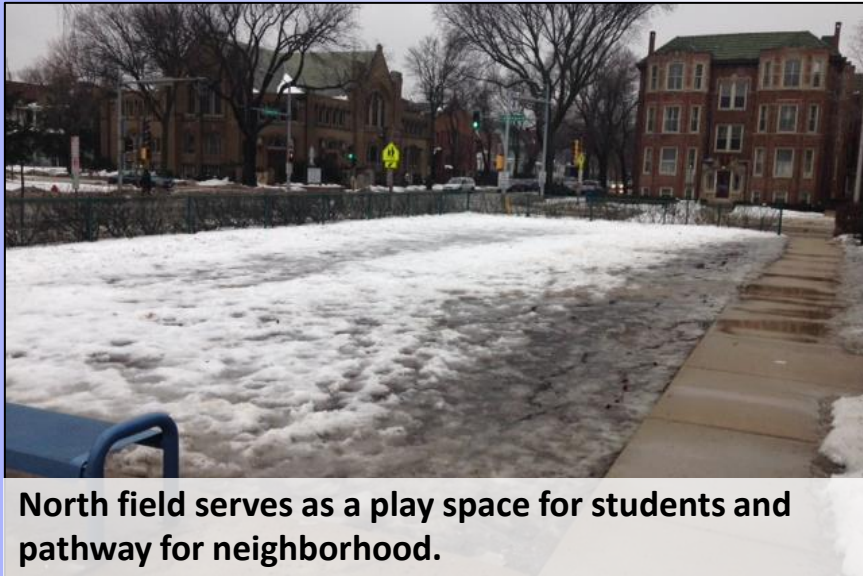
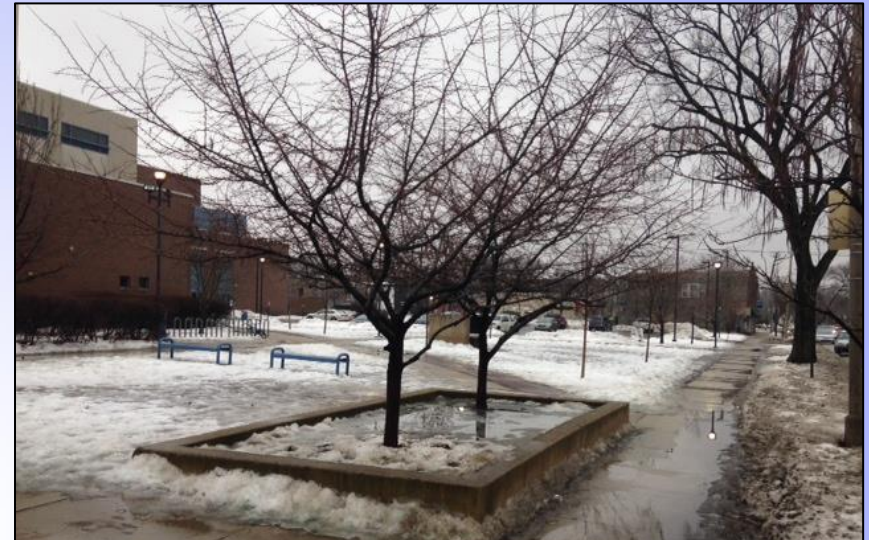
CONDITIONS

- **Poor Lawn Conditions**
- **Desire Lines**
- **Underutilized Planter**

Raised concrete planter acts as an obstacle in the student circulation.

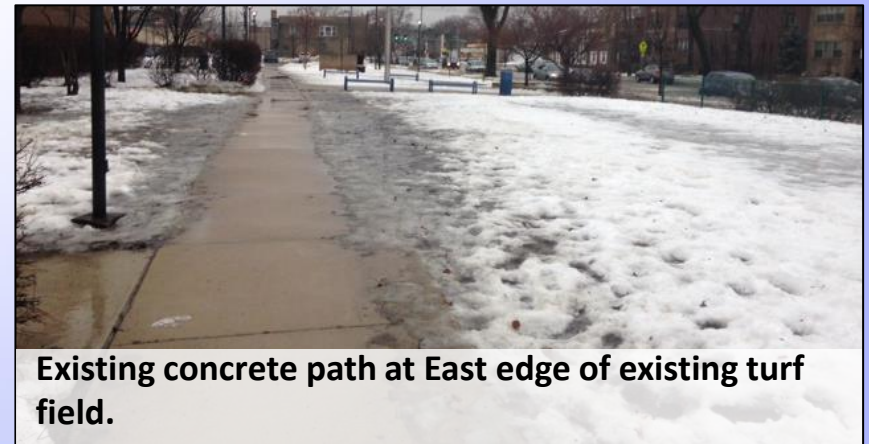
Existing concrete path at East edge of existing turf field.

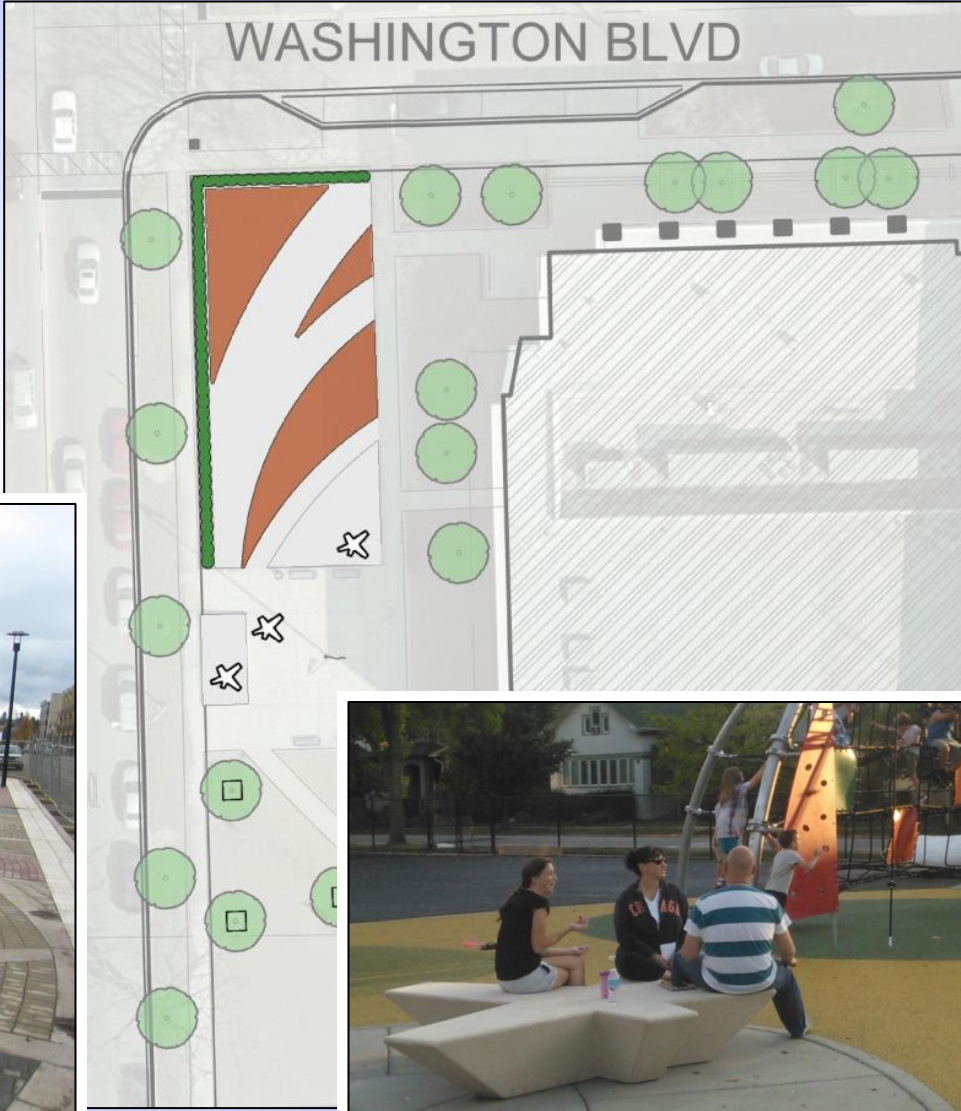
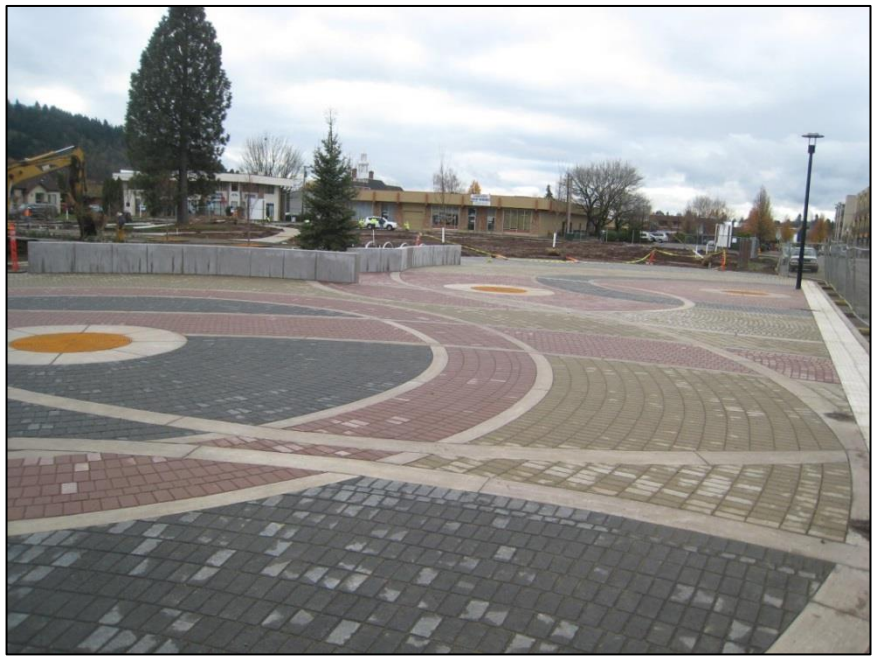
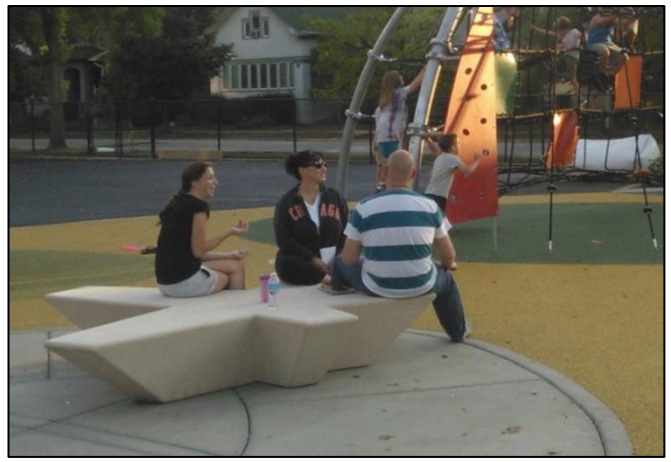
Site Amenities:

- Added Gathering Space
- Connected Entries
- Added Seating
- Wider/ Paved Desired Routes

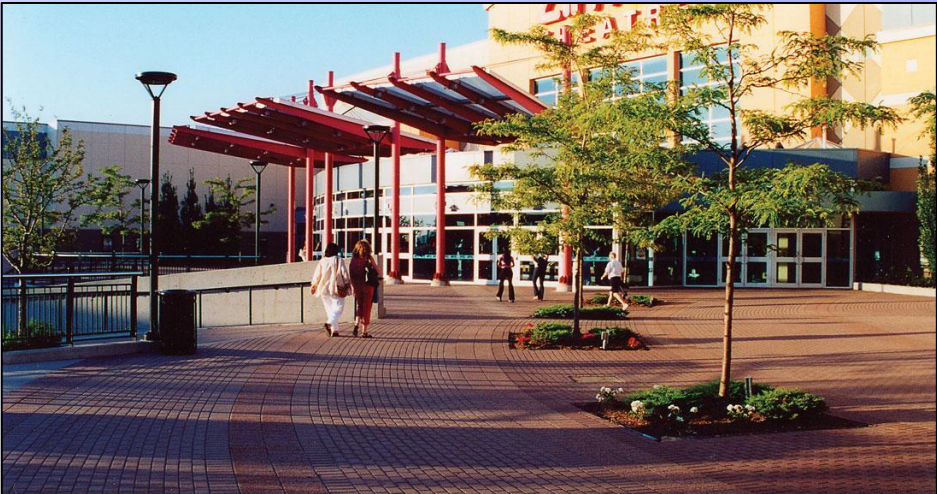
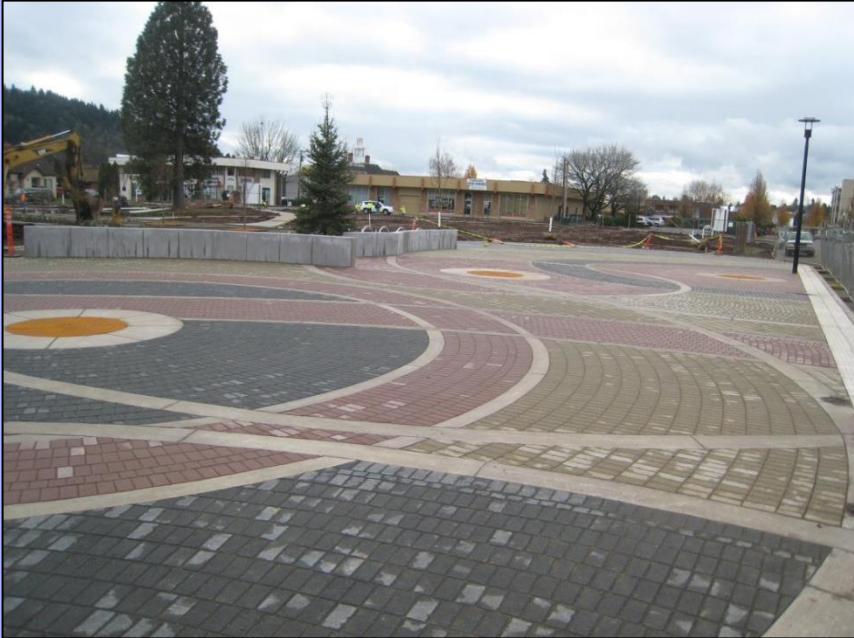
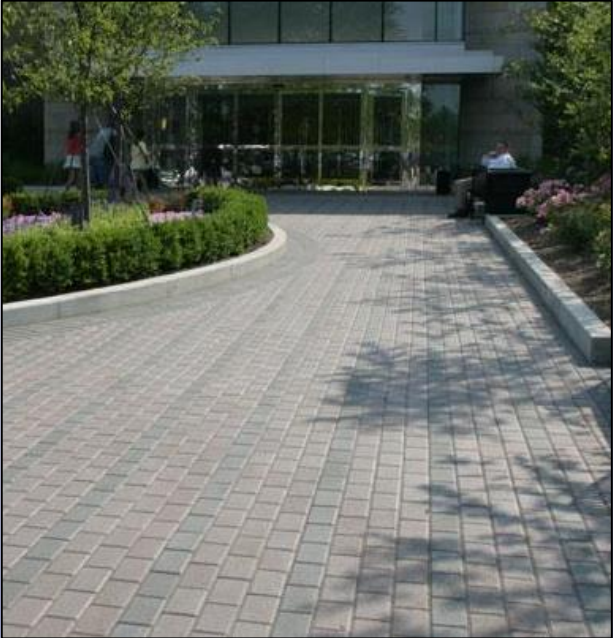
Site Amenities:

- Concrete Paver Surface

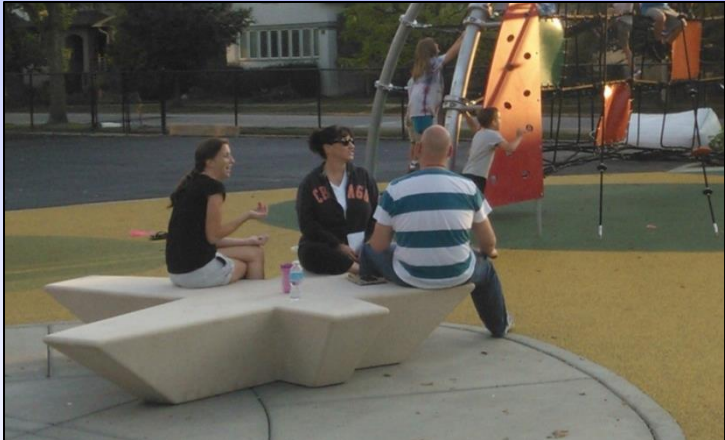
Site Amenities:

- Flor Star Bench
Size : 106" x 97"
Material : Precast Concrete
Color options -
