CONSTRUCTION OBSERVATION REPORT

PROJ NO: 1715	PROJECT: SSSD150 - Tigert Middle School	DATE: 2018,05-08
TIME: 9:00 am	WEATHER: Clear, Warm	TEMP: 46° F
CONTRACTOR:	Headwaters Construction Company	
PRESENT AT SITE:	Dr. Molly Stein, Superintendent, SSSD150 (OAC) Jonathan Balls, Business Manager, SSSD150 (OAC) Bob Gentry, Director of Facilities, SSSD150 (OAC) Logan Bingham, Project Manager, HCC (OAC) John Eskelson, Project Engineer, HCC (OAC) Michael Adams, Project Superintendent, HCC (OAC) A+ Construction Garrett Chadwick, Principal Architect, GPCA (OAC)

The following report and photos describe the status of the Project as of 05.08.2018:

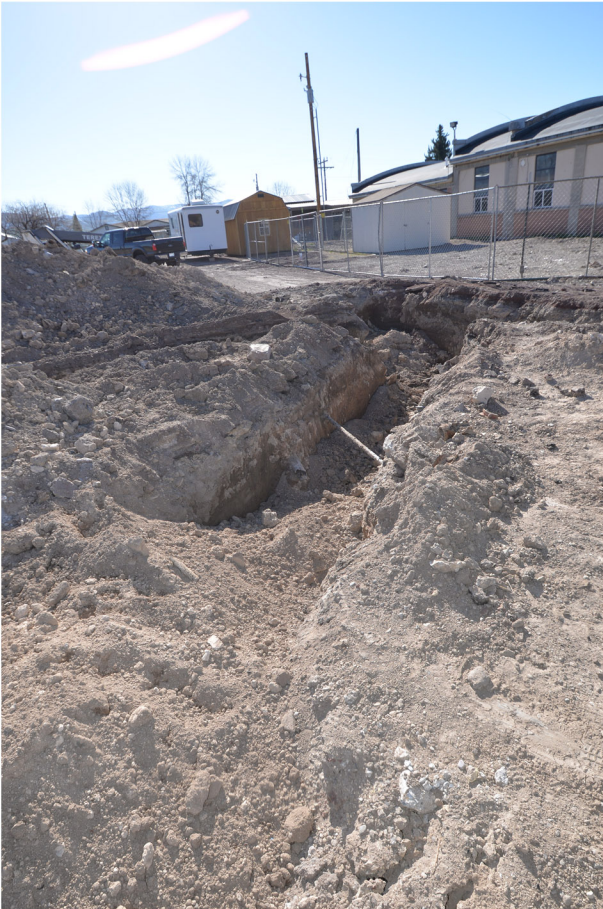
01 - Sewer Line Excavation.JPG

- The sewer line is intended to be routed from the administration building along the east side of the gymnasium addition in its existing trench. It will turn to the west after it passes the north corner of the gym and bypass the manhole it currently ties into and extend to the next manhole to the west. The sewer from the gym will extend north from the toilet rooms out the north wall and connect to the new sewer line.

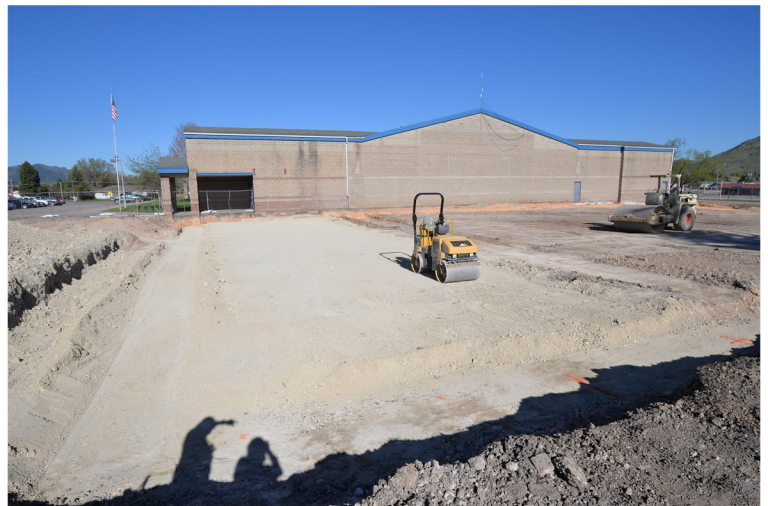
04 - Gymnasium Excavation.JPG

- The sub grade beneath the slab in the gym is not compacting to its required density. The cinder mix will likely have to be removed and replaced with structural fill.

- Subgrade has been excavated at the gymnasium addition. The perimeter footings have, for the most part, met the compaction density requirements. A+ will continue to work in this area in preparation for the concrete formwork and concrete placement.

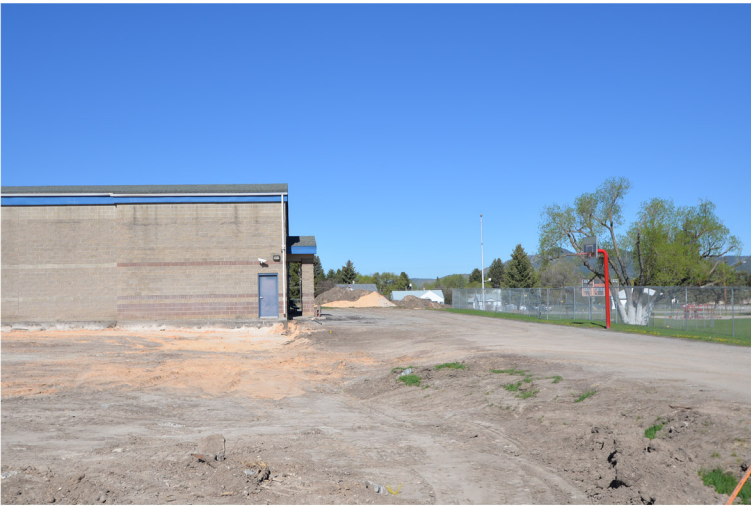
07 - Gymnasium and Classroom Excavation.JPG

- The fill beneath the classroom addition needs to be excavated and replaced. The existing material can be used, but it needs to be placed per the density requirements.
