Texas Education Code 37.108(b) states: At least once every three years, each school district or public junior college district shall conduct a safety and security audit of the district's facilities.

## RECOMMENDATIONS

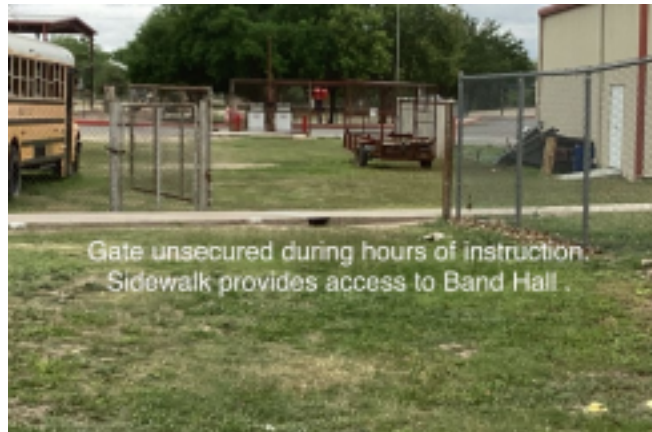
**Perimeter fencing at the band hall.** The fencing at the back of the campus does not currently extend to fully enclose the band hall. Extending the perimeter fence to include the band hall would close a known gap in the campus boundary and bring the fence line into alignment with TxSSC perimeter recommendations. This work should be scoped and included in the next facilities improvement cycle.

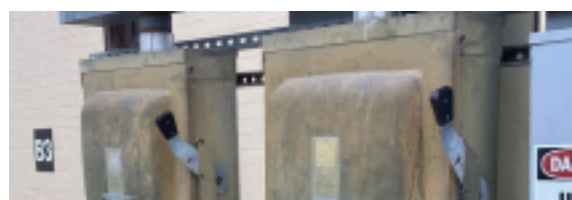
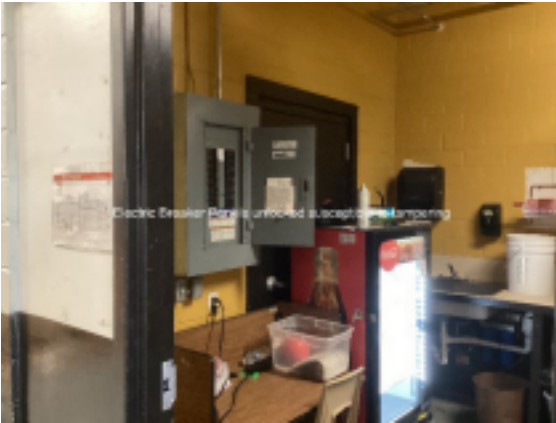
**Securing campus electrical mains.** The electrical mains located in the central area of the campus should be physically locked to prevent unauthorized access or tampering. A locked enclosure or panel cover with controlled key access is consistent with both TxSSC and NFPA 70E guidance, and should be installed as part of routine facilities maintenance.

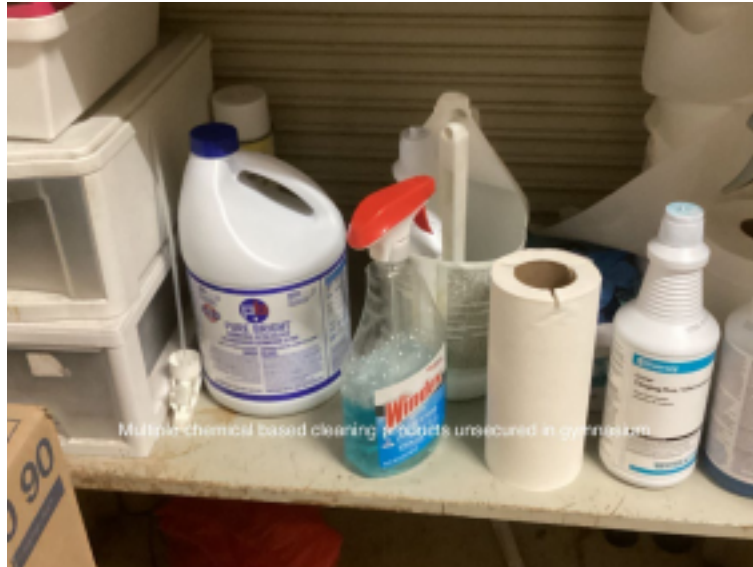
**Cleaning chemical storage.** Cleaning chemicals — particularly any that could become hazardous if mixed — should be securely stored in a locked, ventilated, and clearly labeled location, and a current Safety Data Sheet (SDS) binder should be maintained at each storage point. The district should verify that custodial staff have received refresher training on safe handling and proper segregation of cleaning agents.
