TODD HALL FIRE ALARM PATHWAY AT LIBRARY

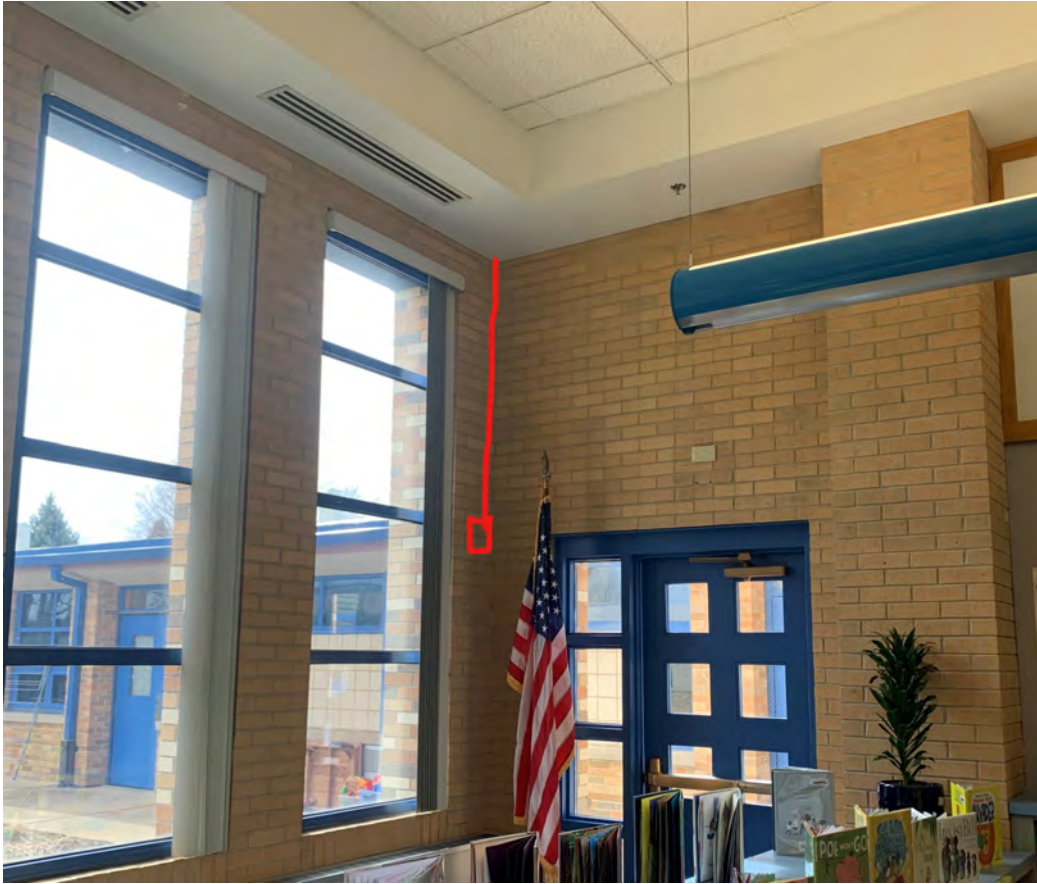
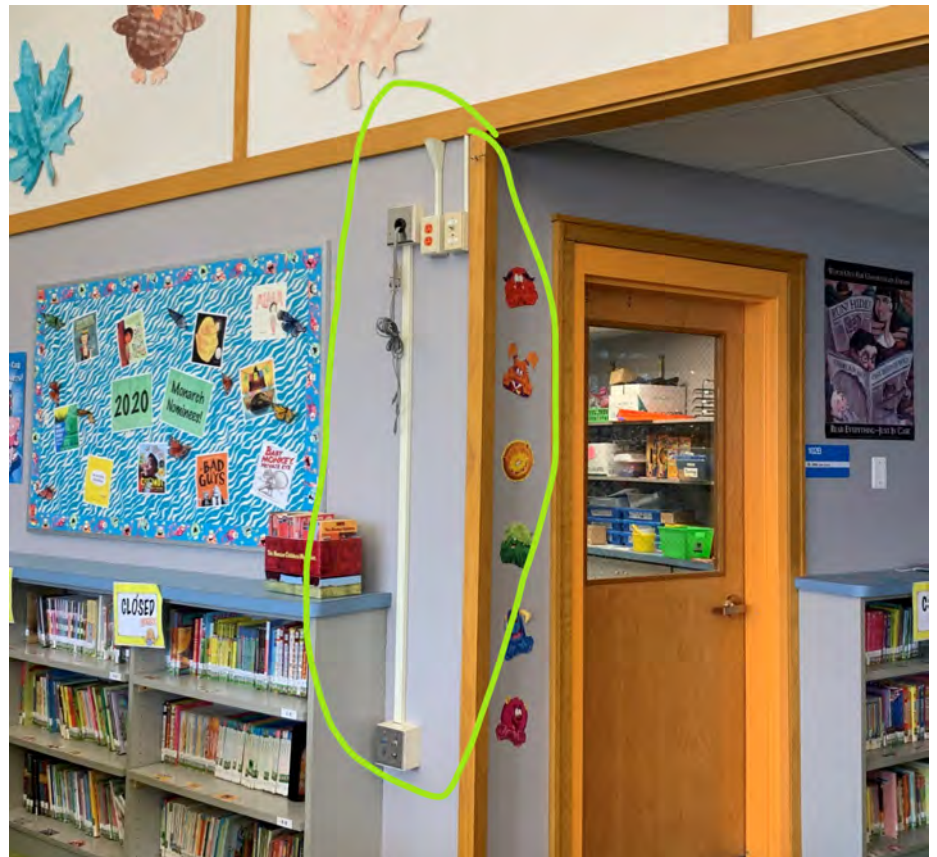
Option 1: Painted wiremold inside library with backbox, through wall to device in courtyard.
No conduit/wiremold on exterior of building.

Library has existing wiremold now in some locations

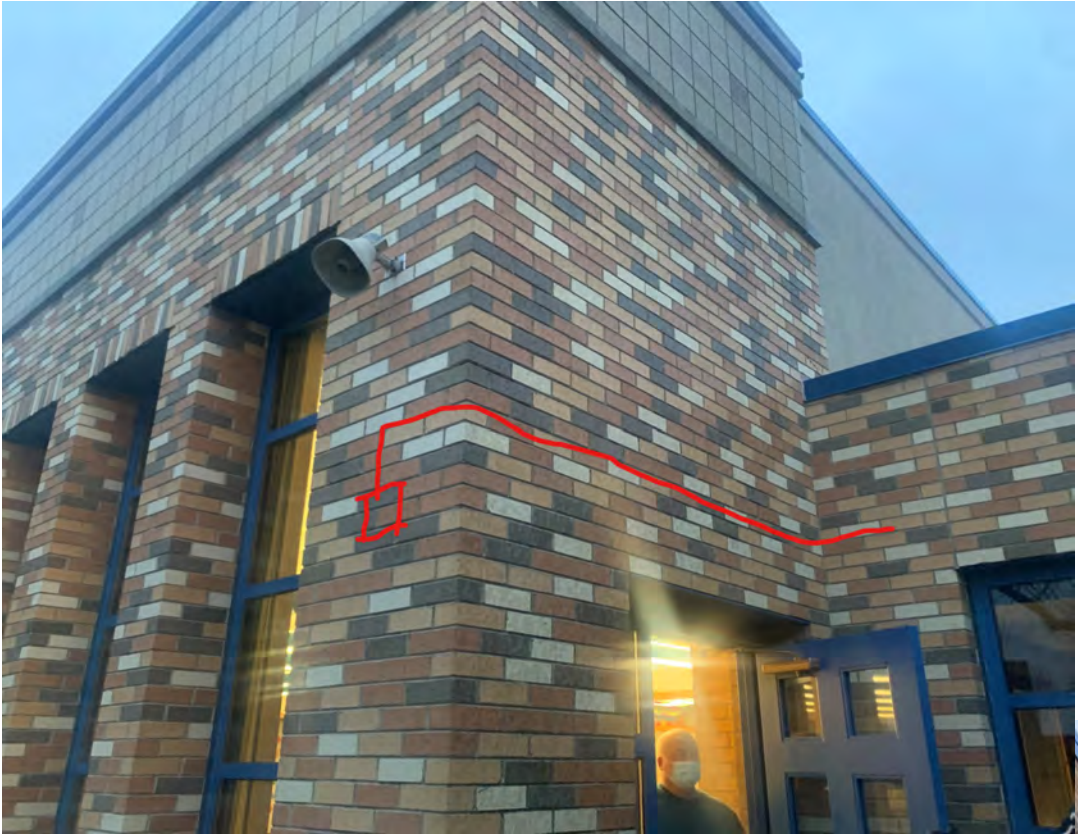
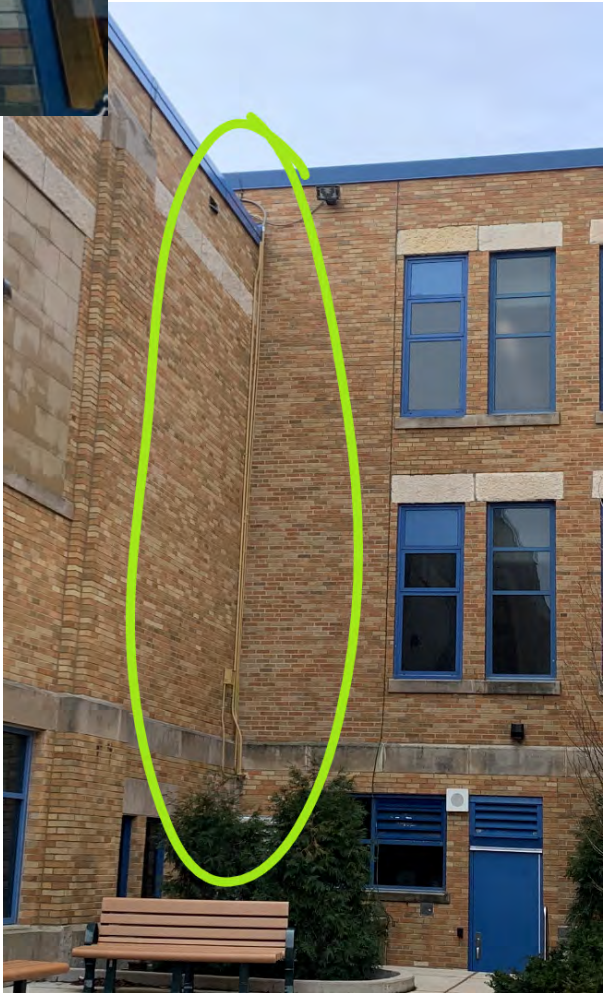
Option 2: Painted conduit on outside of building in courtyard to device. No wiremold in library.

Other locations of painted exterior conduit exist in district (north courtyard at Lincoln Hall)
