Guadalupe Appraisal District

The Guadalupe Appraisal District Board of Directors **(BOD)** has adopted Resolution 2025-03 proposing the acquisition and renovation of the historic Mary B. Erskine Building located at **216 East College Street, Seguin, Texas**, as the future headquarters of the Appraisal District.

As detailed in the attached **Mary Erskine Building Assessment Report** (dated May 6, 2025), the facility requires extensive renovation and modernization to be repurposed for government administration and public services. The **total Probable Project Cost is estimated at \$8,401,765**, which includes design, construction, project management, contingency, and all associated costs necessary to bring the facility into full operational use.

MAY 6, 2025

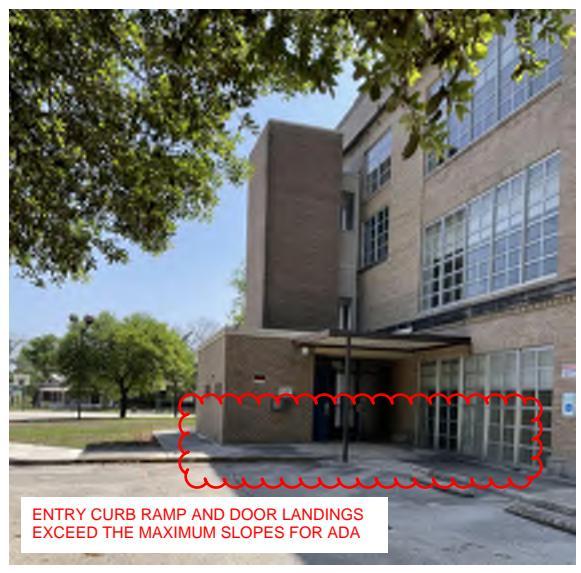
The front entry curb ramp and door landings exceed the maximum slopes for ADA Many areas of the concrete sidewalks to the building are cracked, spalled and uneven Rework concrete front entry steps for compliant entry

Figure 1: Entry sidewalk & curb ramp

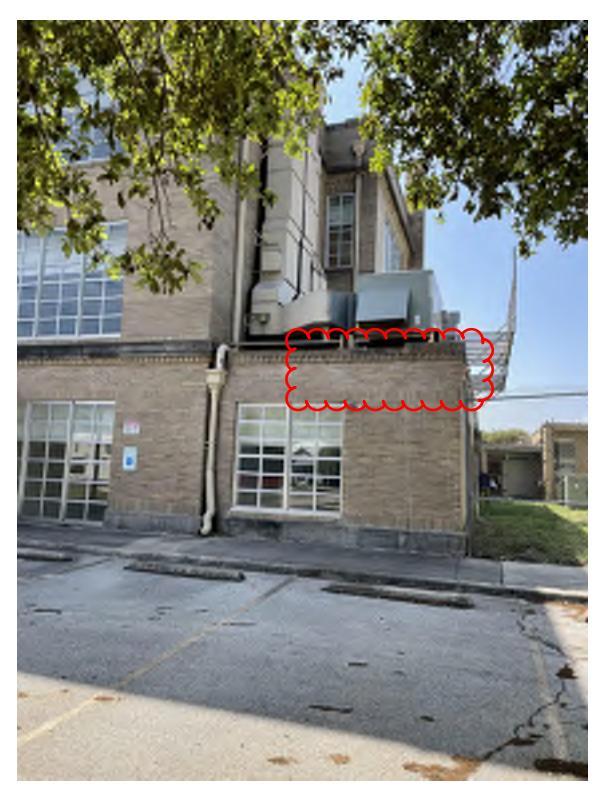
Figure 4: Repoint minor cracking of brick

Provide minor repointing of brick (repair noted in limited areas)

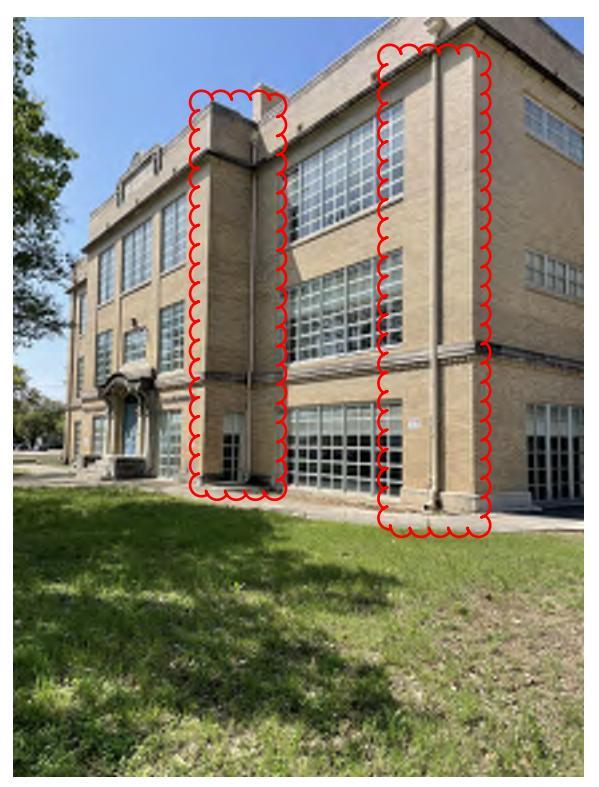
Existing roof downspouts drain across public sidewalks which can cause slippery, unsafe conditions. Consider installing sidewalk trench drains to divert drainage to grassy areas.

Figure 7: Consider installing trench drains for downspouts

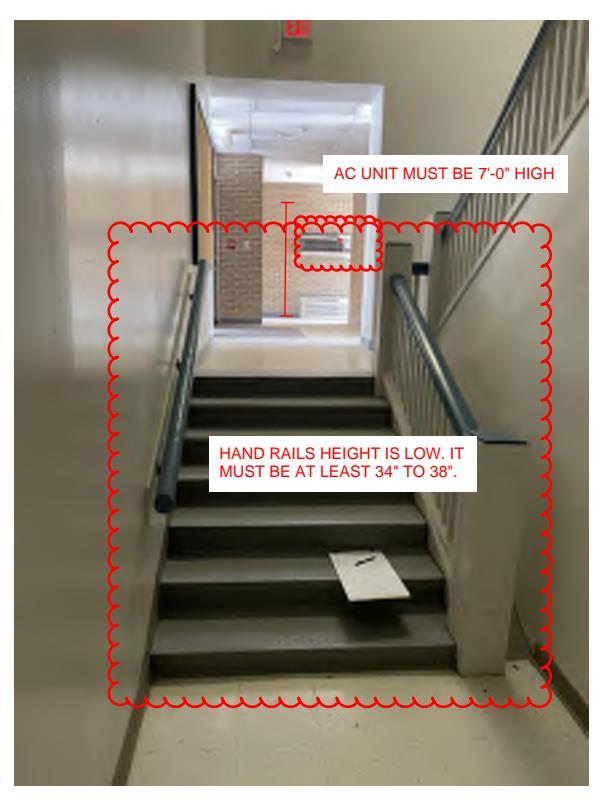
Figure 9: Stair handrails & AC unit not ADA complaint

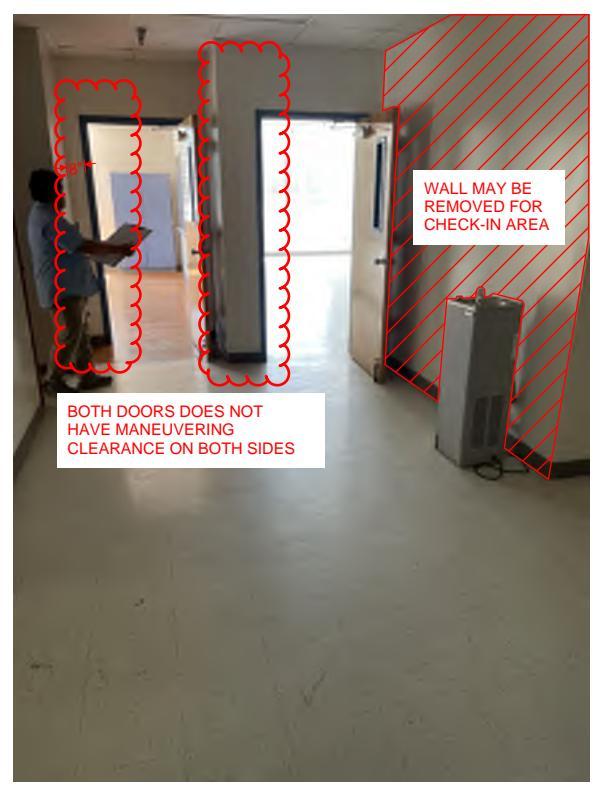
Figure 11: First Floor Basement interior doors

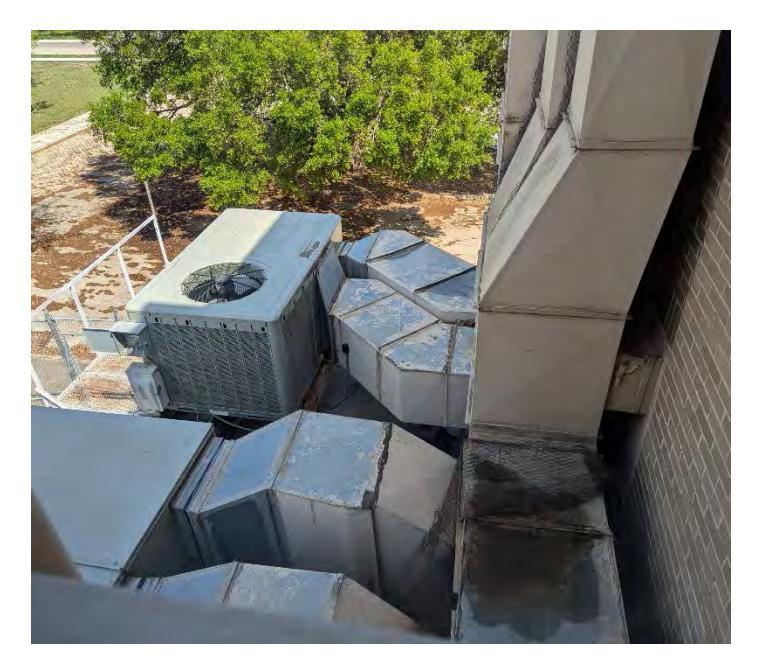
Figure 2. Packaged RTUs as seen from indoor space

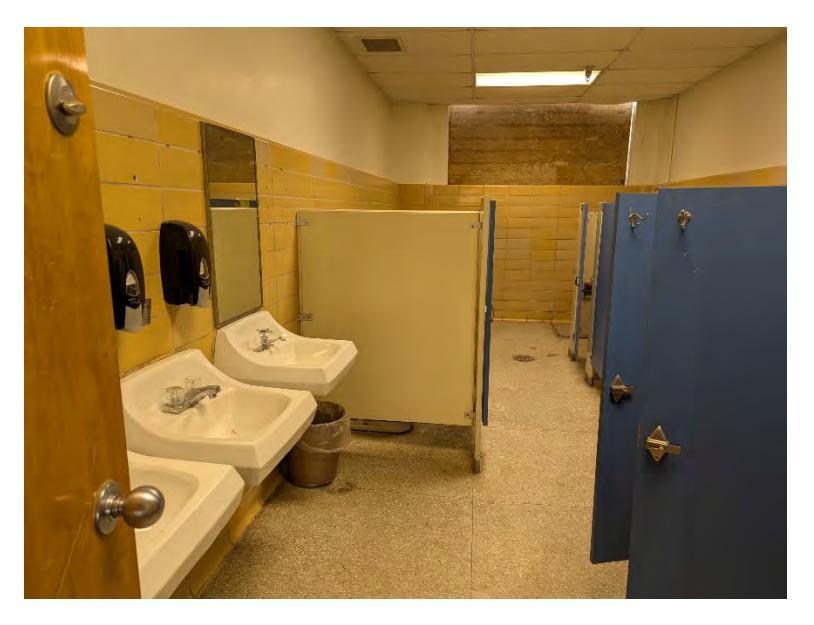
Figure 4. Typical restroom layout

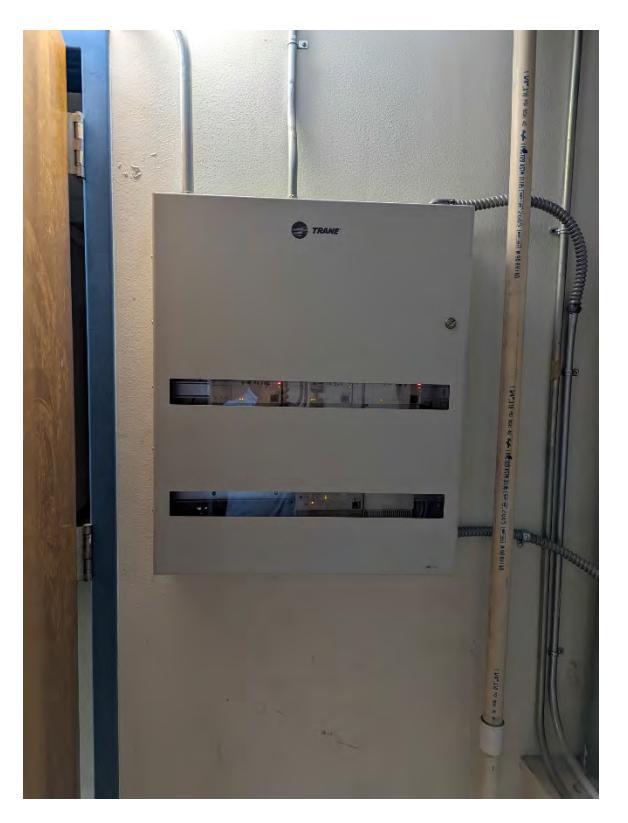
Figure 6. First floor controls cabinet

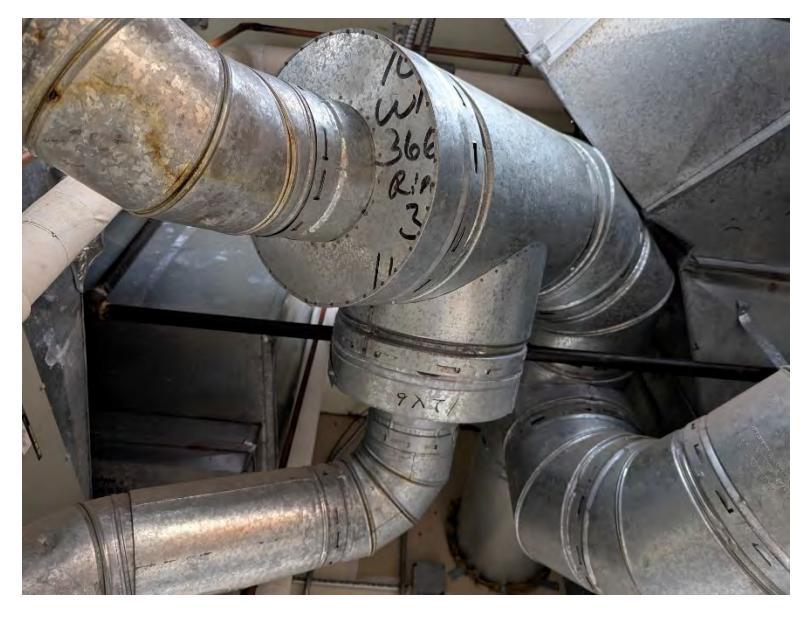
Figure 8. Various ducts tied to vertical air handlers

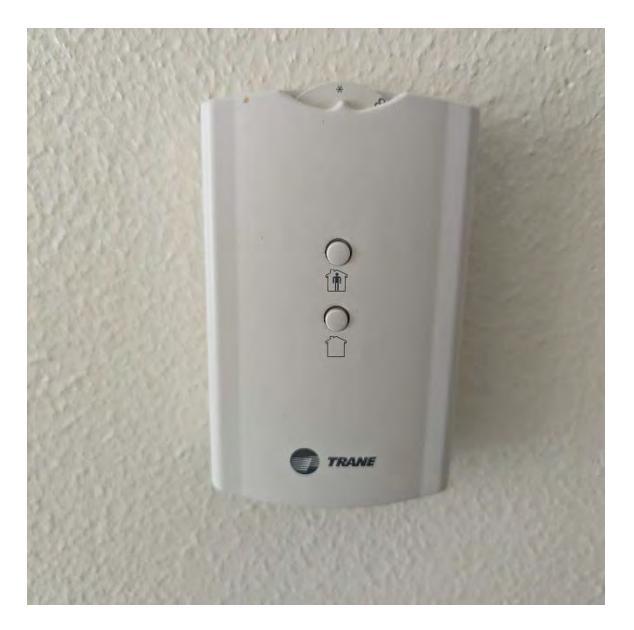
Figure 9. Second floor standalone control thermostat

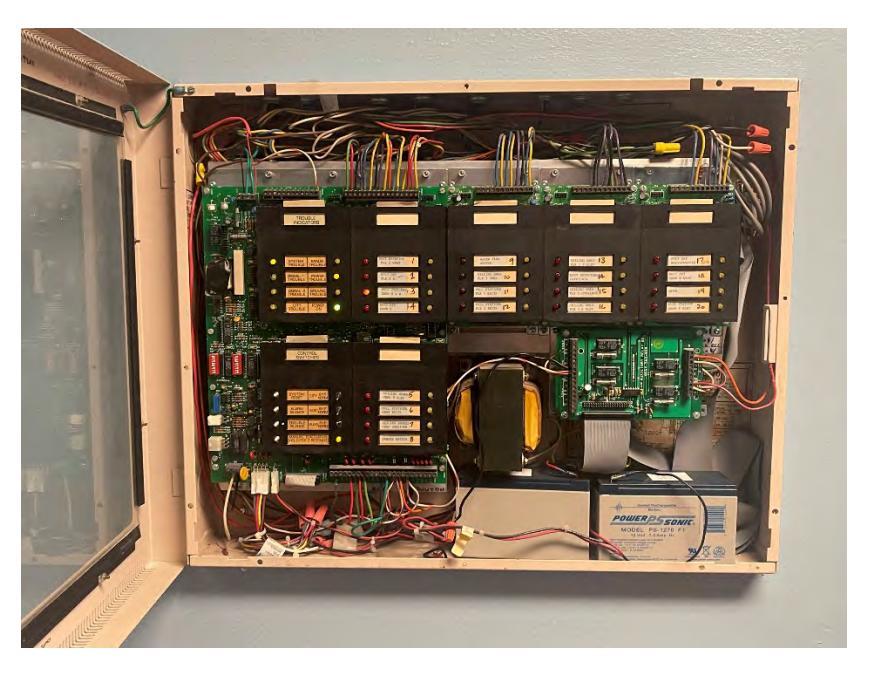
Figure 14. Existing fire alarm control panel
