Geneva Community Unit School District #304
Operations and Maintenance
5 and 7 Year Capital Improvement Plans

Finance Committee Meeting
March 10th 2014

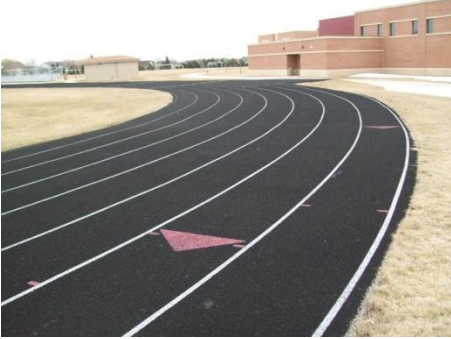
Track – installed in 2005

Track resurfacing is normally required every 8-10 years.

Excessive wear spots are apparent.

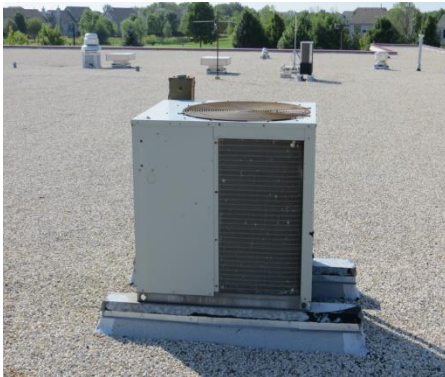
Work Room HVAC System

Original Unit installed for the building.
