Facility Condition Assessment

Granby Memorial Middle School FCA

321 Salmon Brook Street

May 12, 2025 | Project Number: FR256003

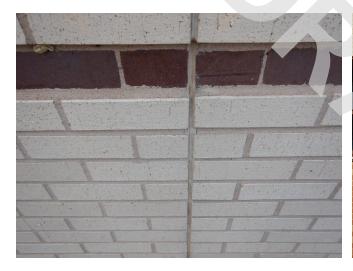
Elastomeric sealant.

- Apply a penetrating masonry sealer.
- Remove and replace deteriorated sealants at the perimeter of the window and door assemblies and penetrations.
- Replace loading dock manual, steel, overhead doors.
- Repoint exterior masonry.

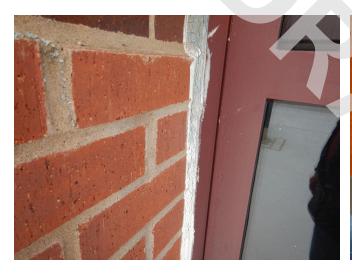
View of elastomeric sealant around the door.

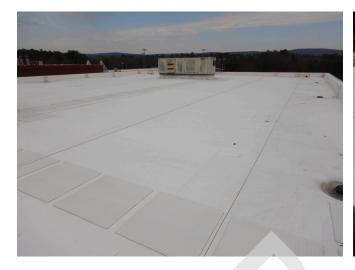
Gym: Roof overview facing northwest.

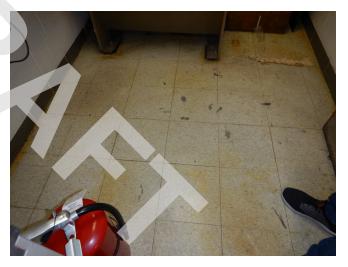
Elevator equipment room flooring.

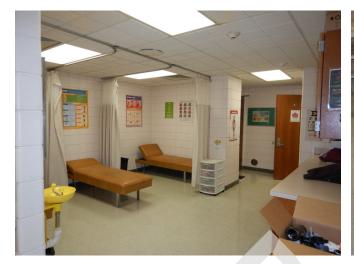
Overview of the Clinic.

Clinic flooring finish.

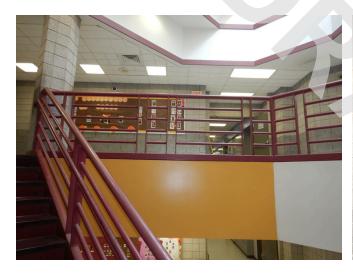
Upper level corridor wall finishes.

2nd floor classroom corridor.

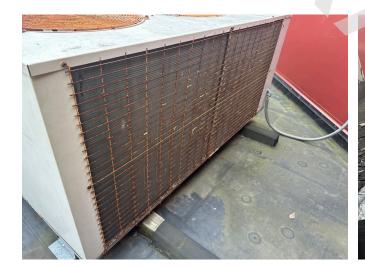
- The exterior ductwork of RTU-7 was observed in poor condition. The insulation was observed with portions of the sealant detached and insulation exposed. Additionally, the DSC reported previous occurrences of leaks associated with the ductwork. Replacement of the exterior ductwork is recommended as part of routine maintenance. No cost is included in the Costs Tables.

Typical condition of exterior ductwork.

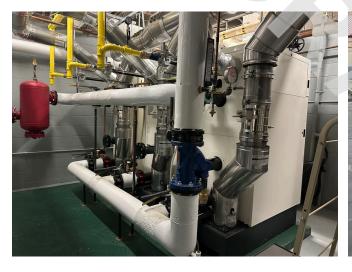
Typical condensing water boilers.

Replacement of the boilers and HHW pumps.

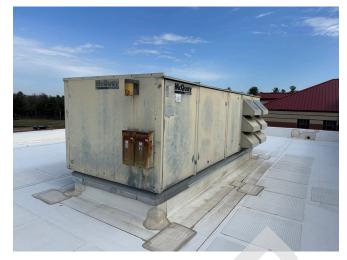
- The exterior AHUs were observed in generally fair to poor condition and at the end of the expected EUL. The AHUs were observed with surface corrosion on the enclosures and disconnect switches, non-sealing access doors when in the latched position, broken exterior service lights, and deteriorated refrigerant piping. No replacements or refurbishments of the units were reported by the DSC. Refurbishment and/or replacement of a portion of the AHUs is recommended early in the evaluation period. A cost is included in the Costs Tables.

Typical roof-mounted VAV-AHU with heating only.

DX mini-split-system cassette unit.

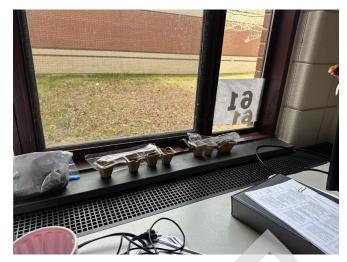
Typical HHW baseboard unit heater.

Typical roof-mounted AHU with heating and cooling coils.

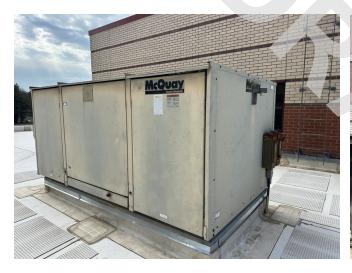
- The DOAS was observed in generally fair condition and at the end of the expected EUL. The DOAS was observed with surface corrosion on the enclosures and disconnect switches and non-sealing access doors when closed. Replacement of the OAHU is recommended early in the evaluation period. A cost is included in the Costs Tables.

DOAS. Dust collector.

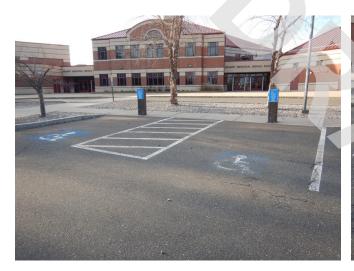
Accessible parking at the front elevation of the building.

Create new van-accessible parking space.

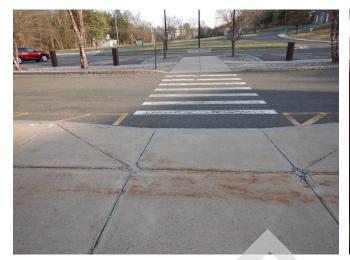
Route to an accessible building entrance.
