Geneva CUSD 304 5-Year Capital Improvement Plan 2013

Geneva Community Unit School District #304

April 8, 2013

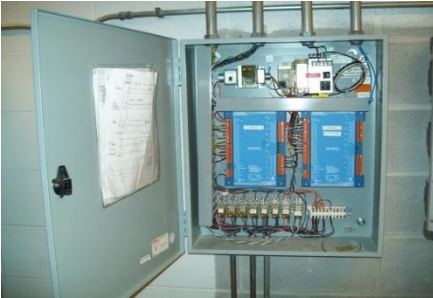
Lon Controller

Lon controls throughout the building

Outdated and costly to repair

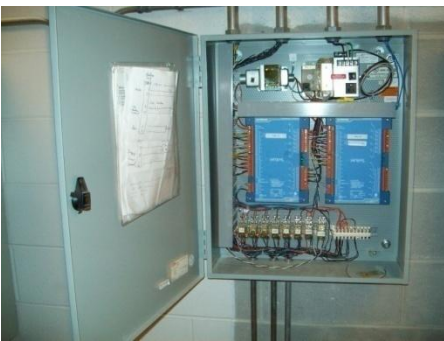
Lon Controller

Lon controls throughout the building

Outdated and costly to repair

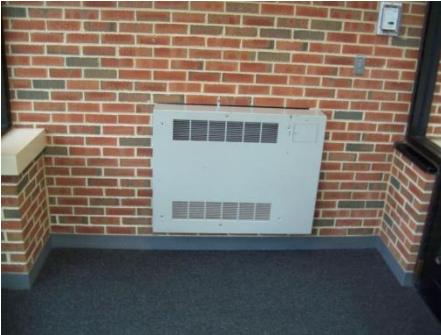
Cabinet Unit Heaters

15 units are over 35 years old.

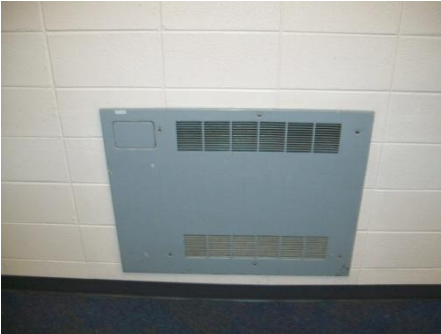
Cabinet Unit Heaters

9 units are over 20 years old.

Blowers are failing.

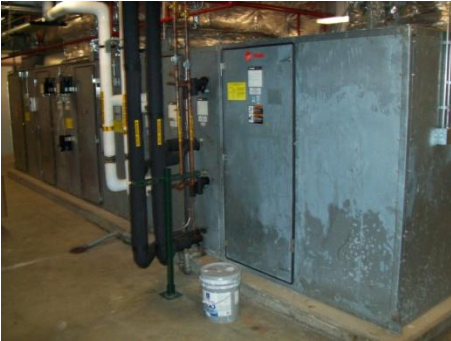
Air Handling Unit

Inefficient. Serves the office and classroom wing.

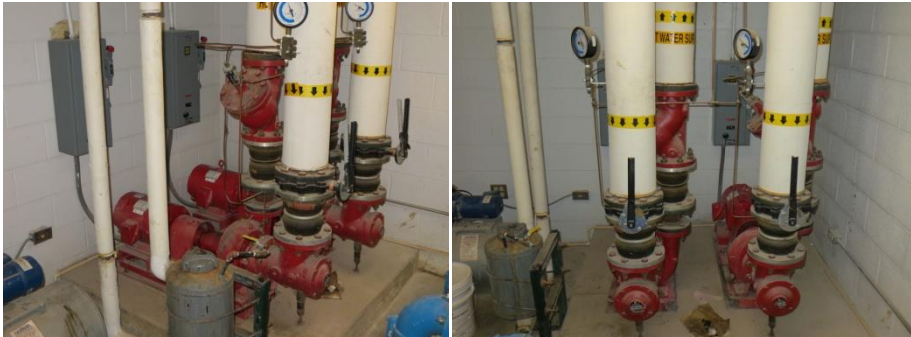
Primary and Secondary Boiler Pumps

Original to the building. Need replacing with energy efficient design and variable frequency drives for increased energy efficiency.

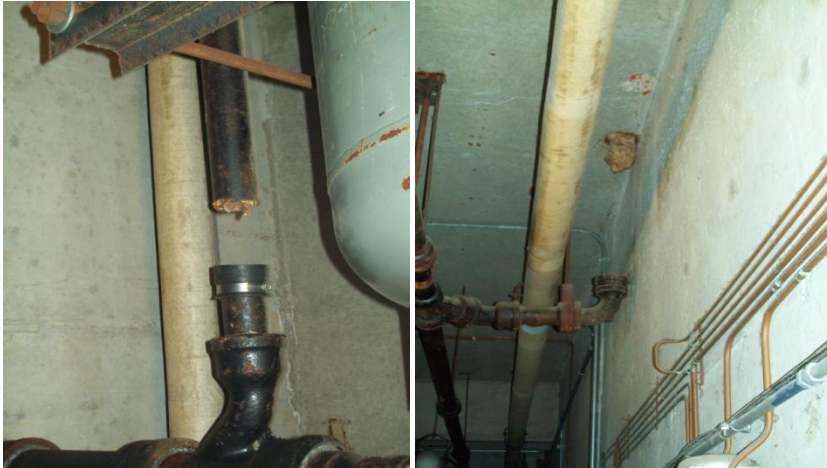
Plumbing Drains

Pipes have become clogged and drains have been re-routed
