Geneva Community Unit School District #304
Operations and Maintenance
7 Year Capital Improvement Plan

Finance Advisory Committee

March 8, 2021

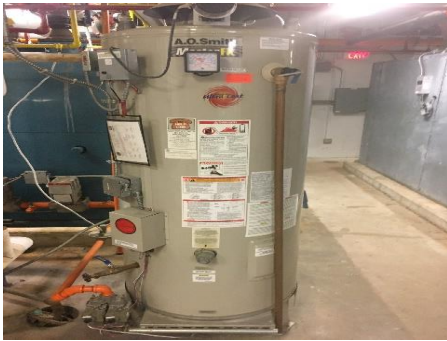
Hot Water Heater

The 75- gallon A.O. Smith water heater is nearing the end of its life cycle.

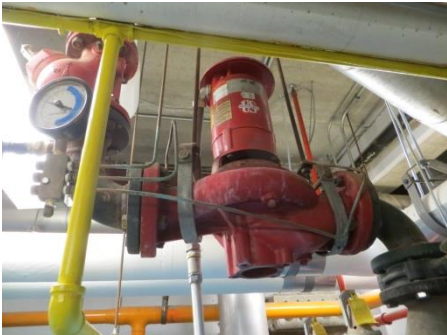
Primary Boiler Pumps

Original to the building.

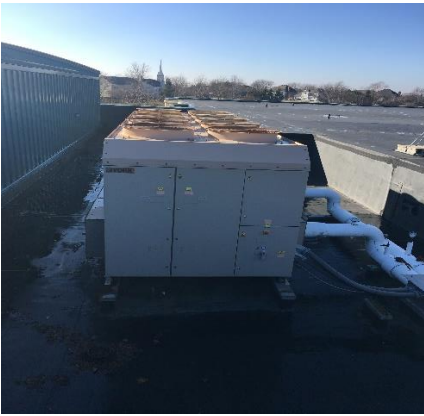
Chiller

19 years old chiller and nearing the end of its service life as per ASHRAE.

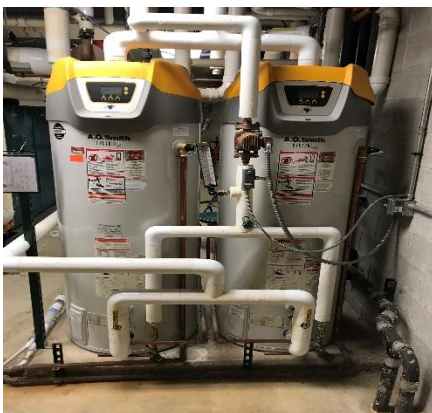
Hot Water Heaters

The two 100- gallon A.O. Smith water heaters are nearing the end of their life cycle.

Replacement will be needed within the next two to five years.

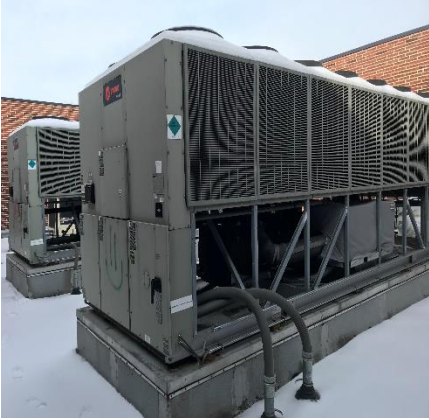
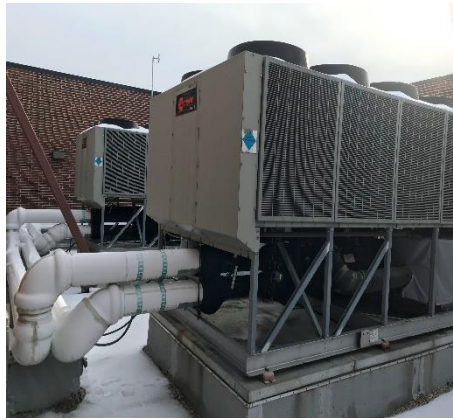
Trane Chillers

13 years old chillers are nearing the end of their service life as per ASHRAE.

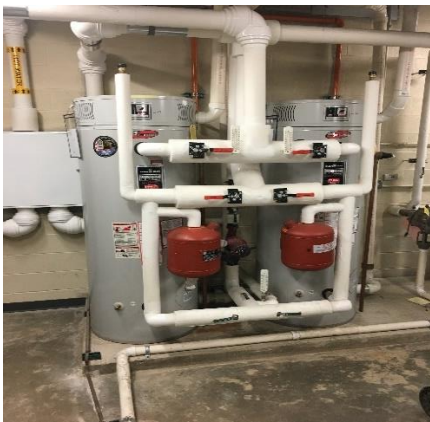
Hot Water Heaters

The two 100- gallon Bradford White water heaters are nearing the end of their life cycle.

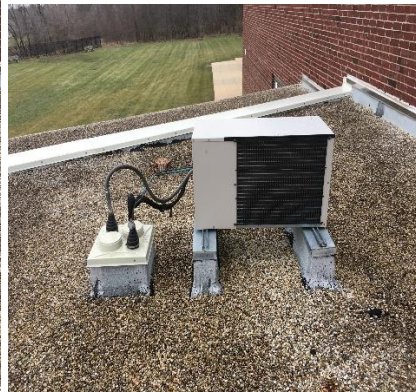
York Chillers

12 years old chillers are nearing the end of their service life as per ASHRAE.

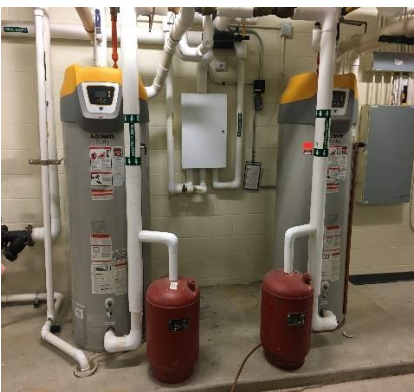
Hot Water Heaters

The two 100- gallon A.O. Smith water heaters are nearing the end of their life cycle.

Replacement will be needed within the next three to seven years.
