Geneva Community Unit School District #304
Operations and Maintenance
7 Year Capital Improvement Plan

April 12, 2021

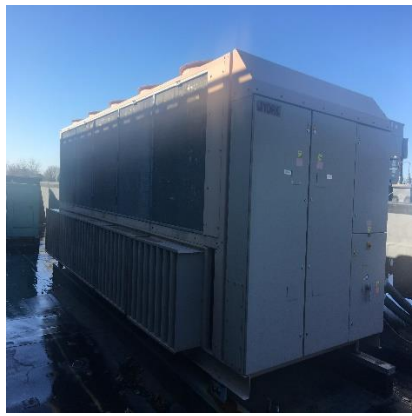
Chiller

19 years old chiller and nearing the end of its service life as per ASHRAE.

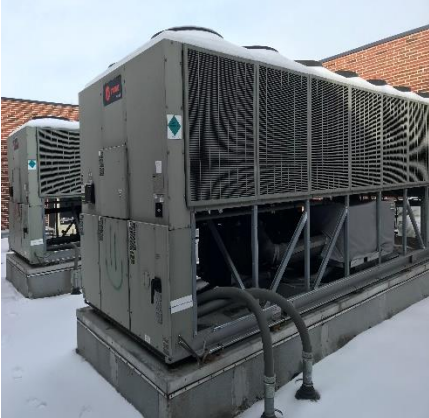
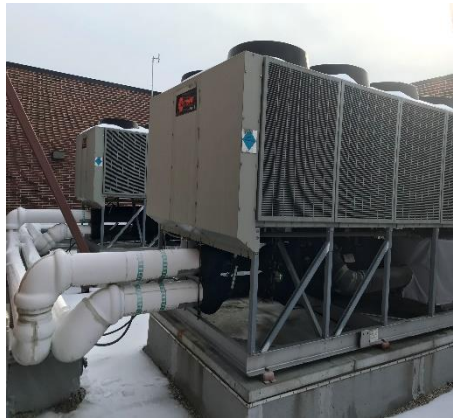
Trane Chillers

13 years old chillers are nearing the end of their service life as per ASHRAE.

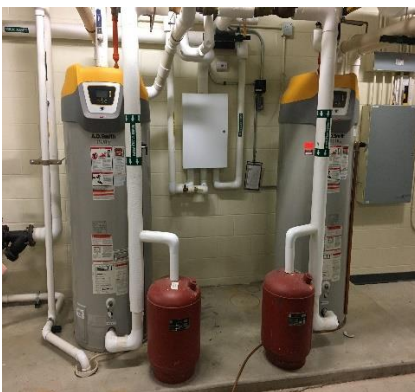
Hot Water Heaters

The two 100- gallon A.O. Smith water heaters are nearing the end of their life cycle.

Replacement will be needed within the next three to seven years.
