Geneva Community Unit School District #304
Operations and Maintenance
7 Year Capital Improvement Plan

March 9, 2020

Introduction

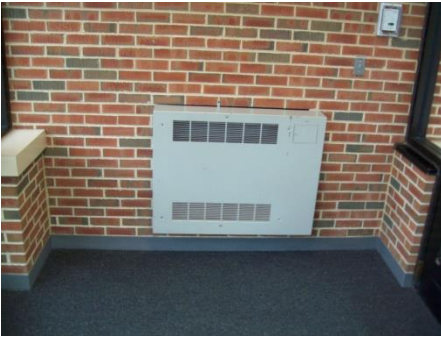
Cabinet Unit Heaters

15 units are over 39 years old.

Replace with energy efficient units.

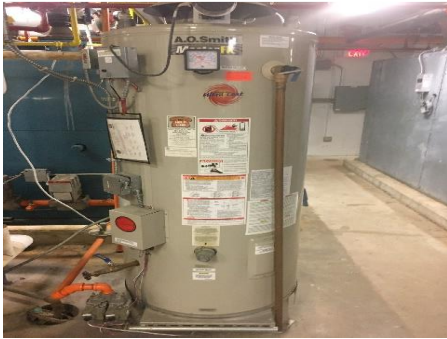
Hot Water Heater

The 75- gallon A.O. Smith water heater is nearing the end of its life cycle.

Replacement will be needed.

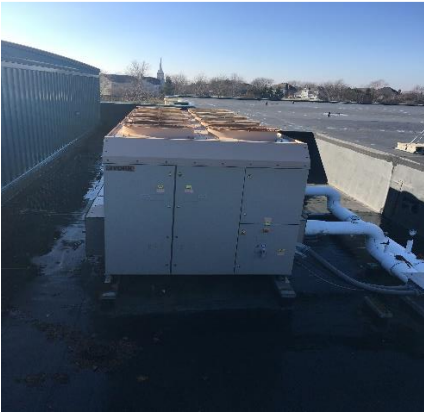
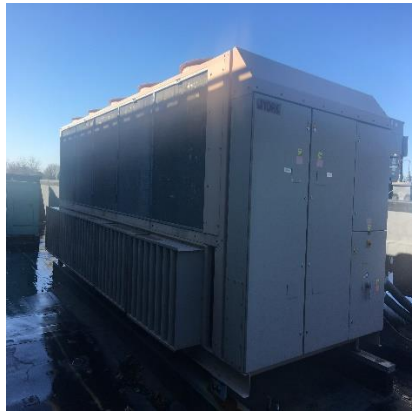
Chiller

18 years old chiller and nearing the end of its service life as per ASHRAE.

Repairs are becoming more frequent.

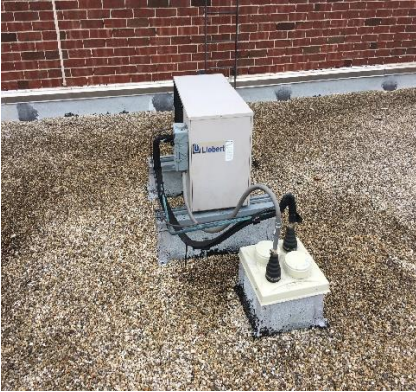
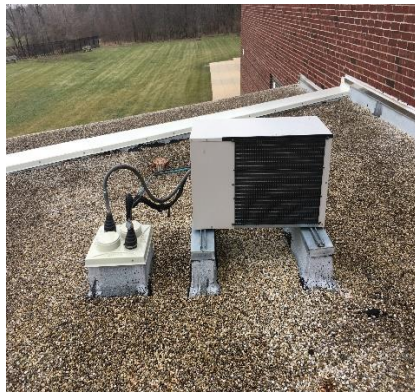
Air Handling Unit

Air handling unit is nearing the end of its life cycle.

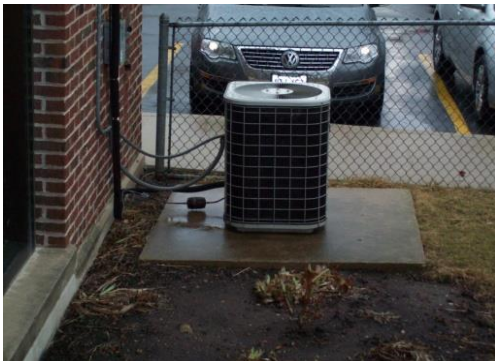
Fan Coil and Condensing Units

The entire building is cooled with fan coil units.
