Geneva Community Unit School District #304  
Operations and Maintenance  
7 Year Capital Improvement Plan

April 25, 2022

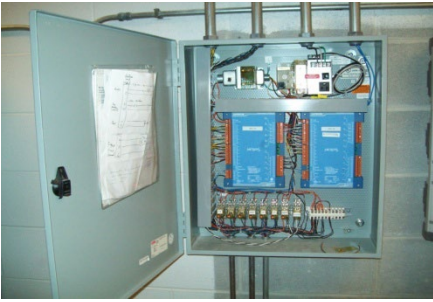
### Lon Controller

Lon controls throughout the building.

Outdated and costly to repair.

Replace Lon to BACnet.

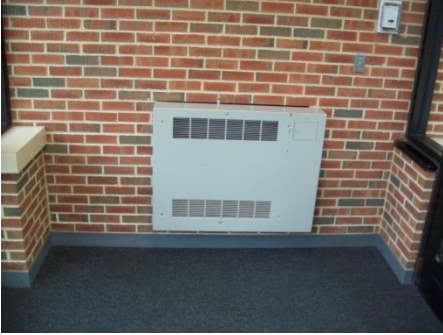
## **Cabinet Unit Heaters**

15 units are over 41 years old.

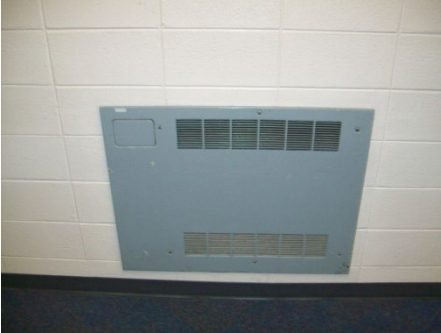
## **Cabinet Unit Heaters**

9 units are over 26 years old.

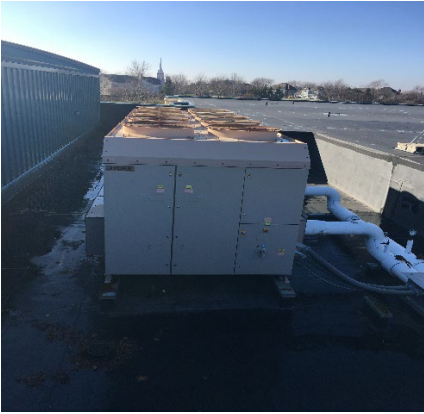
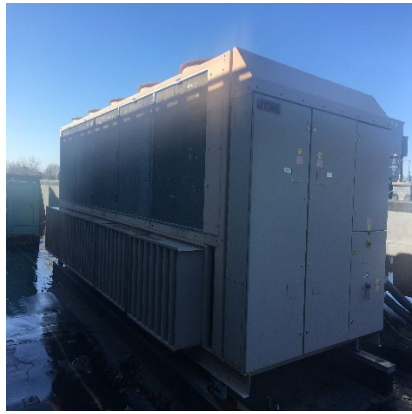
## Chiller

20 years old chiller and nearing the end of its service life as per ASHRAE.

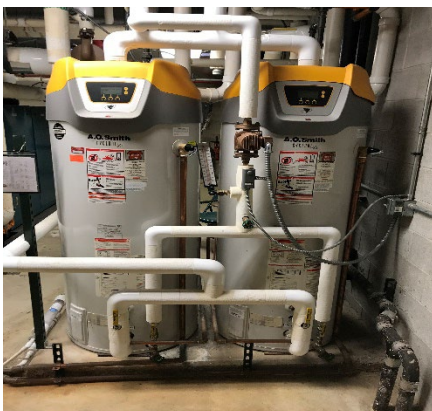
## Hot Water Heaters

The one 100-gallon A.O. Smith water heater is nearing the end of its life cycle.

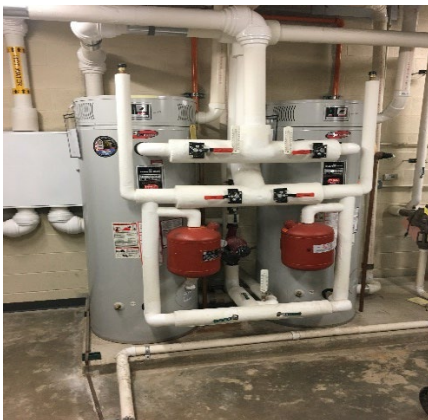
## Hot Water Heaters

The two 100-gallon Bradford White water heaters are nearing the end of their life cycle.

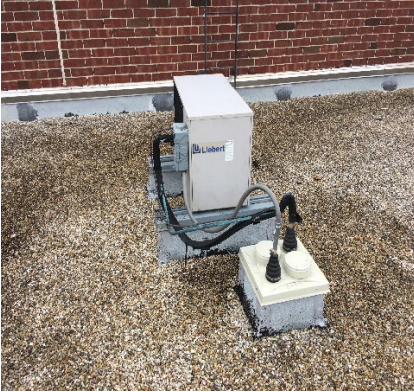
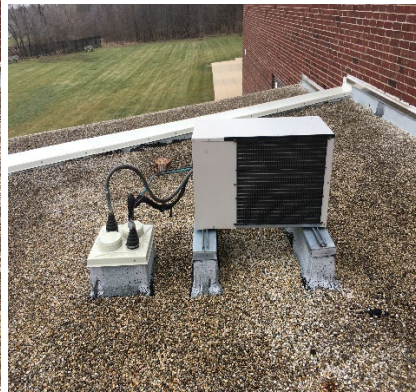
### Air Handling Unit

Air handling unit is nearing the end of its life cycle.

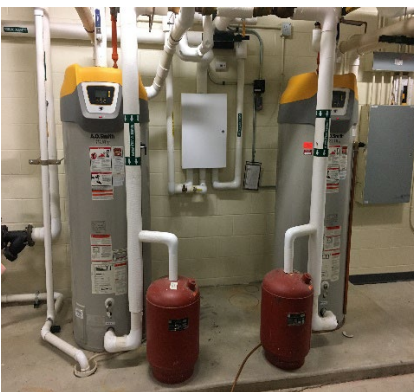
### Hot Water Heaters

The two 100-gallon A.O. Smith water heaters are nearing the end of their life cycle.
