Geneva CUSD 304 5-yr Capital Improvement Plan 2012

Geneva Community Unit School District #304

July 30, 2012

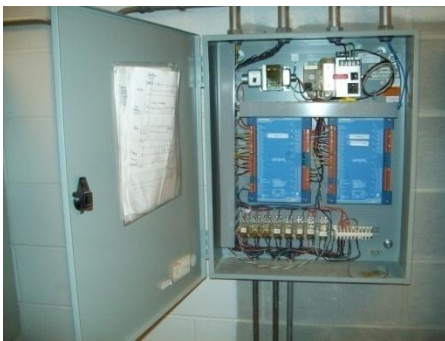
Lon Controller

Lon controls throughout the building

Outdated and costly to repair

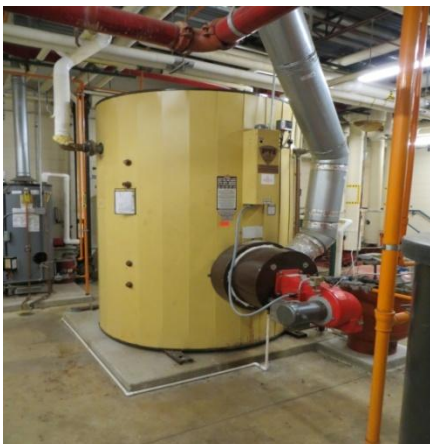
Domestic Hot Water Heater

Original 1500 gallon water heater has exceeded its life span of 10-15 years. Plan on replacing in the next 5 years with a more efficient and properly sized water heater.

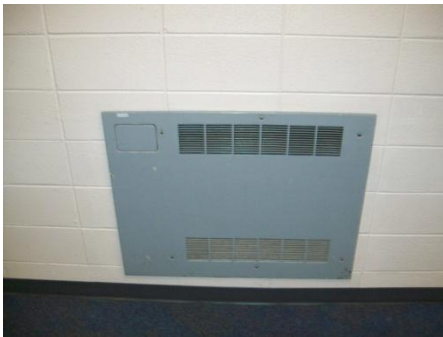
Cabinet Unit Heaters

9 units are over 20 years old.

Blowers are failing.

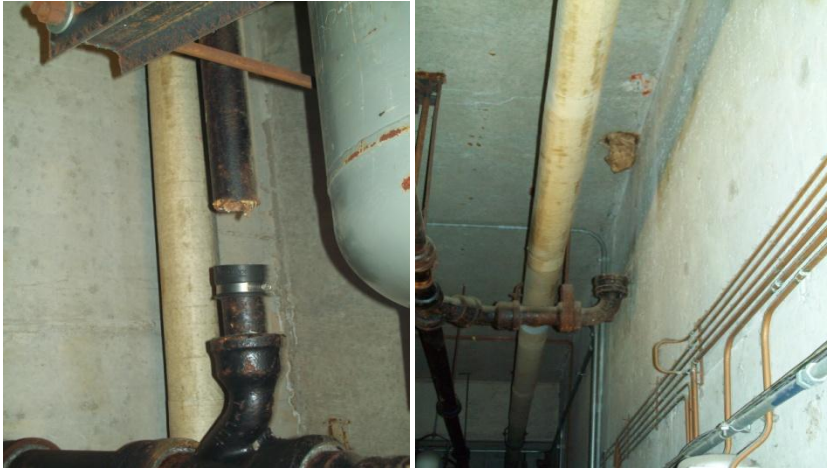
Plumbing Drains

Pipes have become clogged and drains have been re-routed
