DULL OLSON WEEKES
architects inc.

PARKROSE
SCHOOL DISTRICT

FACILITY REPORT

JUNE 2009

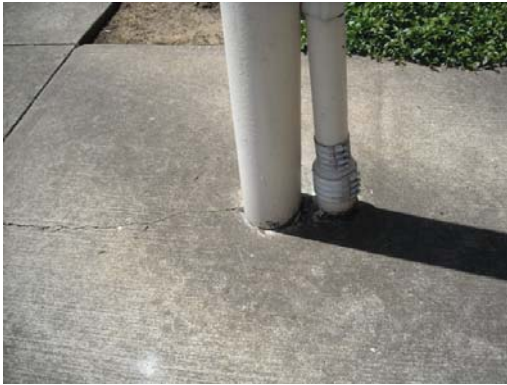
Damaged sidewalk

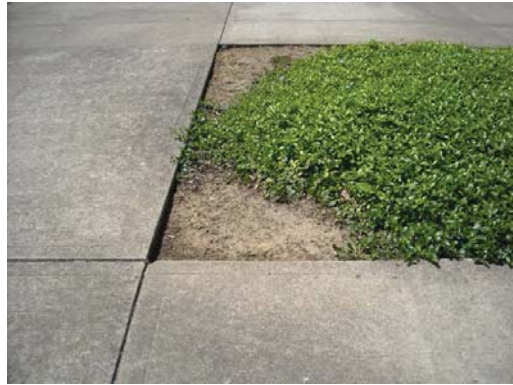
Misc landscaping work needed

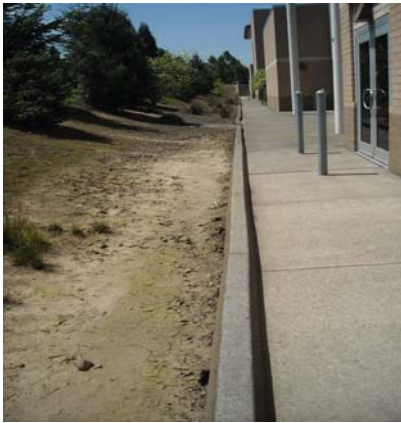
Storm water drainage issues

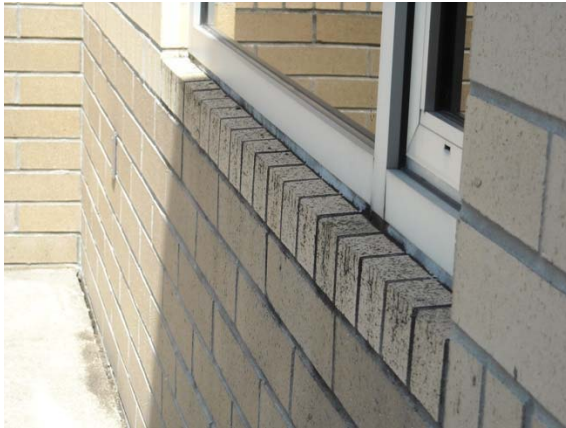
Clean window sills and brick wall

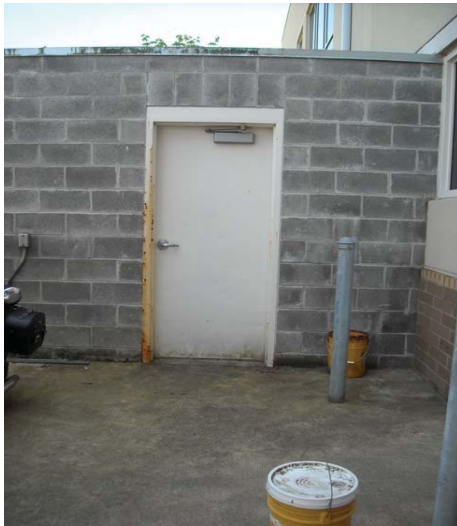
Exterior hollow metal door

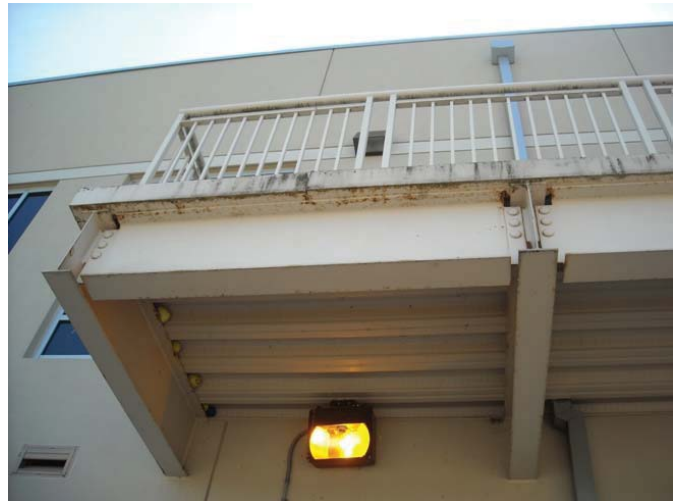
Paint the balcony structure

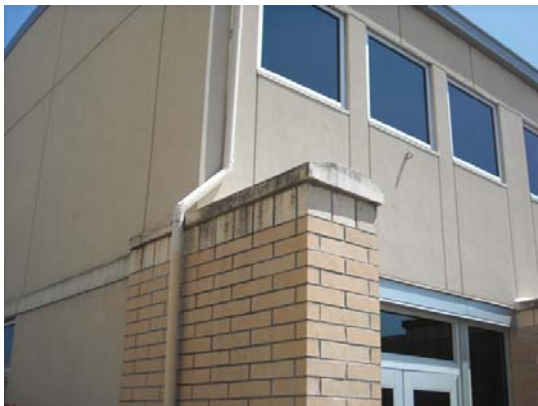
Clean exterior brick walls

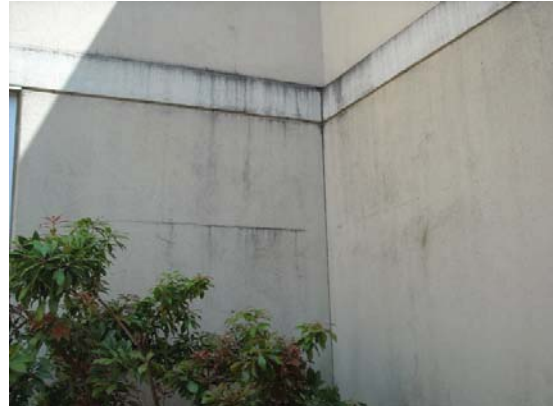
Repair cracked walls

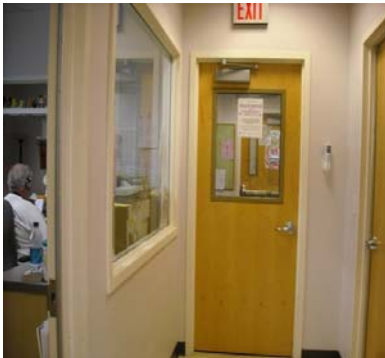
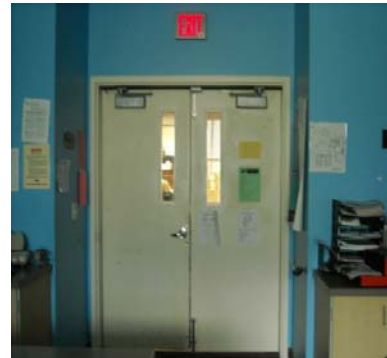
Panic hardware required at exit doors

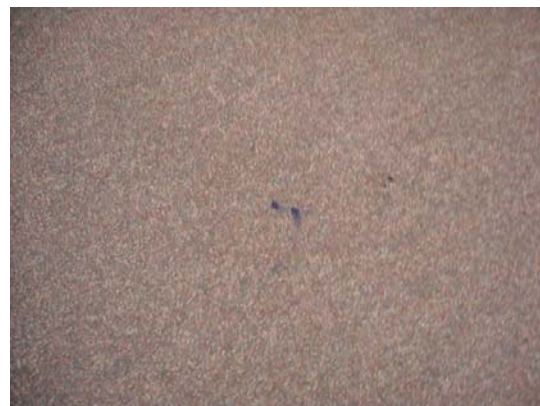
Stained carpet

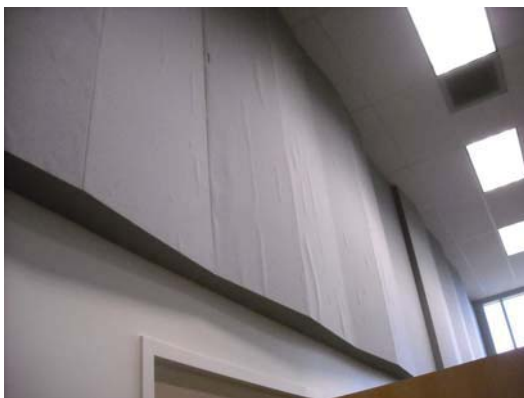
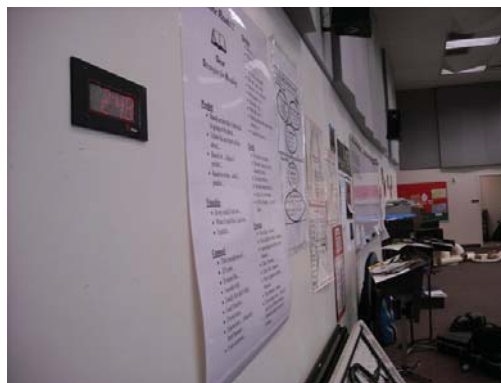
The acoustical panels in the band and music rooms appear to have a bubbling effect on its surface. The floor in the band storage rooms appears cracked. Repair and install carpet in area. The carpet in the Band room is stained and needs to be professionally cleaned and new base installed in the areas where missing. New tack surfaces are needed in the Band and the Music room.

Acoustical panels damaged and more tack surface needed in band & music rm.

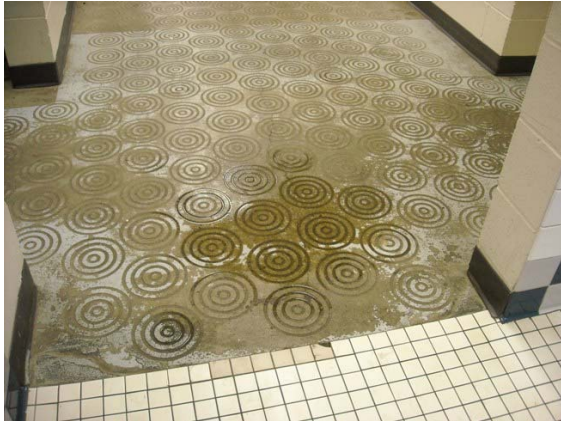
Ponding in locker room floors

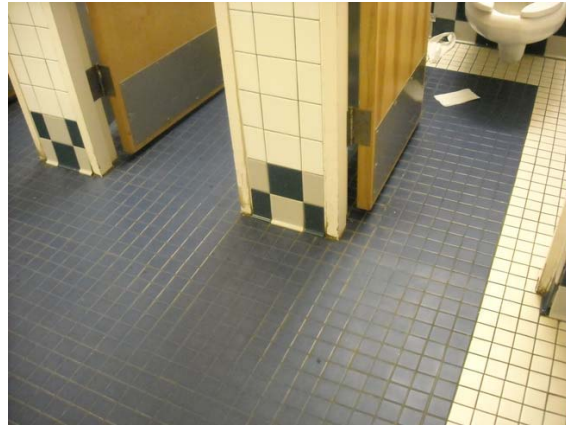
Toilet tiles to be cleaned

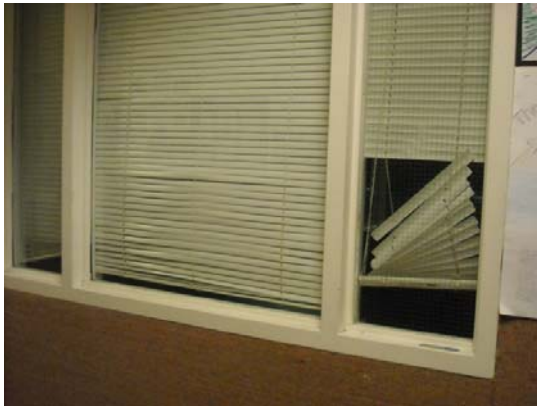
Broken blinds

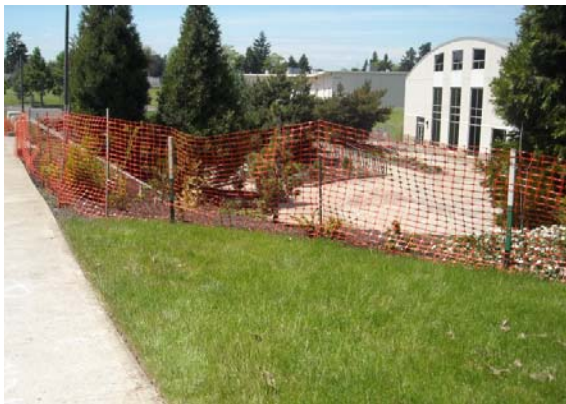
Install permanent safety barrier

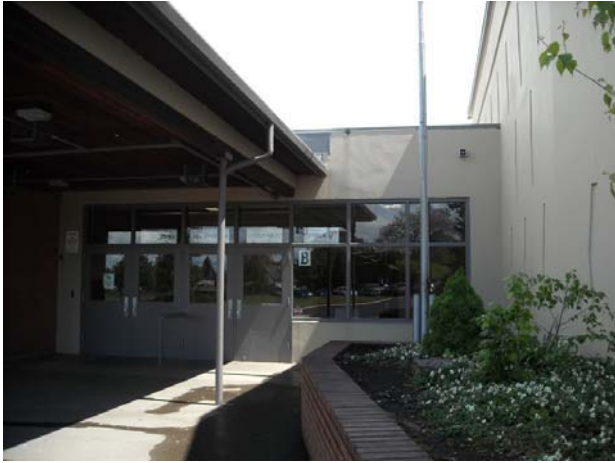
No ADA door operator. Poor site drainage

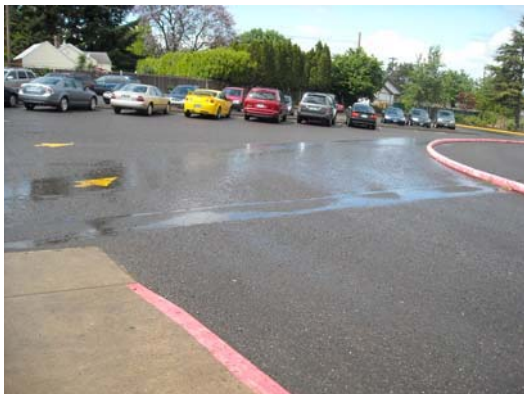
Site drainage

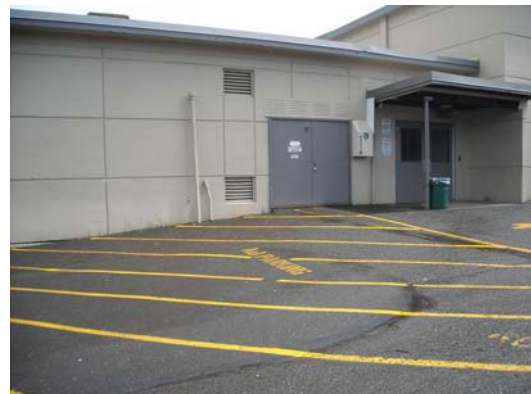
Needs bollards

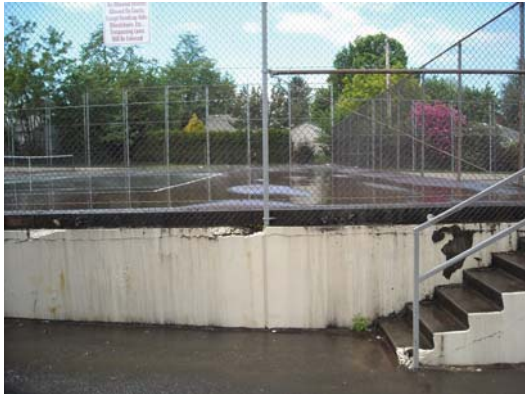
Tennis court - water stagnation

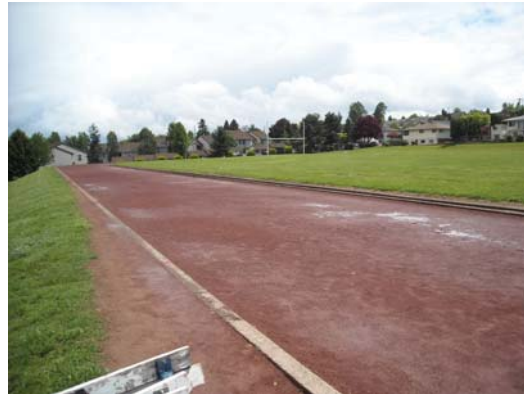
Unfinished track

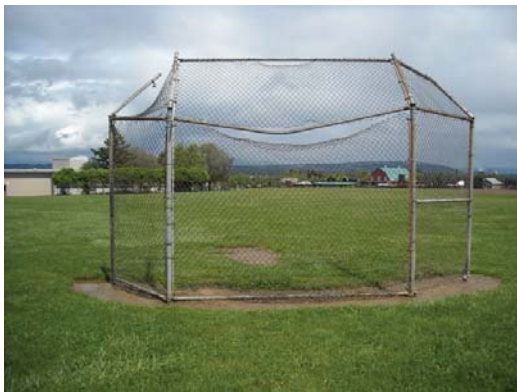
Damaged baseball backstop

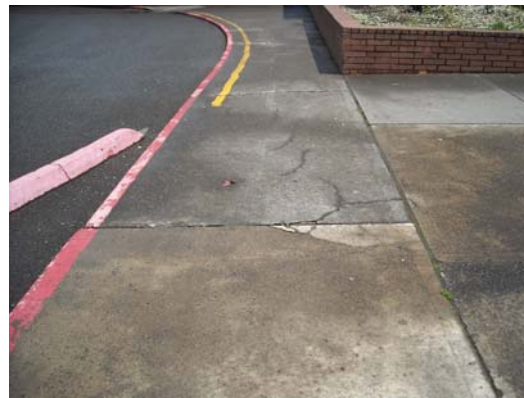
Damaged sidewalks and curb

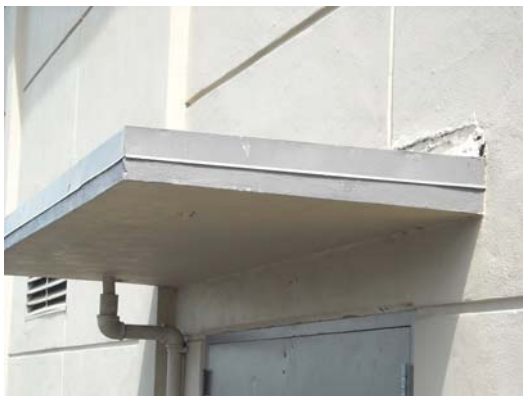
Flashing not installed properly

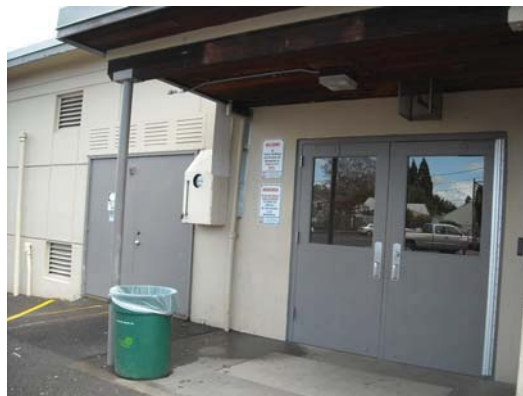
Leaking downspout

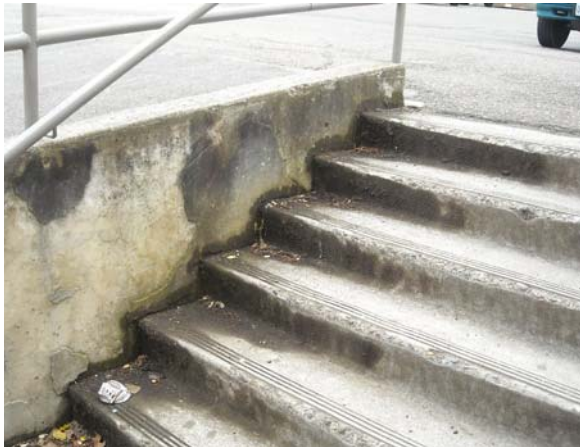
Water drains down into kitchen area

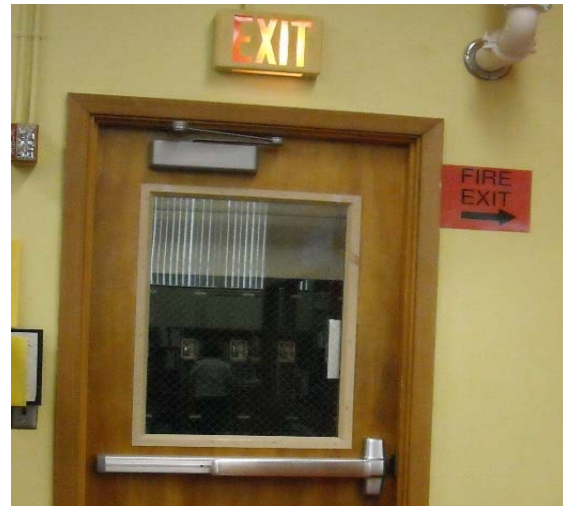
Wooden door / signage / wired glass

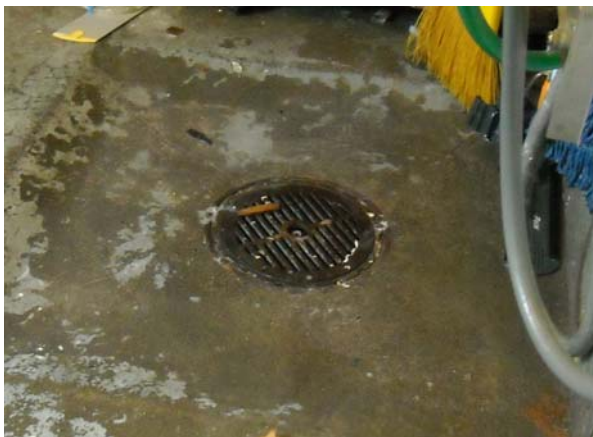
Mop sink in kitchen?

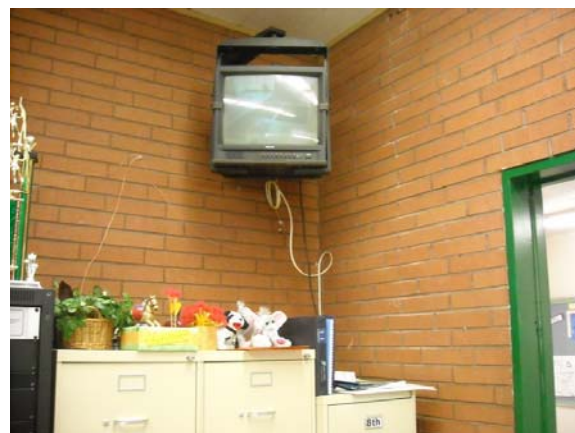
Reception with poor electrical wiring

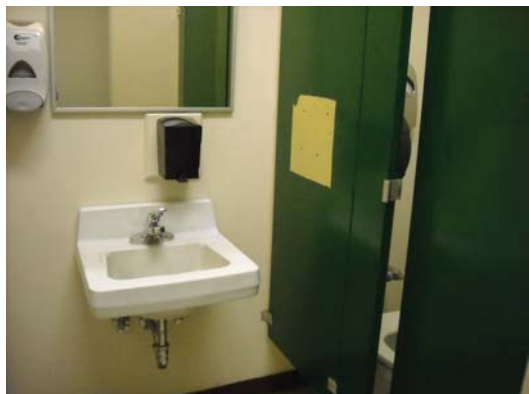
Toilets to be remodeled

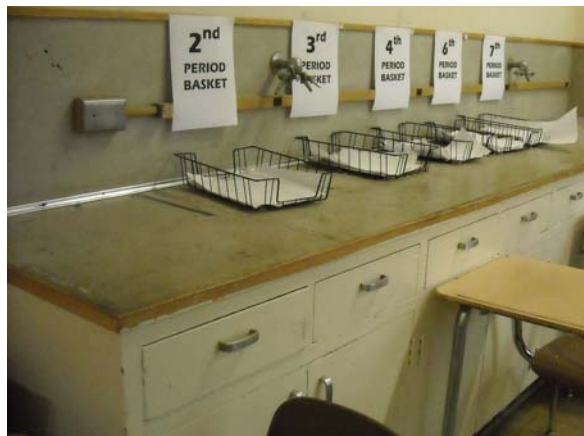
Refinish casework / new counter top

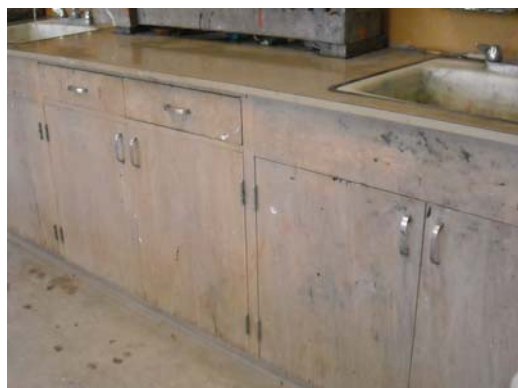
Art classroom casework

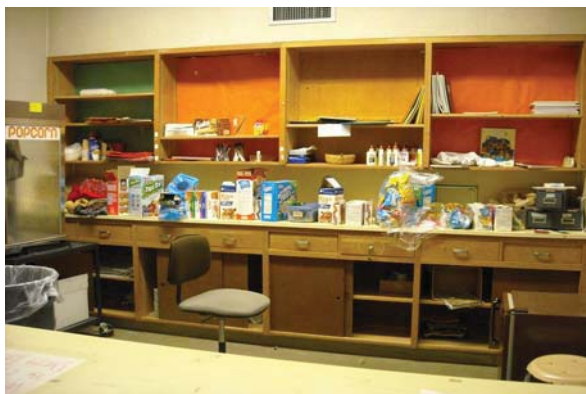
Student store

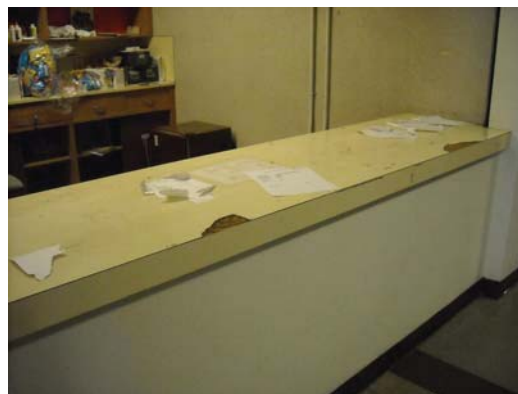
Damaged counter at student store

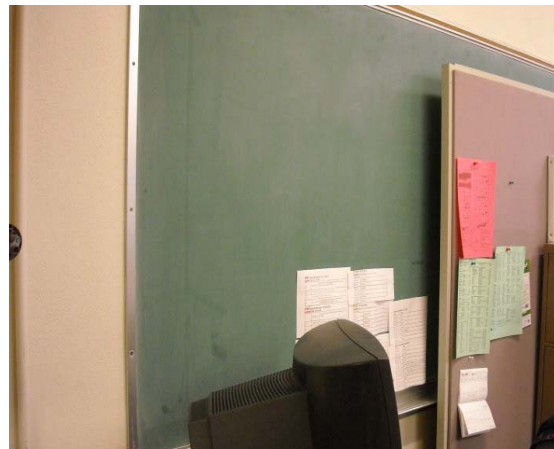
Remove chalk boards

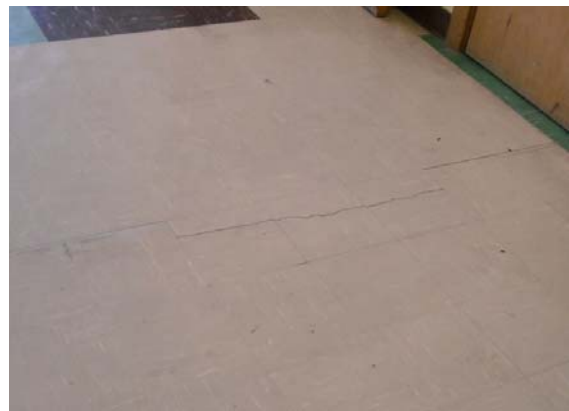
Damaged VAT tiles

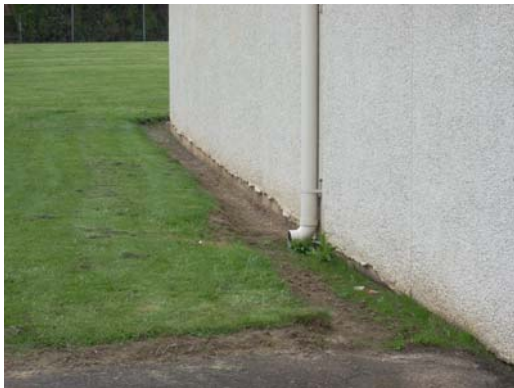
The sidewalk, particularly in front of the accessible stalls, is cracked and in need have repaired. At the south side of the site, the lawn slopes toward the building, this has caused some damage to the building's exterior. On the west side, near the playground, the asphalt sloping toward the cleanout is in need of repair.

Exterior damage / grading

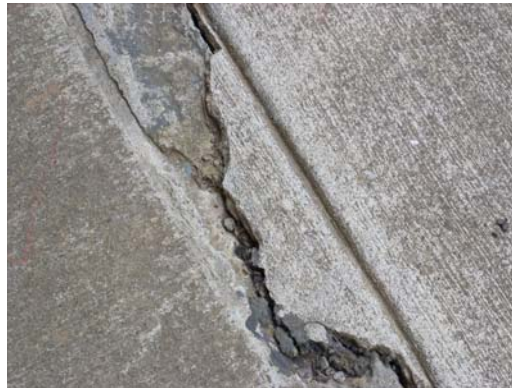
Cracked asphalt

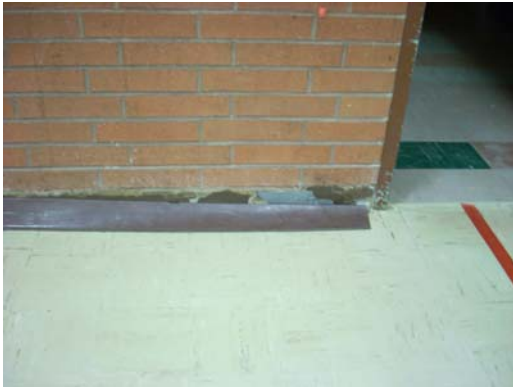
The building has many finishes and materials that are beyond their useful life. The primary issue on the interior is the wall base. It is of various materials and sizes and it detaching from the interior walls. In some areas the base has been removed but not replaced. The interior walls themselves are in good condition, and need to be repainted with the exception of the brick wall in the cafetorium, that has cracks. Many of the ceiling tiles throughout the building (including the annex) have water damage and/or are popping off the substrate. In several of the classrooms, there appears to be an issue with the settling of the building, particularly at the ceiling. The kitchen's ceiling tile is peeling off the substrate.

Interior – base not adhering to wall

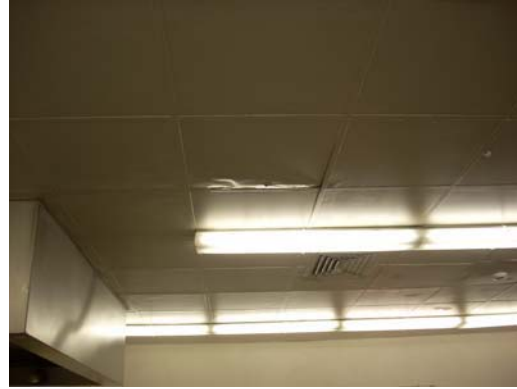
Kitchen ceiling tile

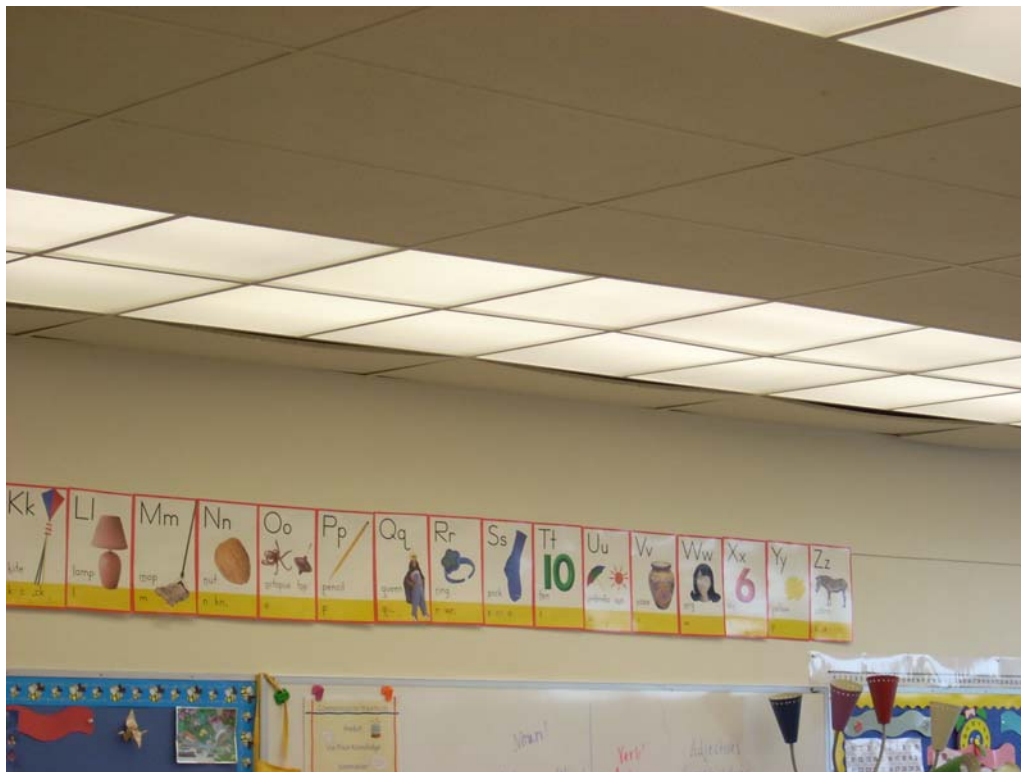
Classroom ceiling issues

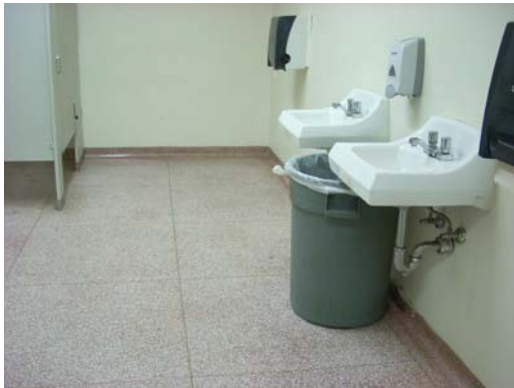
Toilet facilities were upgraded to provide accessible stalls. Lavatory piping needs to be wrapped; flooring is showing signs of age and there is damage to walls. There are some single stall toilets in the annex classrooms that are not compliant and are in need of finish upgrades. The door into the kitchen and the serving counter do not appear to meet accessibility

Student toilet room

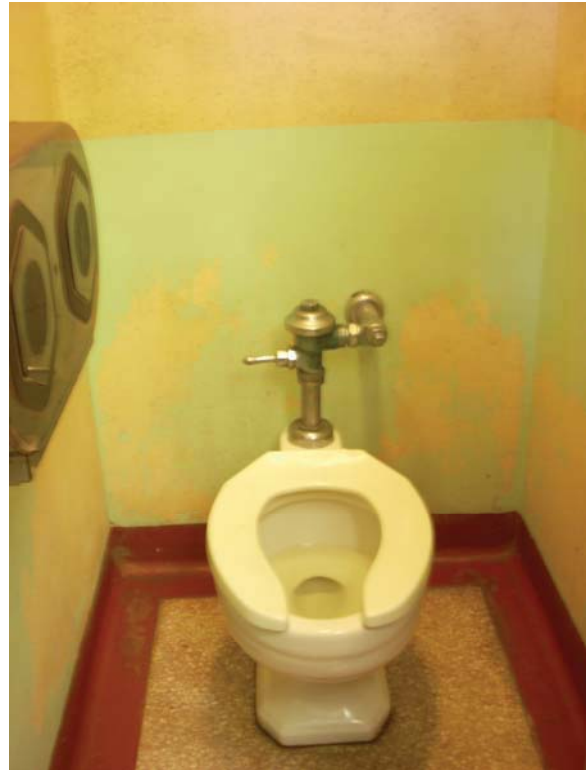
Annex- single stall toilet

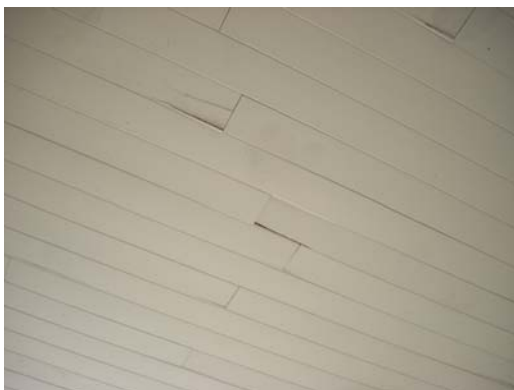
Covered walkway ceiling

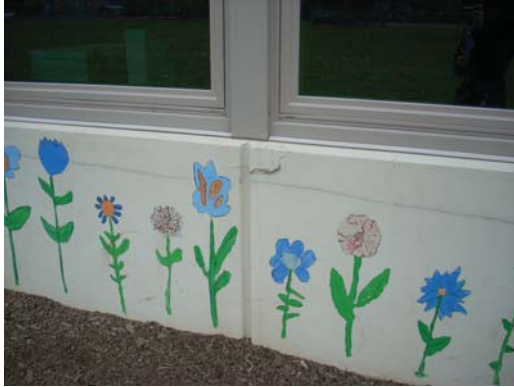
Damaged exterior

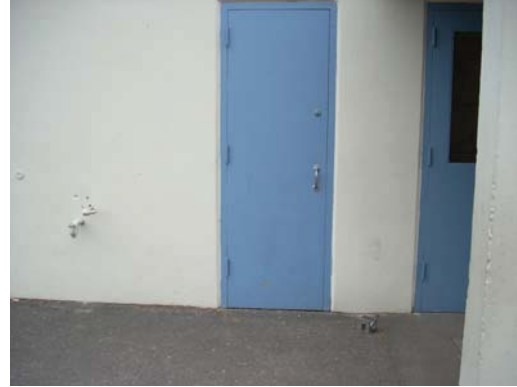
Damaged exterior

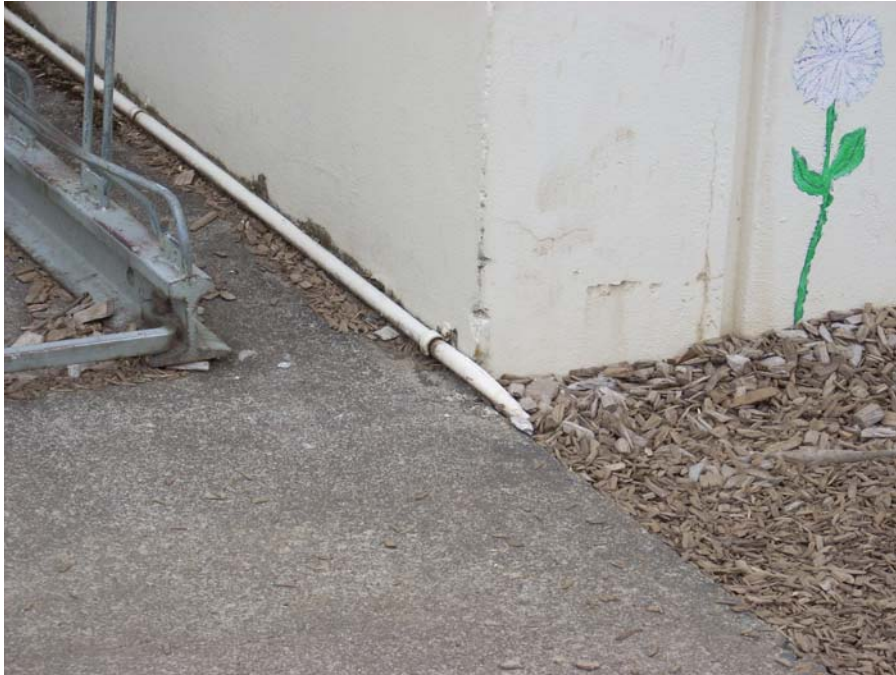
Exterior – façade and exposed piping

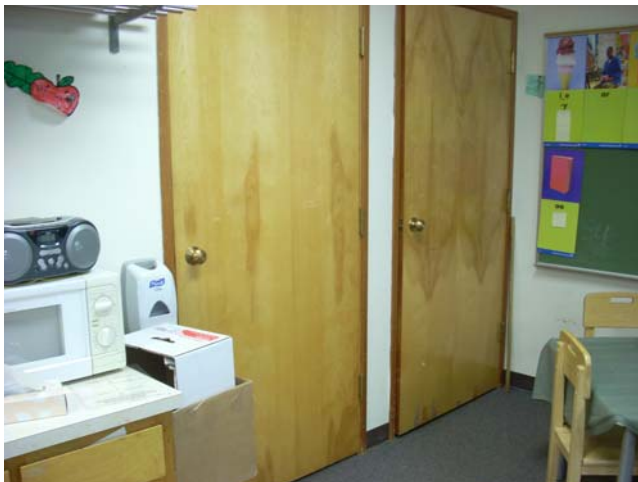
Portable classroom – noncompliant hardware

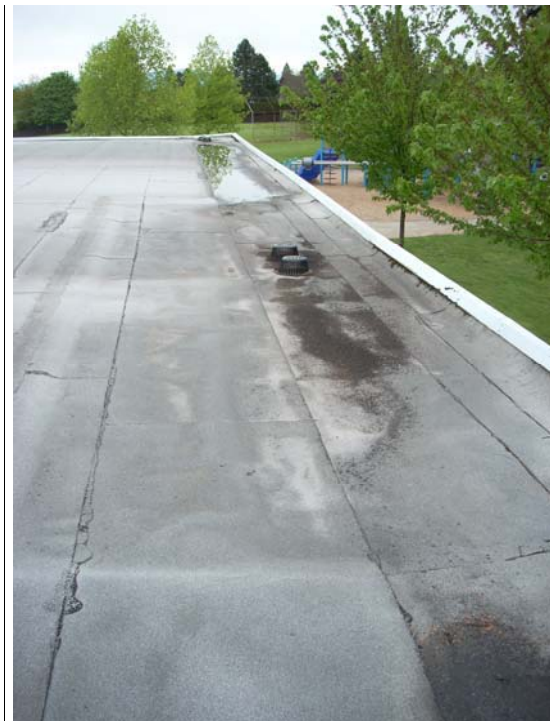
Roof - ponding

1. Most of the flooring, ceilings, and other interior finishes are original. Due to the age of this facility along with asbestos, these should be considered for replacement.
2. The exposed wood structure within the facility is in excellent condition and should be maintained.
3. A thorough inspection / analysis of the roof and roof structure are recommended.

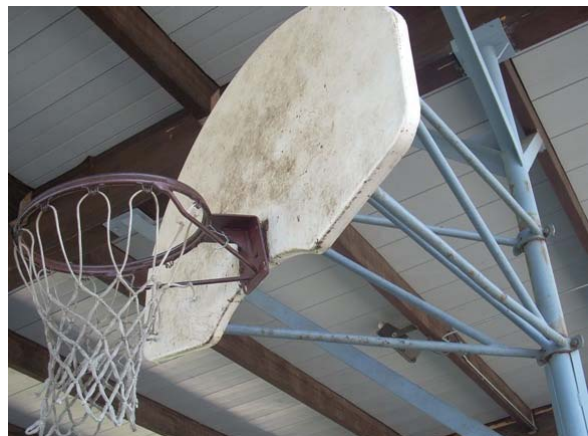
Basketball hoop

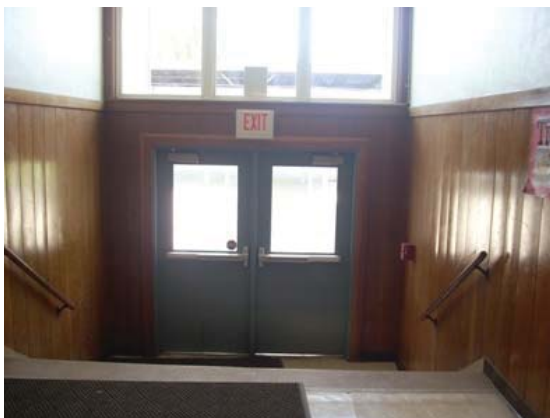
Non-energy efficient glass

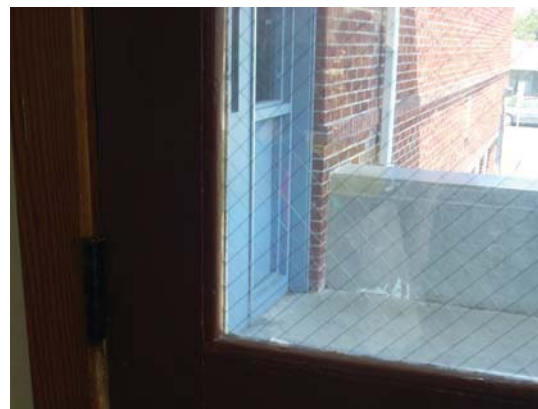
Wired glass

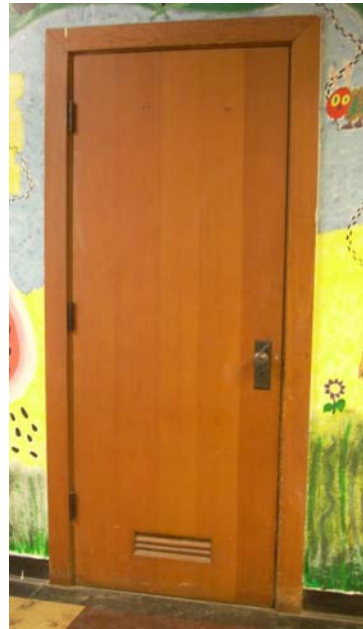
Non-compliant door knob

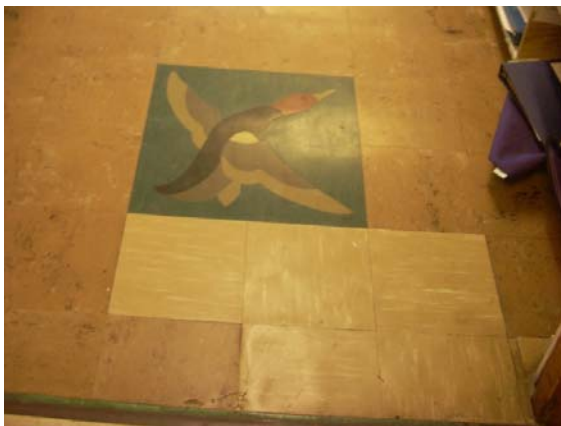
Damaged VAT flooring tile

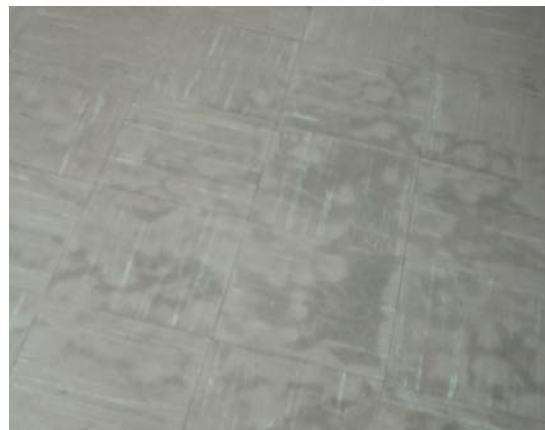
Discolored floor tile

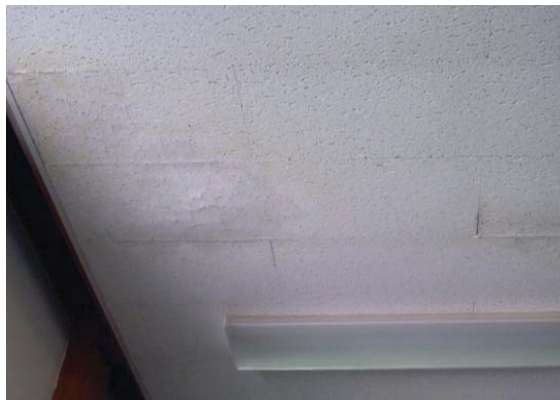
Water damaged glue-up ceiling tile

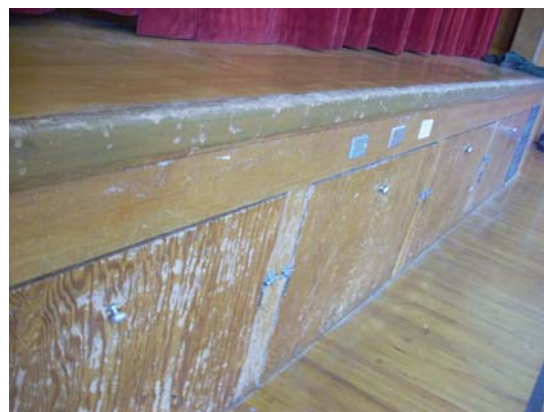
Casework below stage

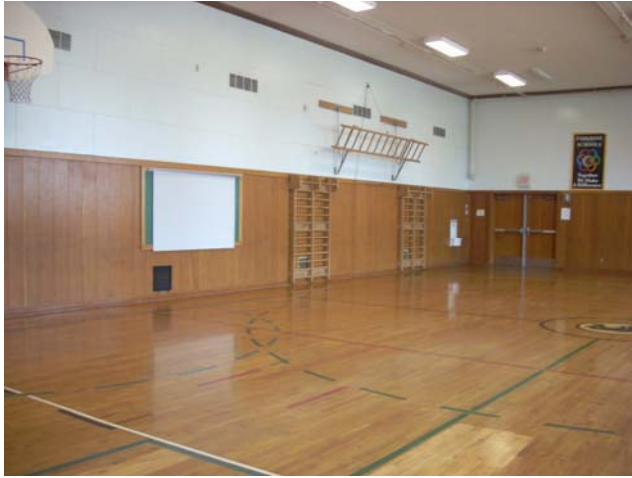
Install acoustical panels

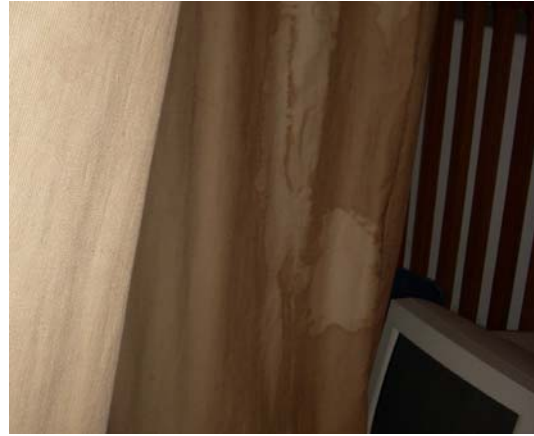
Replace stained stage curtain

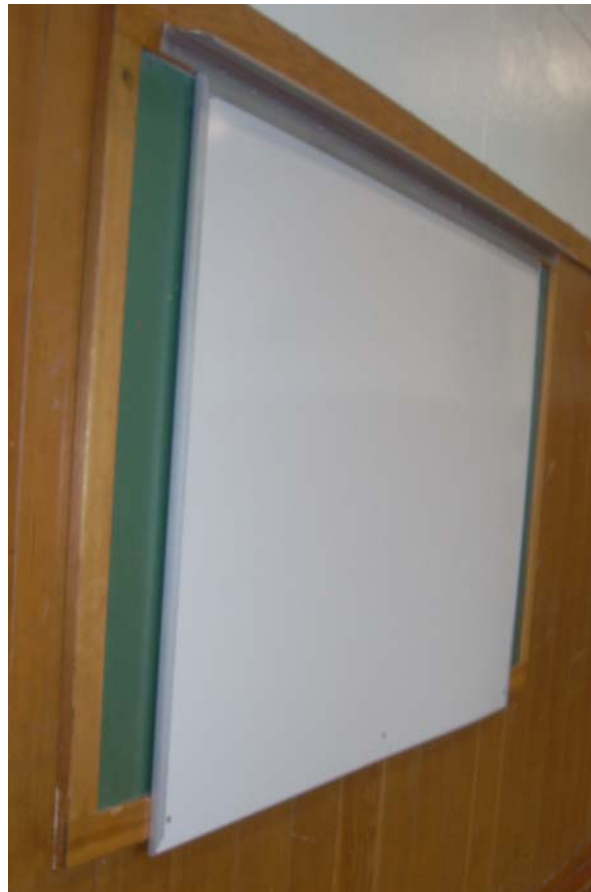
Remove all chalk boards

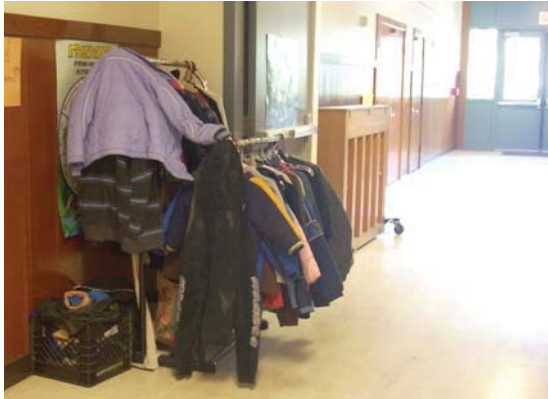
Requires coat storage area

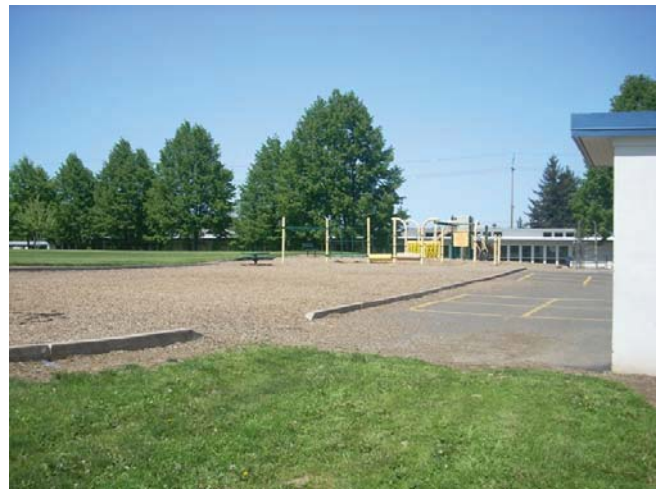
Insufficient site lighting

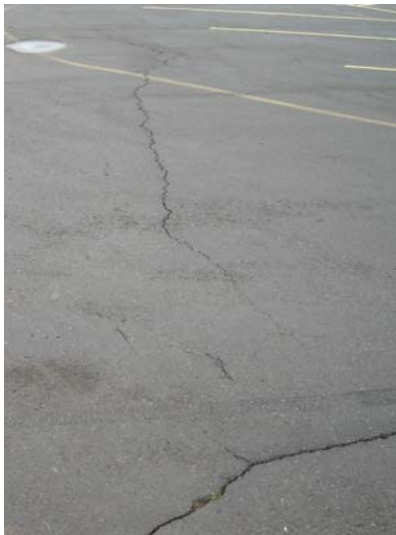
Cracked driveway / ponding

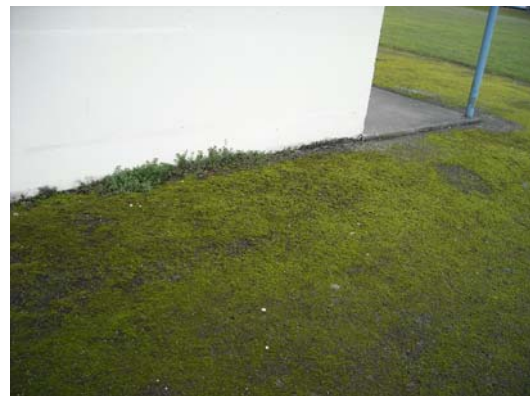
Moss growth at exterior wall

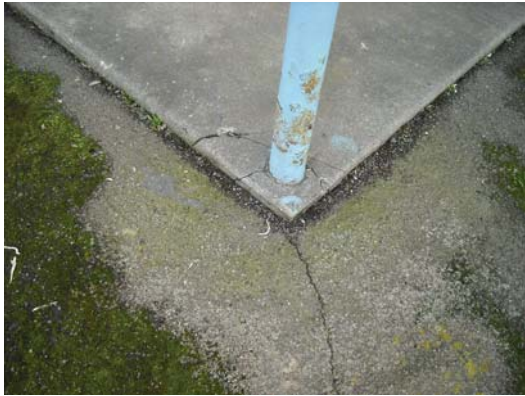
The exterior canopy columns are rusted and need to be thoroughly inspected for structural adequacy. The hard paved areas at the basketball area need to be resurfaced and new play equipment installed.

Damaged column at canopy

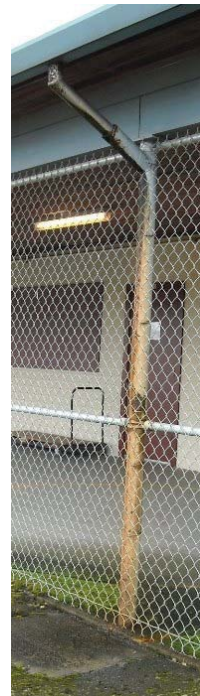
Damaged column / leaking drain

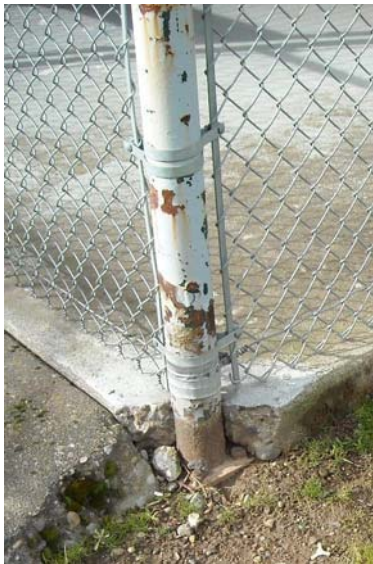
Damaged column at canopy

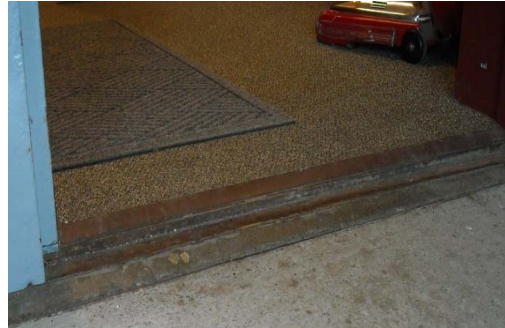
Non-compliant threshold

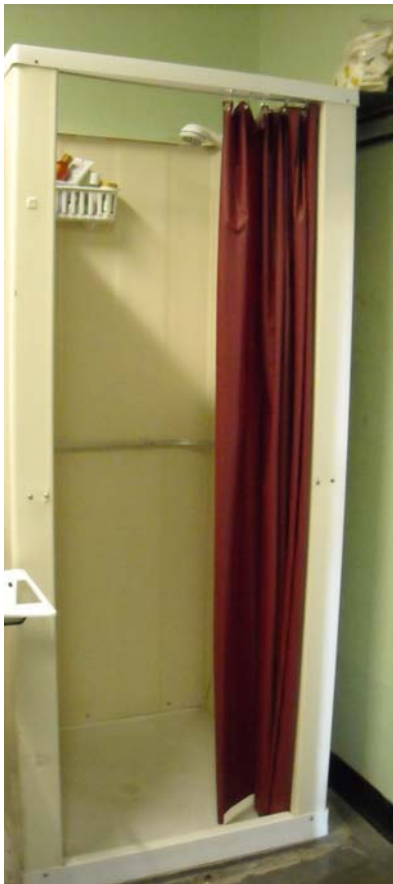
Non-compliant shower

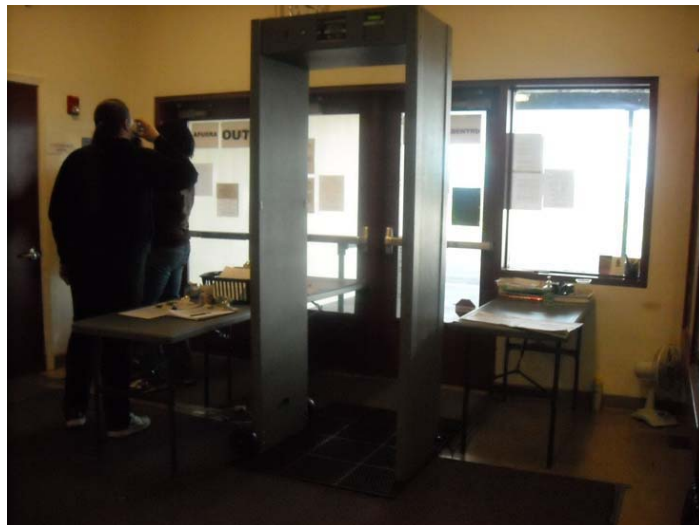
Non-compliant main egress

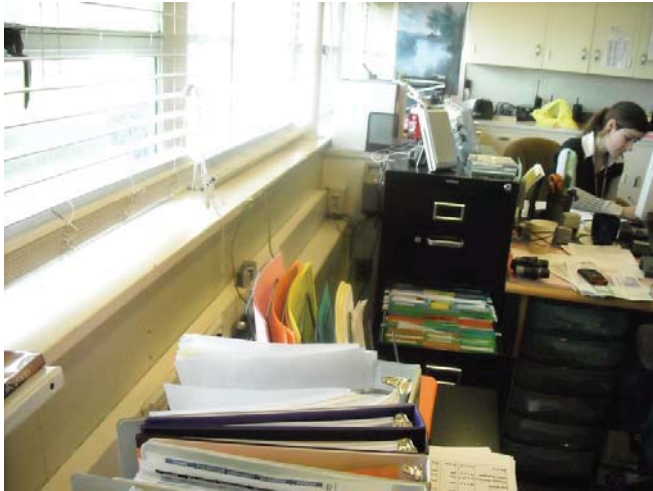
Crowded reception area

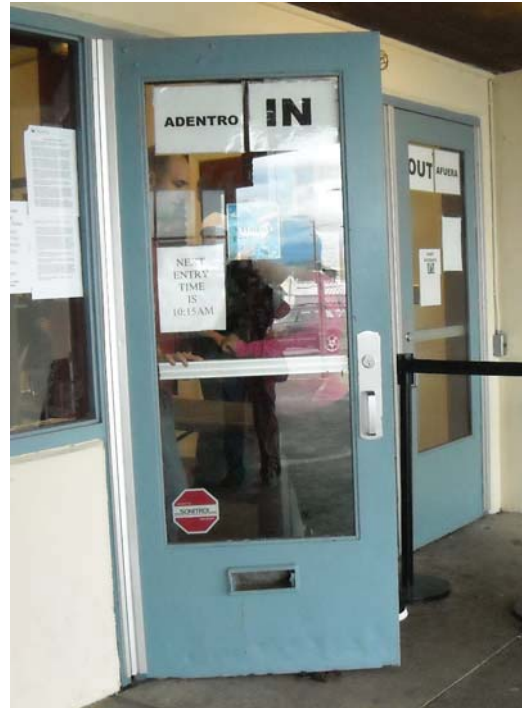
Entry door needs upgrades

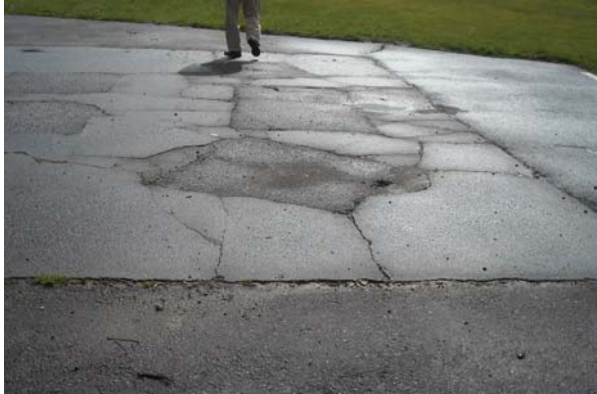
Damaged hard play area

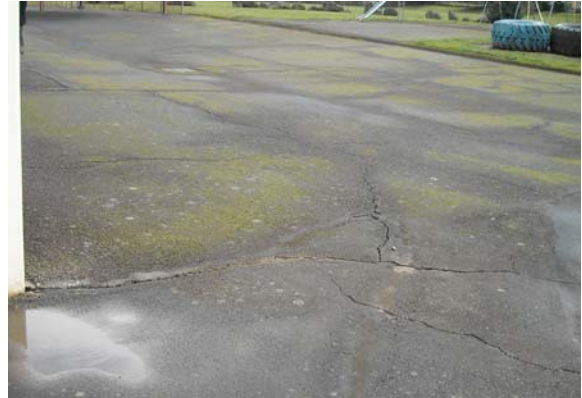
Damaged hard play area- rear side

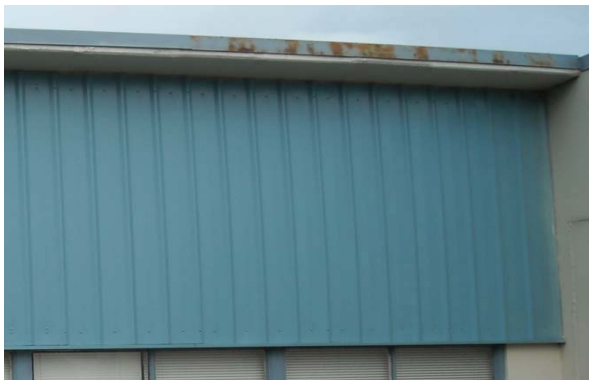
Rusted eave flashing

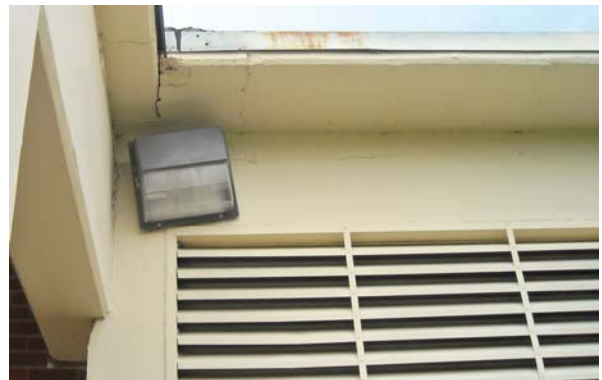
Damaged overhang

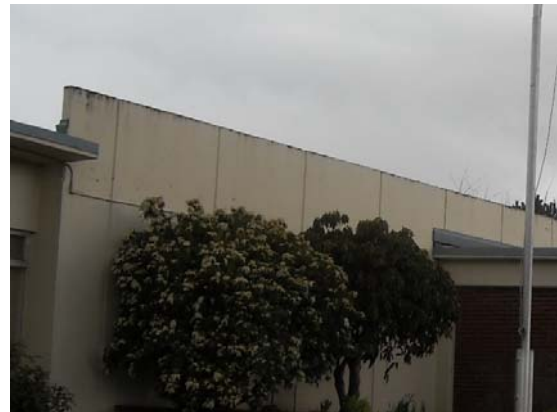
Coping needed @ entry

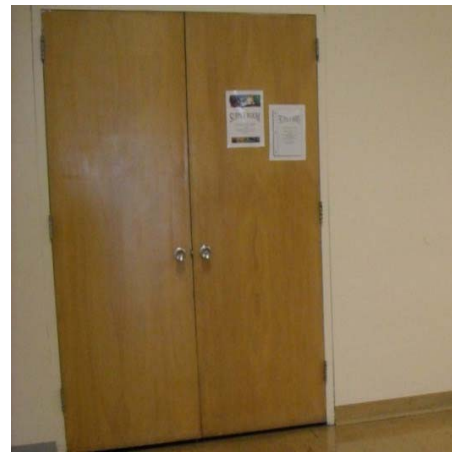
Non-compliant door knobs

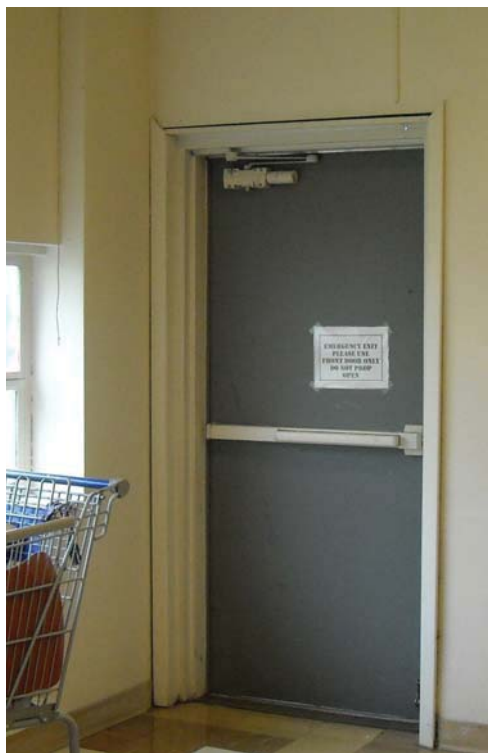
Exit doors without exit sign

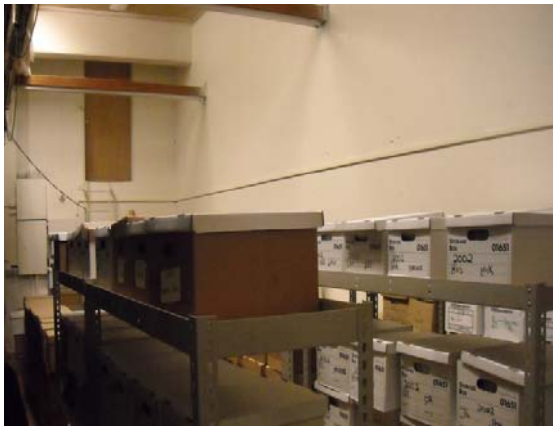
Stage used as store room

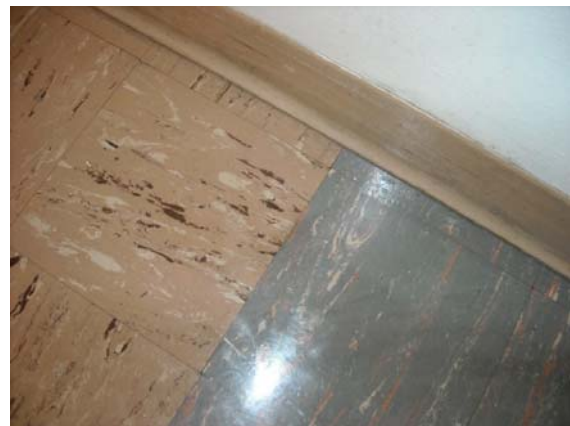
Existing VAT floor tiles

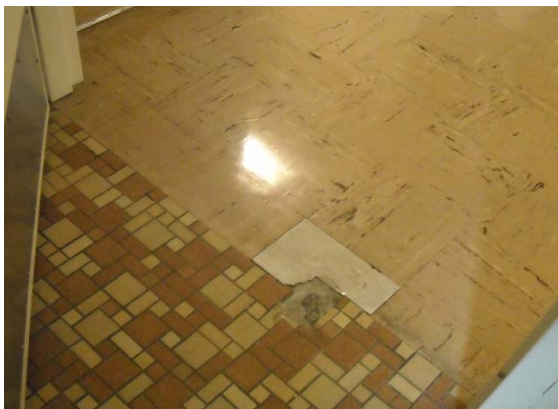
Damaged flooring at toilet

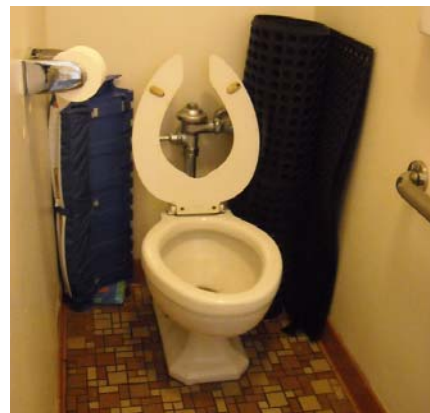
Toilets to be modernized

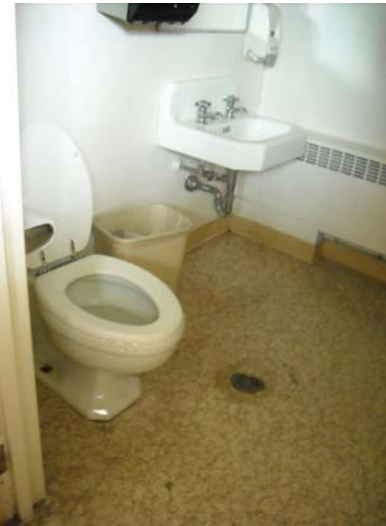
Toilets need to be modernized

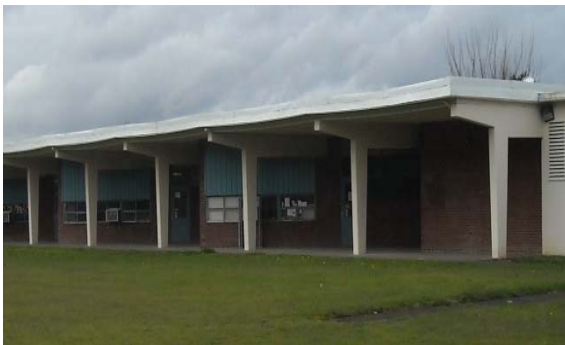
Roof edge appears sagged

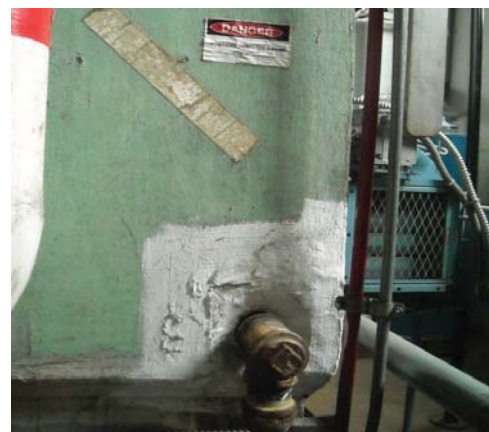
Asbestos to be inspected
