DULL OLSON WEEKES
architects inc.

PARKROSE
SCHOOL DISTRICT

FACILITY REPORT

JUNE 2009

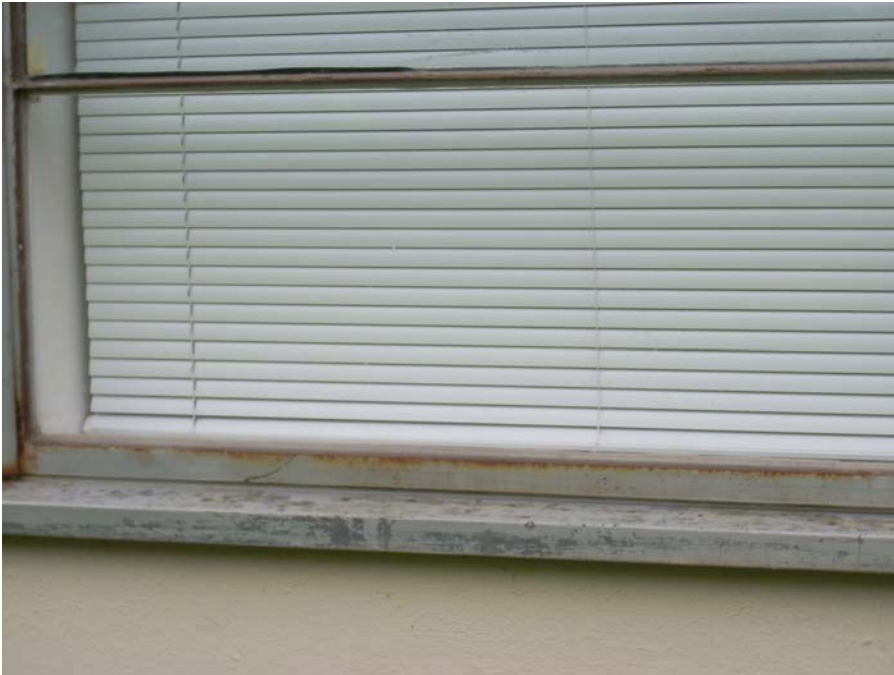
Exterior windows

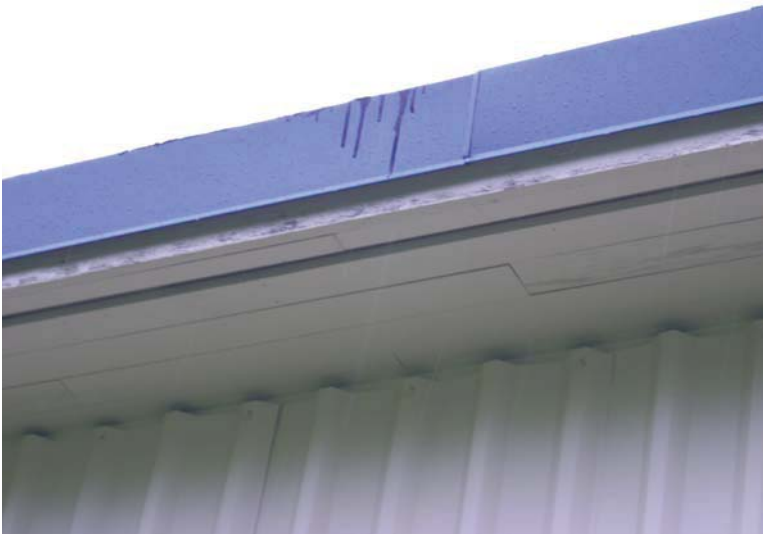
Fascia and overhang

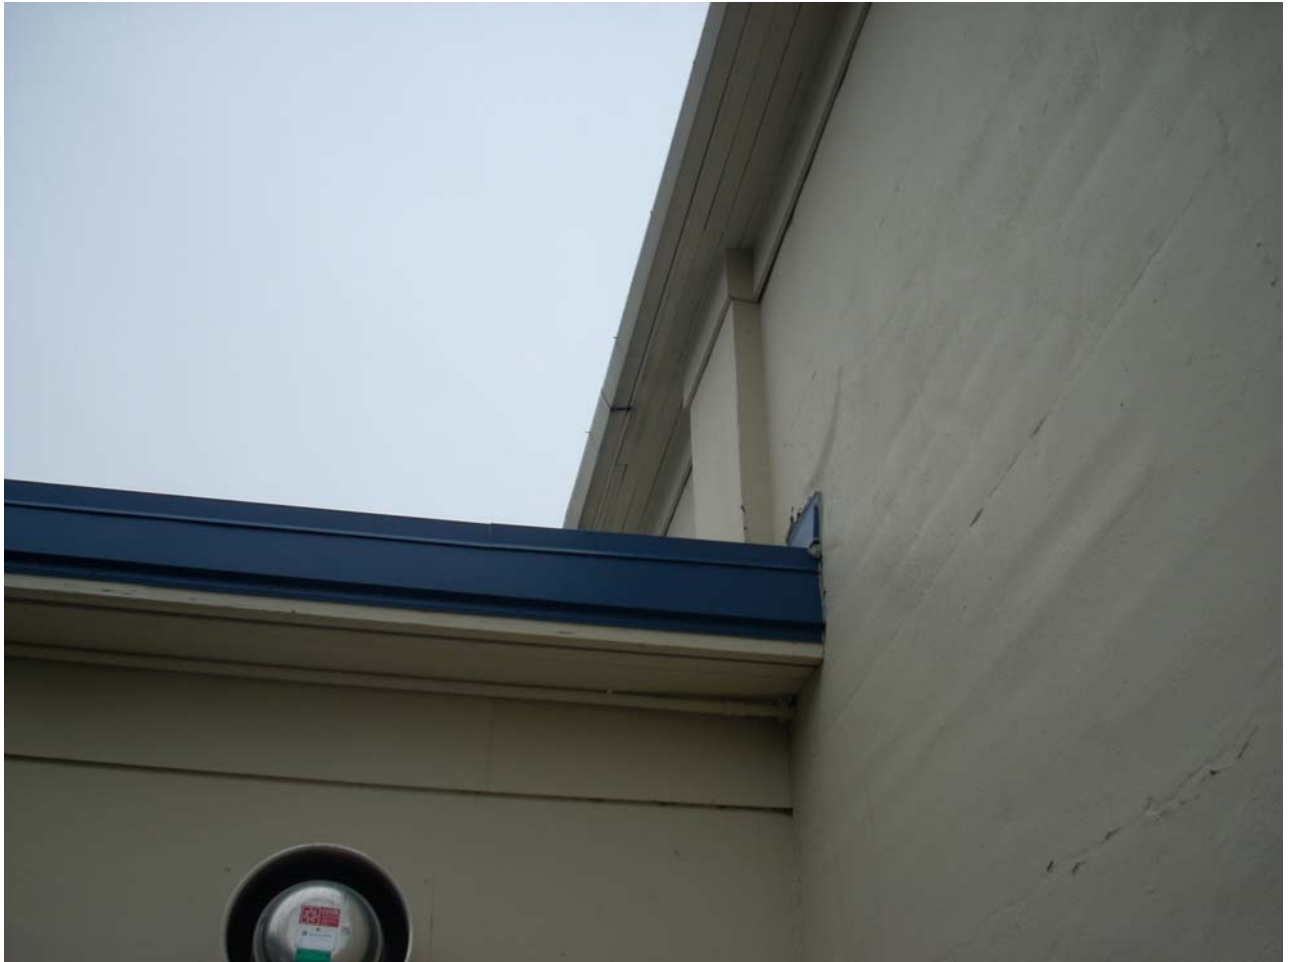
Wall / roof conditions

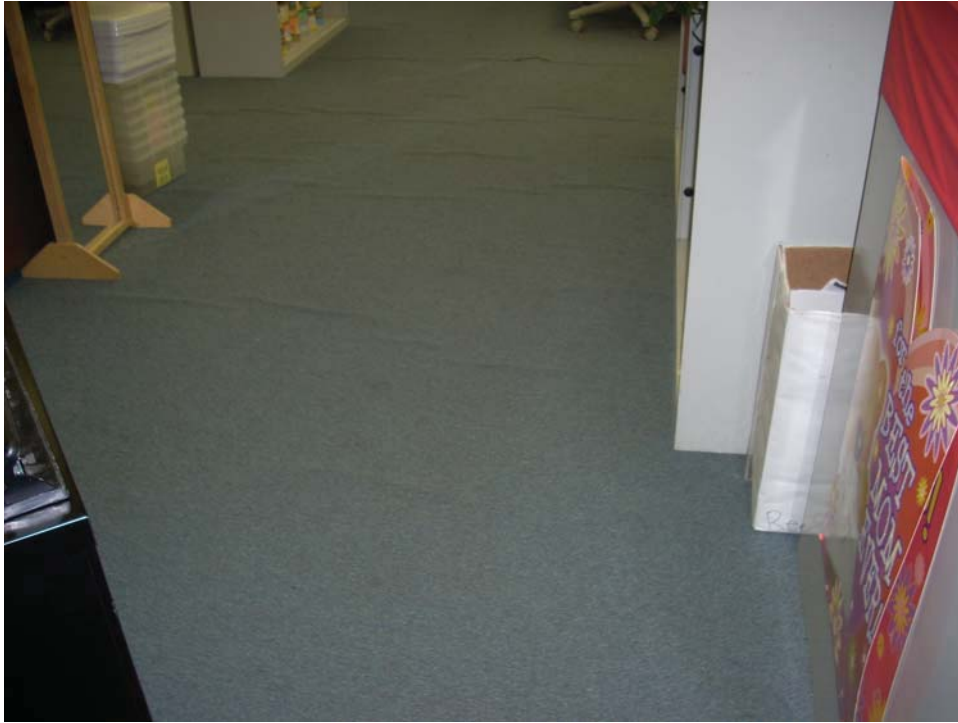
Carpet

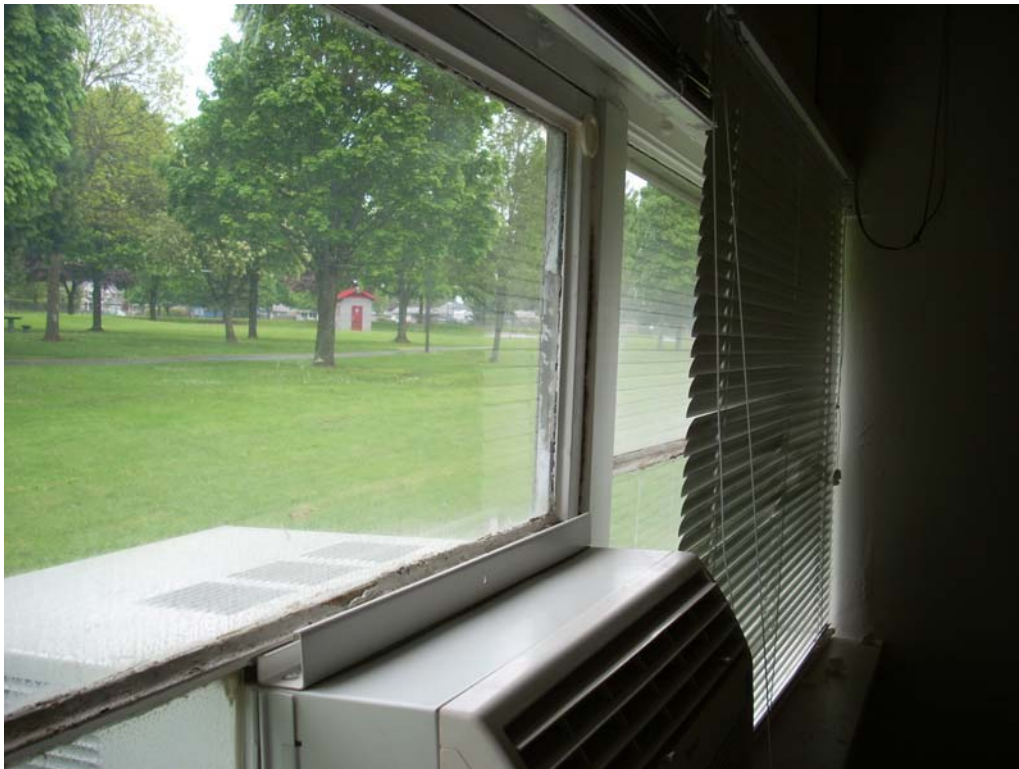
Interior window

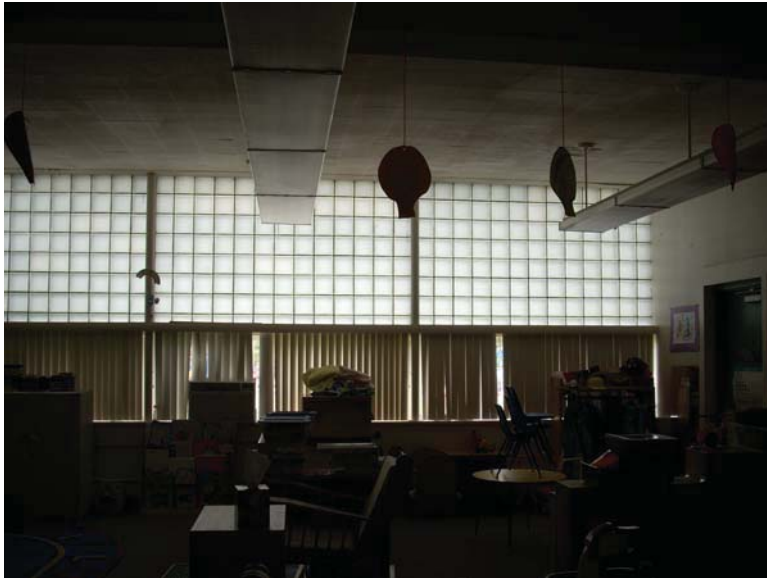
Interior windows

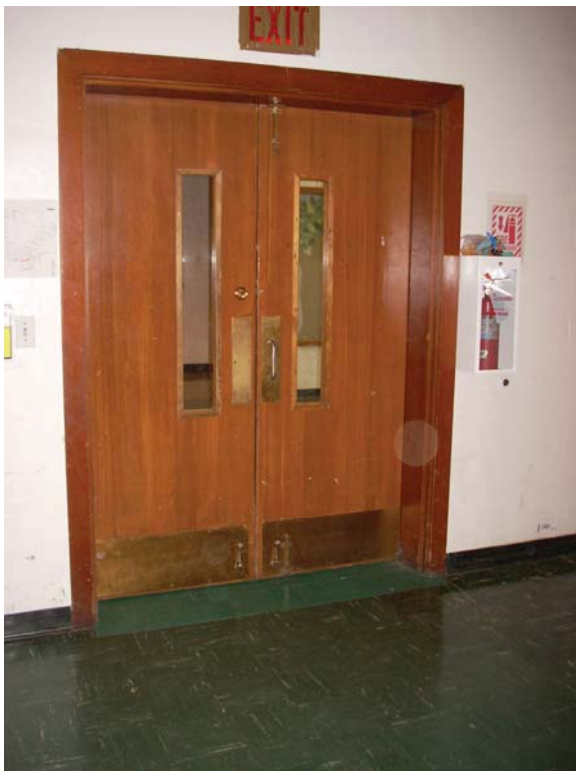
Door / door hardware

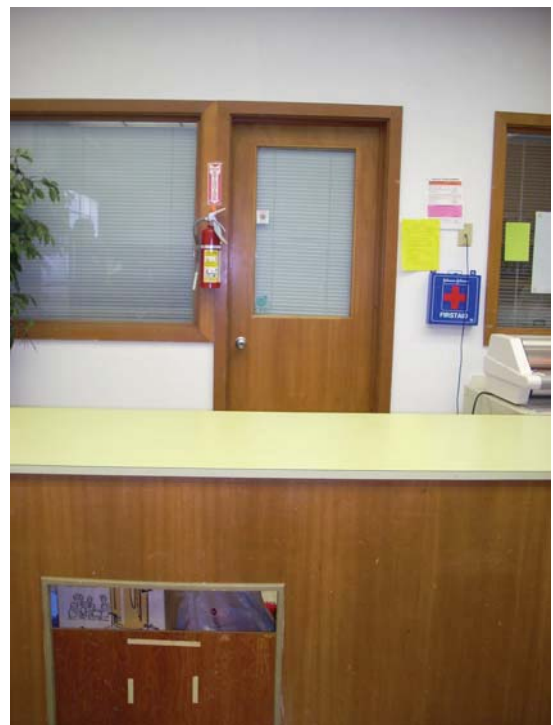
Door / hardware and countertop

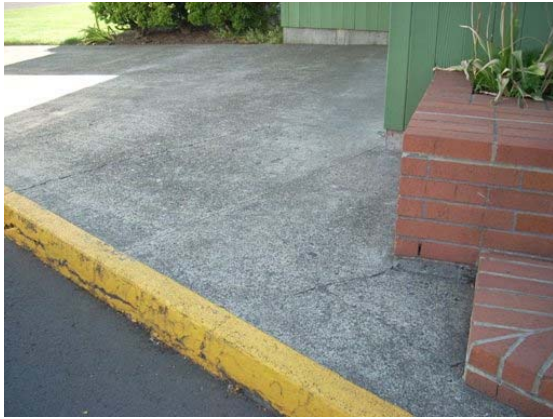
Cracked curbs & sidewalk

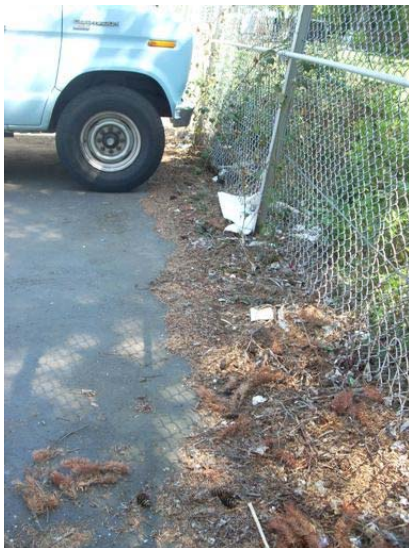
Earth and other debris at fence

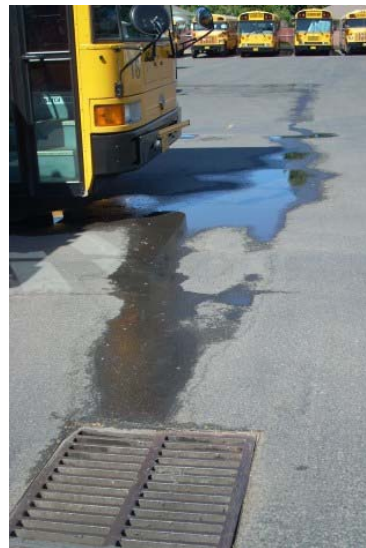
Site drainage issues

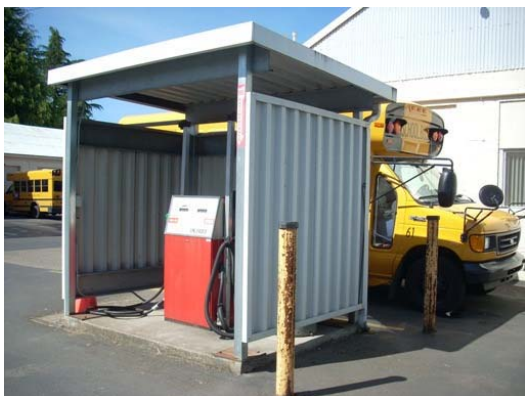
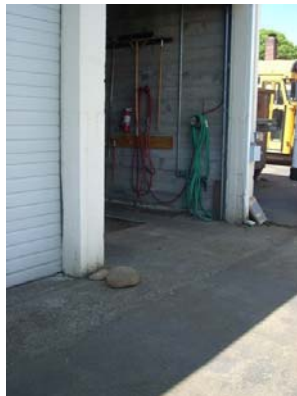
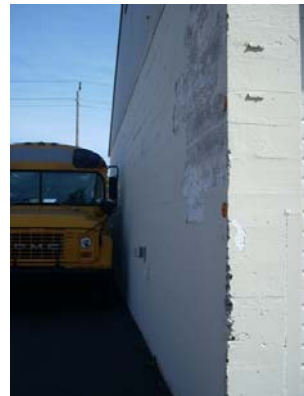
More bollards required at several places on site

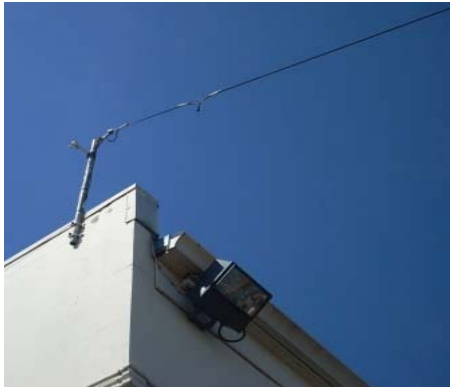
Exposed overhead cables

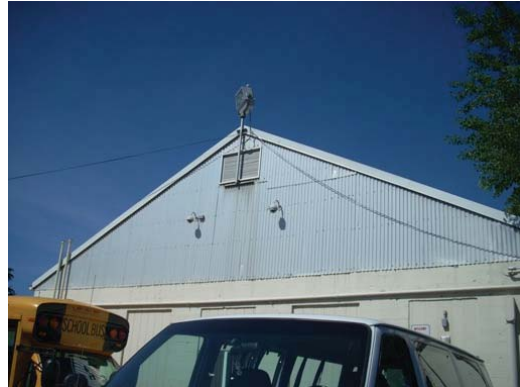
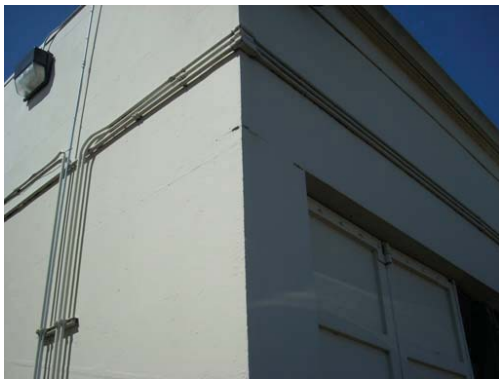
Cracks on exterior of building

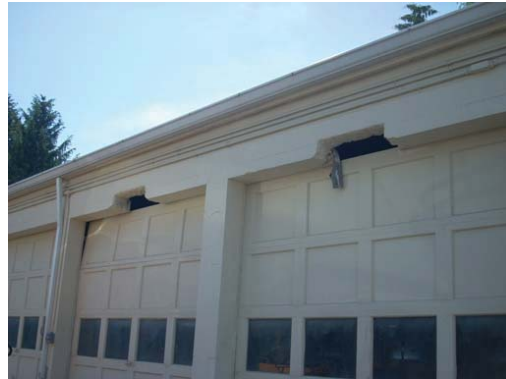
Bottom of beams needs repair

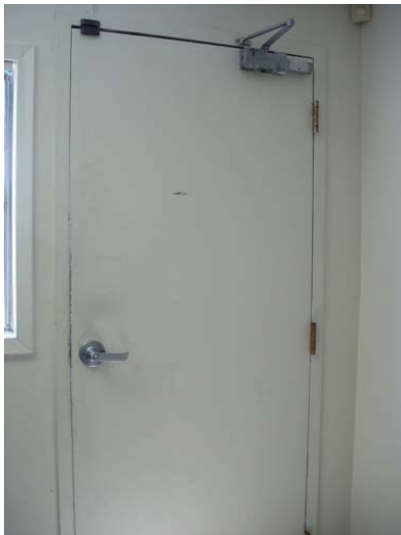
Panic hardware missing

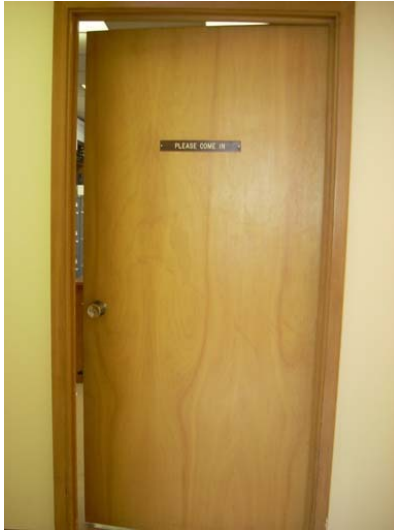
Non compliant door knob

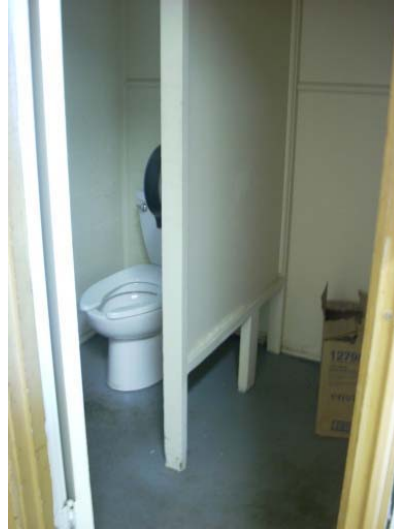
Toilet not ADA compliant

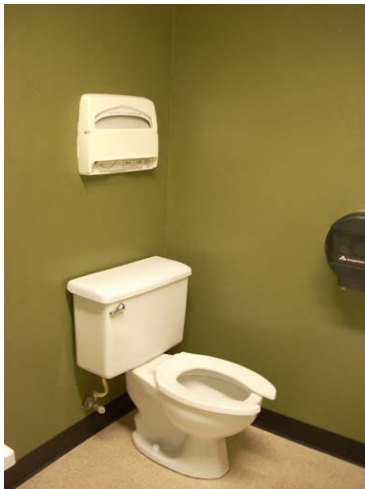
Toilet not ADA compliant

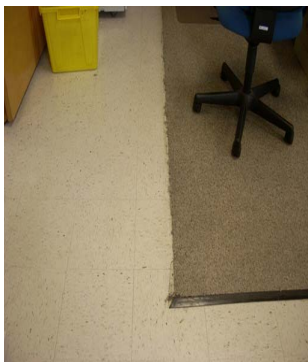
Install new carpet

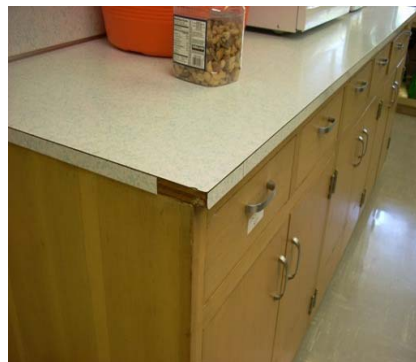
Casework and counter
