Geneva Community Unit School District #304
Operations and Maintenance
7 Year Capital Improvement Plan

Finance Advisory Committee

April 10, 2023

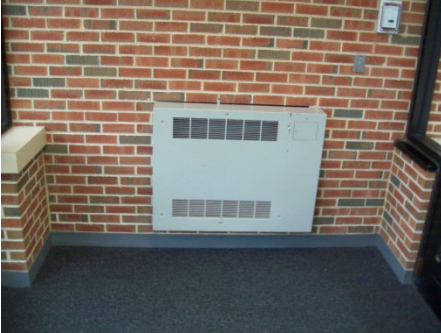
Cabinet Unit Heaters

15 units are over 42 years old.

Replace with energy efficient units.

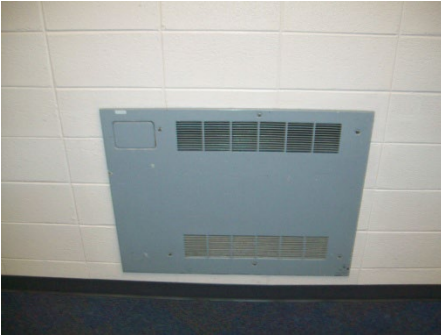
Cabinet Unit Heaters

9 units are over 27 years old.

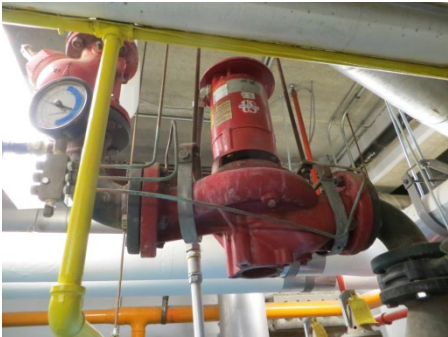
Primary Boiler Pumps

Original to the building.

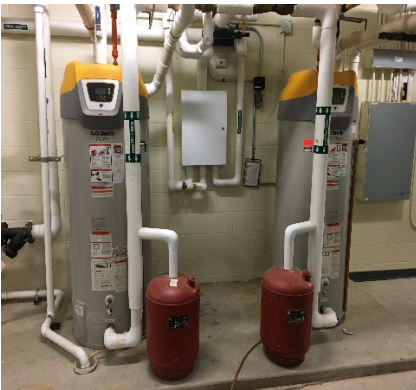
Hot Water Heaters

The two 100-gallon A.O. Smith water heaters are nearing the end of their life cycle.

Replacement will be needed within the next two to five years.
