**Geneva Community Unit School District #304  
Operations and Maintenance  
7 Year Capital Improvement Plan**

## **Board of Education Meeting**

**January 25, 2016**

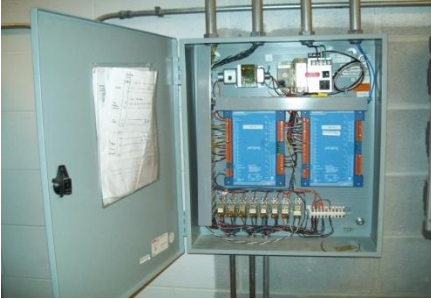
## Lon Controller

Lon controls throughout the building.

Outdated and costly to repair.

Replace Lon to Bacnet.
