Geneva CUSD 304 5-Year Capital Improvement Plan 2013

Geneva Community Unit School District #304

March 11, 2013

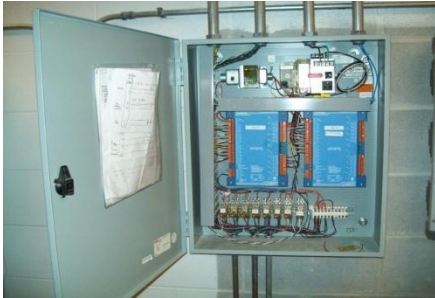
Lon Controller

Lon controls throughout the building

Outdated and costly to repair

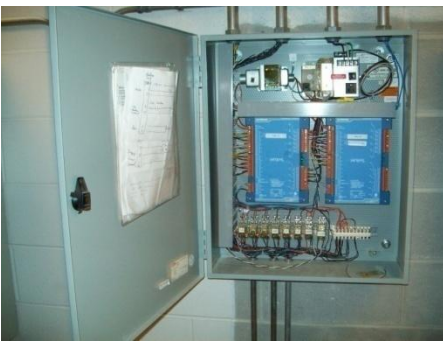
Lon Controller

Lon controls throughout the building

Outdated and costly to repair

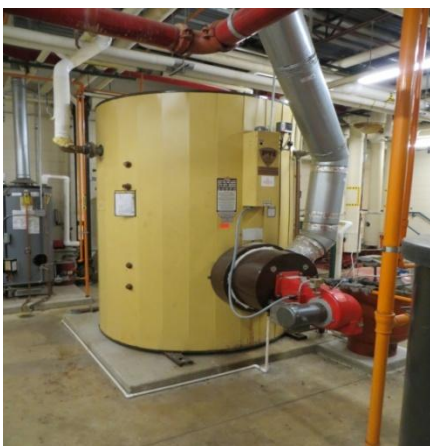
Domestic Hot Water Heater

Original 1500 gallon water heater has exceeded its life span of 10-15 years. Plan on replacing in the next 5 years with a more efficient and properly sized water heater.

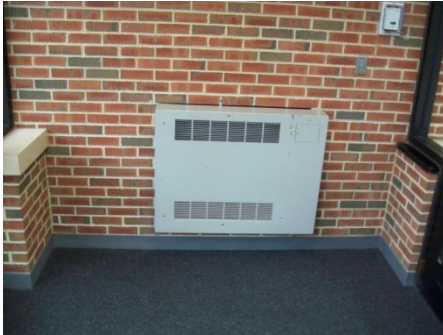
Cabinet Unit Heaters

15 units are over 35 years old.

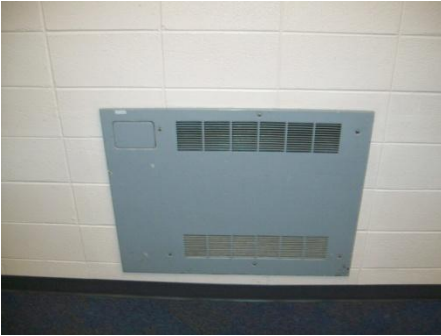
Cabinet Unit Heaters

9 units are over 20 years old.

Blowers are failing.

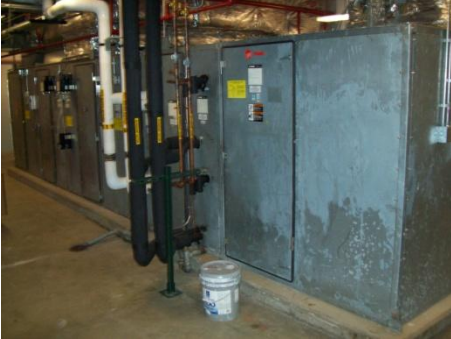
Air Handling Unit

Inefficient. Serves the office and classroom wing.
