FACILITY CONDITION ASSESSMENT

FACILITY CONDITION ASSESSMENT REPORT OF CI JOHNSON ELEMENTARY SCHOOL 1934 Liberty Street Aurora, Illinois 60505

EMG Project #: 112945.15R-009.017
Date of Report: April 25, 2015
On site Date: April 7, 2015

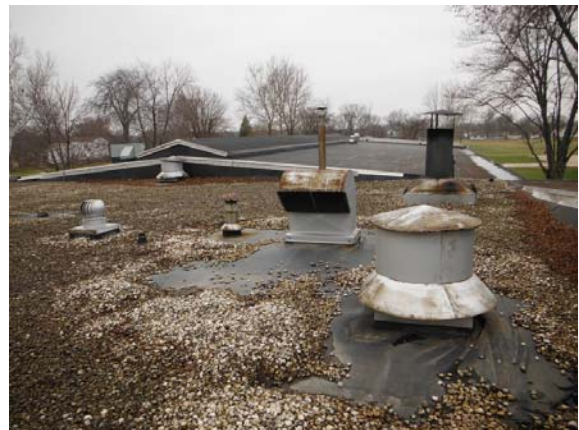
Photo #6:	Roof over front central section and 200 wing
-----------	--

Roof drainage appears to be inadequate. Significant areas of ponding are evident on the sides of the roof at both the 200 and 300 wings and a clogged scupper noted on east side of the 300 wing roof at the ponding area. The low spots in the roof must be reframed to promote adequate drainage to existing drainage devices during the next roof replacement. In addition, clearing and minor repair of drain system components should be performed regularly as part of the property management's routine maintenance program.

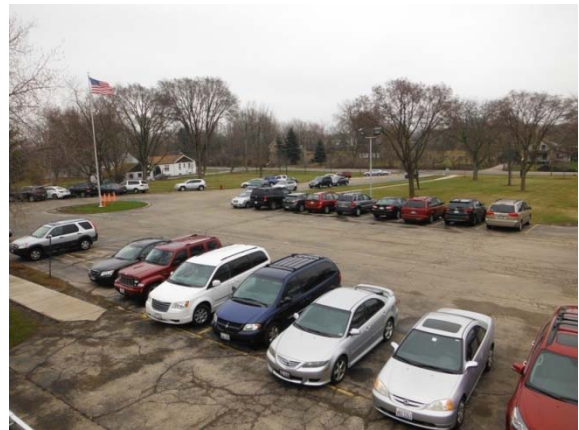
Photo #10:	Overview of site parking
------------	--------------------------

The asphalt pavement is in fair to poor condition, with overall heavy surface wear, worn striping, widespread alligator cracking, and a moderate number of depressions and potholes. The area immediately entering and exiting the property main drives are generally in the worst condition. The most severely deteriorated areas must be cut and patched during the early portion of the evaluation period, and all of the areas are recommended for replacement as soon as the budget allows, as well as seal coating and re-striping.

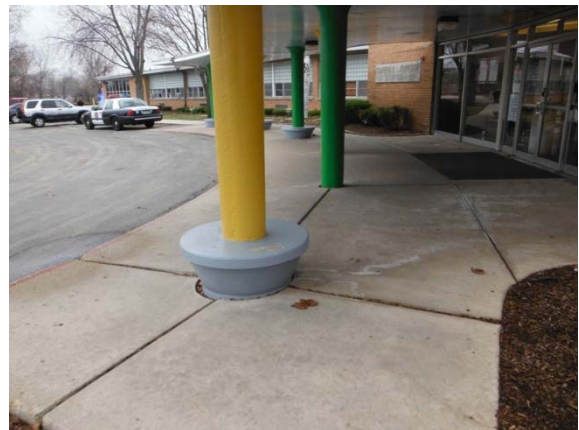
Photo #12:	Site concrete sidewalk
------------	------------------------

The concrete sidewalks along the front of the school, adjacent to the main building entrance, were observed to have minor areas of settlement, with separation areas leaving large gaps between the sections of sidewalk and isolated areas of spalled concrete occurs. As such, sectional replacement of the concrete sidewalk will be required early during the evaluation period.

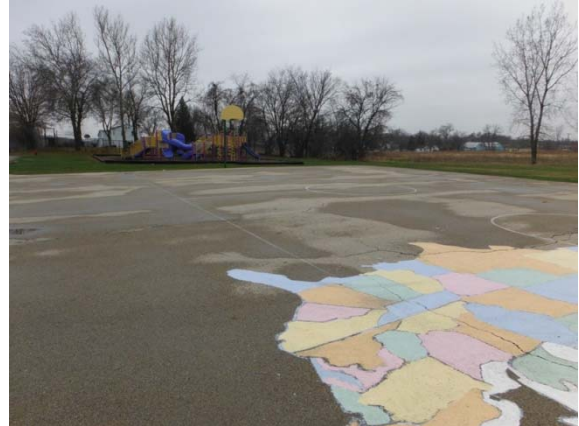
Photo #14:	Basketball court
---------------	------------------

The basketball court asphaltic pavement is worn and cracking at various locations throughout. Crack sealing and seal coating of the basketball court surface will be required early during the evaluation period.

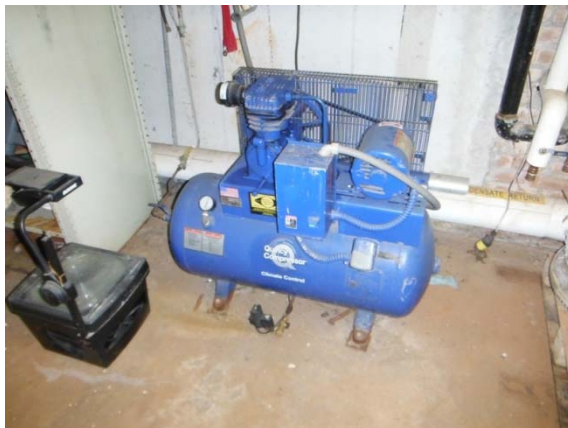
Photo #41: HVAC air compressor

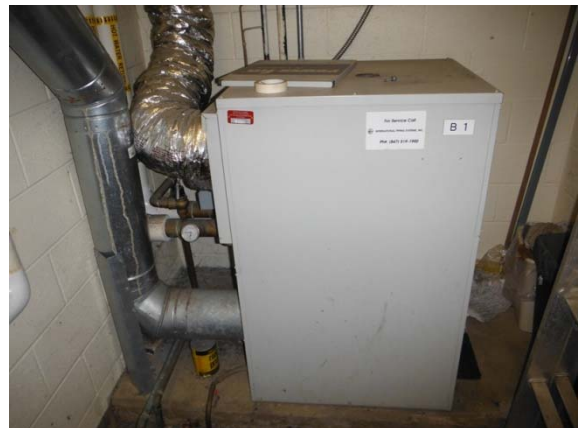
Photo #42: HVAC boiler in 2005 addition

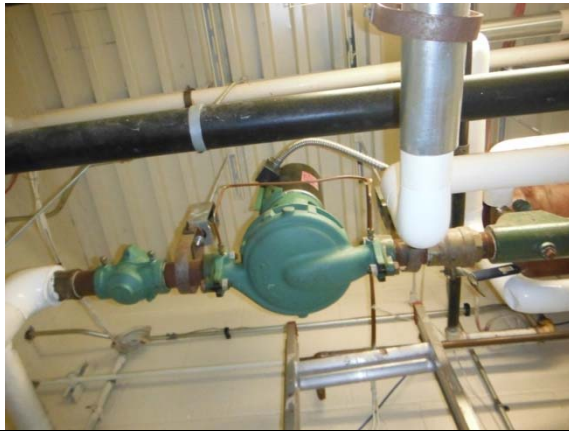
Photo #43: HVAC circulation pump

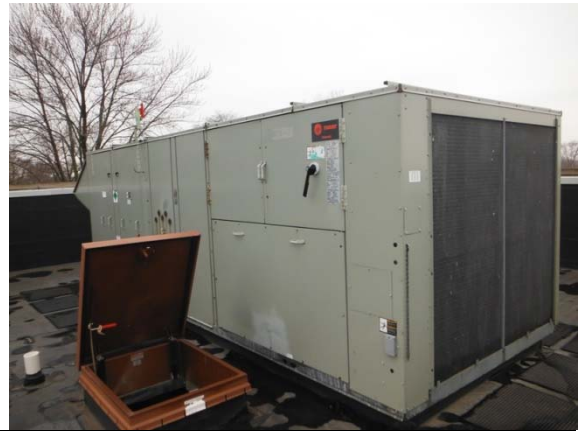
Photo #44: Gas-fired RTU for 2005 building addition

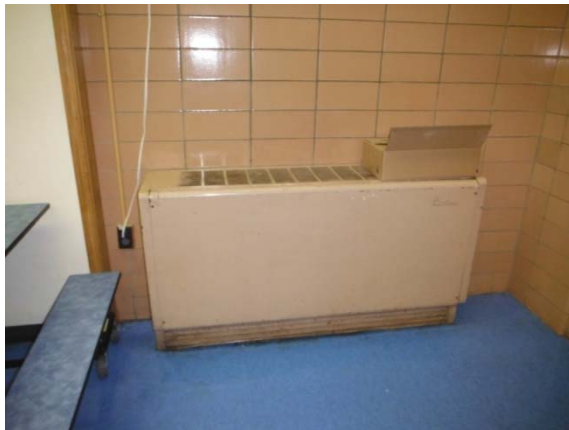
Photo #45: Horizontal unit ventilator in cafeteria

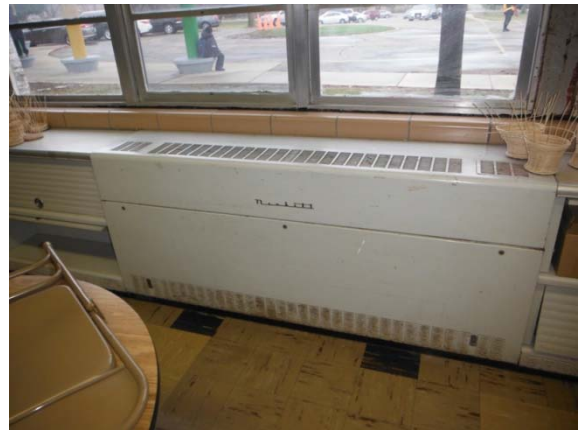
Photo #46: Horizontal unit ventilator in original building classroom

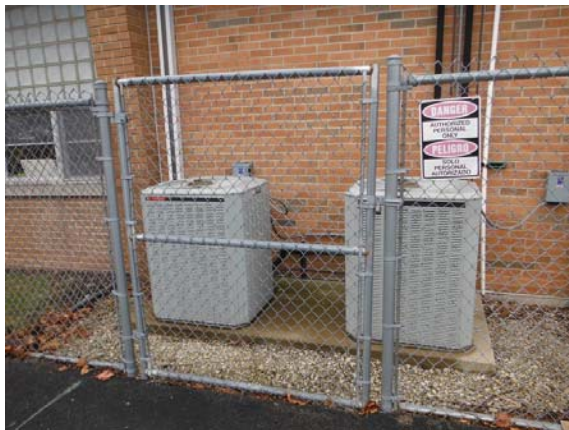
Photo #47: Condensers for kindergarten classrooms

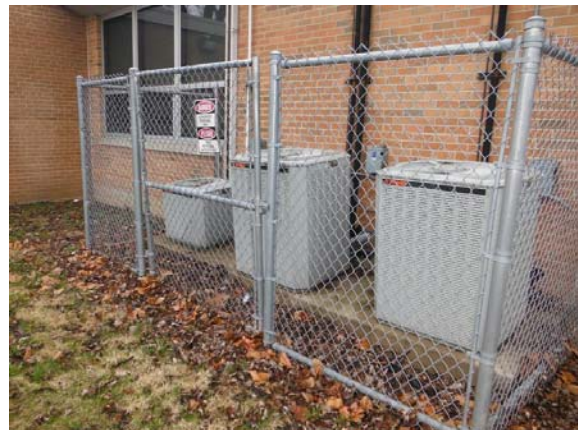
Photo #48: Condensers for Computer lab, Learning center and office area

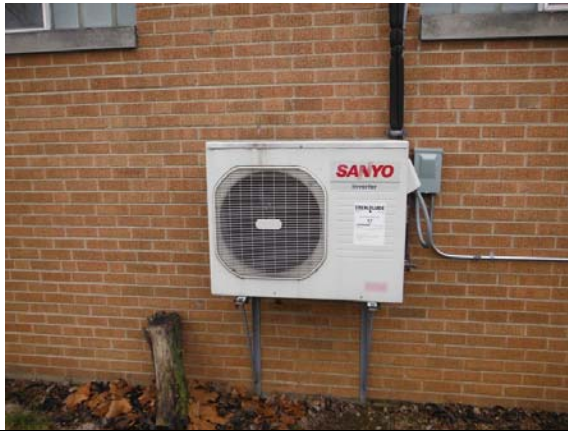
Photo #49:	Ductless split system condenser for Parent liaison office
------------	---

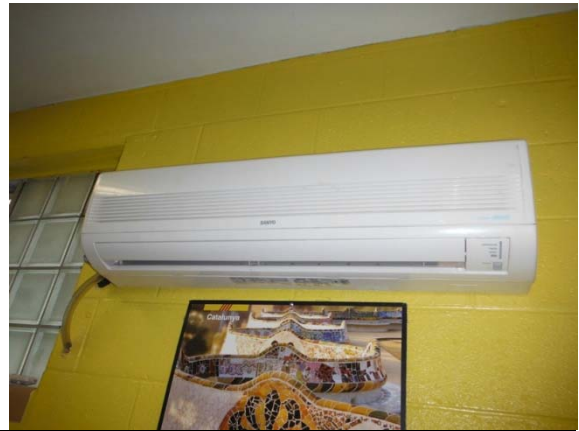
Photo #50:	Ductless air handler in Parent liaison office
------------	---

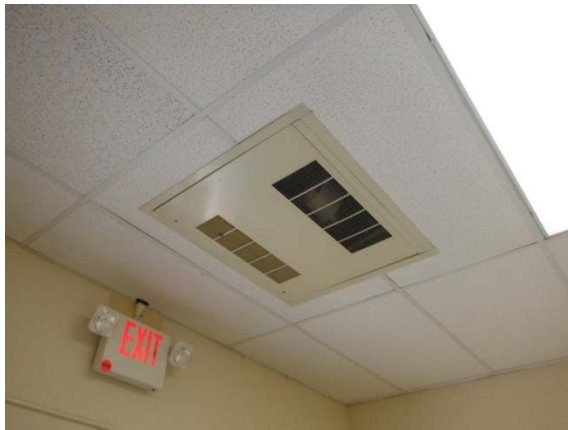
Photo #51:	Common area fan coil unit above entrance door
------------	---

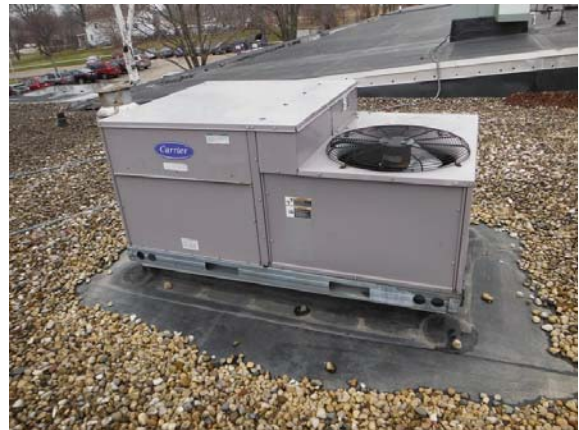
Photo #52:	Electric RTU for main office area
------------	-----------------------------------

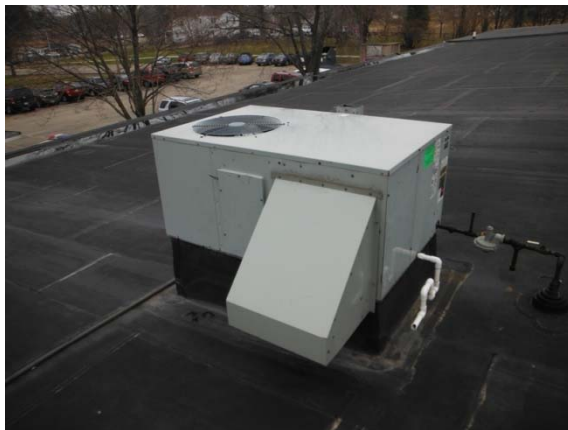
Photo #53:	Gas-fired RTU for main office area
------------	------------------------------------

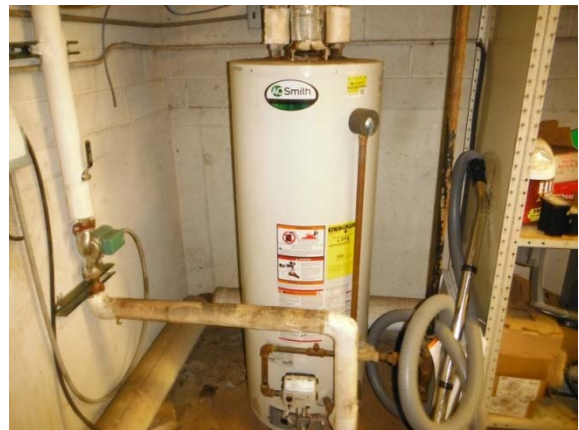
Photo #54:	Domestic water heater (1 of 4)
------------	--------------------------------

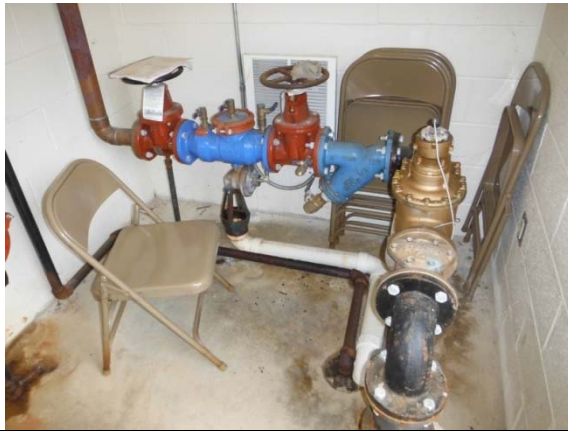
Photo #55:	Domestic water backflow preventer and water meter
------------	---

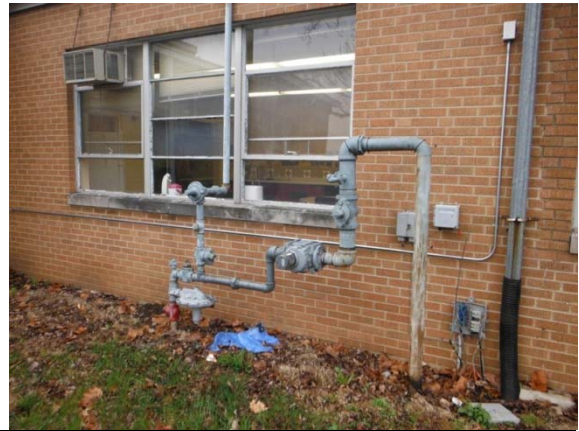
Photo #56:	Gas metering
------------	--------------

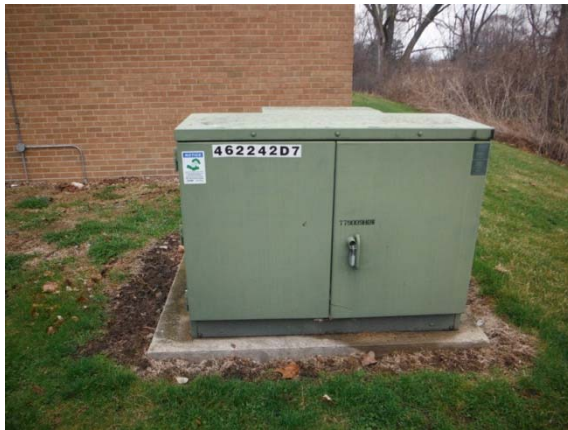
Photo #57:	Transformer
------------	-------------

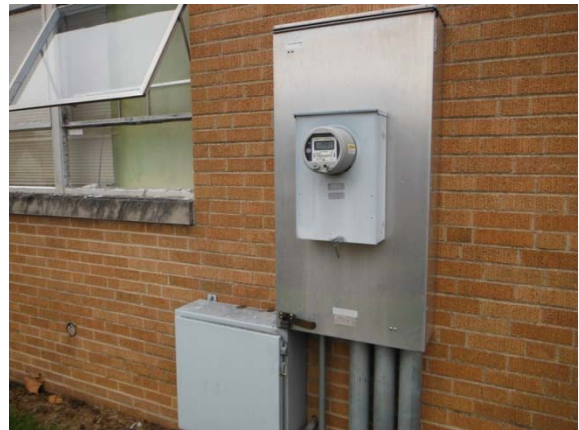
Photo #58:	Electrical meter
------------	------------------

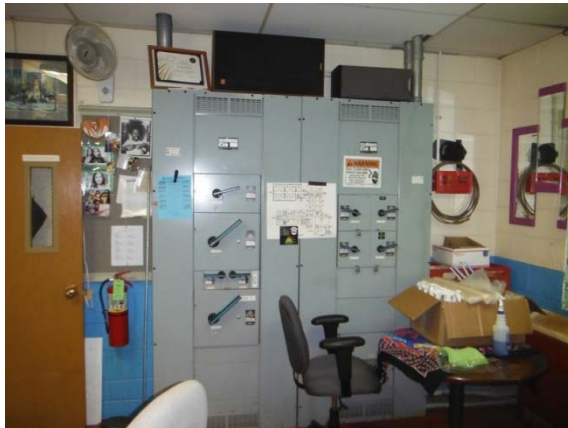
Photo #59:	Main electrical switchboard
------------	-----------------------------

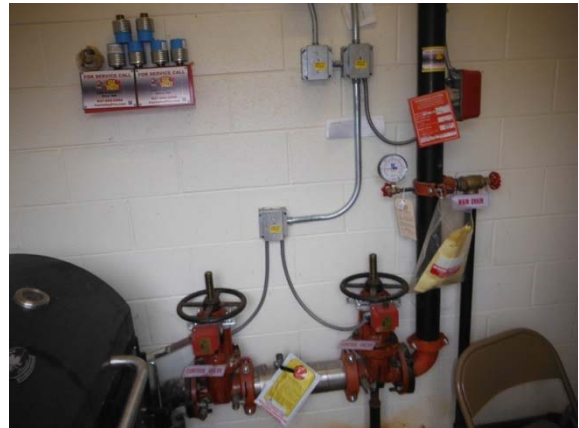
Photo #60:	Sprinkler riser
------------	-----------------

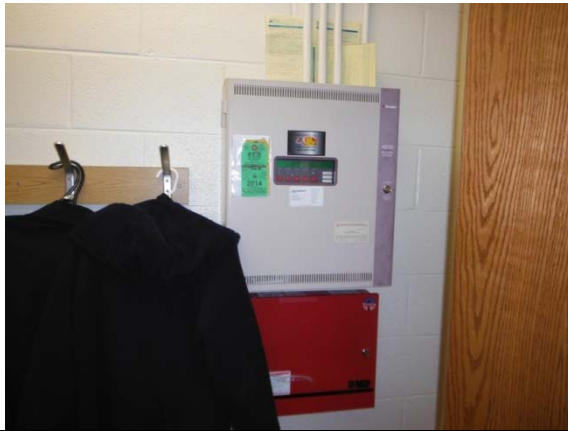
Photo #61: Central fire alarm panel

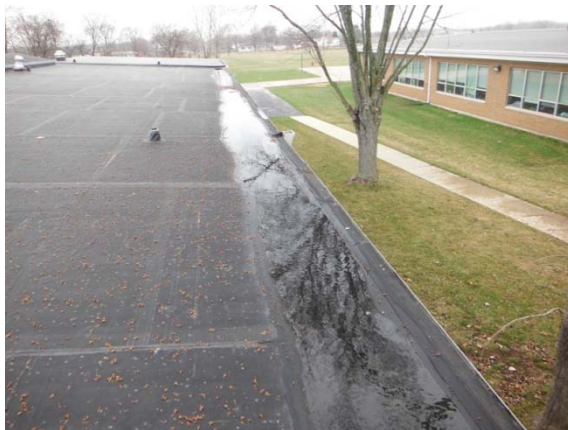
Photo #65: Ponding along north side of 200 wing roof
