June Facilities, Finance & Operations Committee Meeting  
Friday, June 12, 2026  
9:00 AM  
Zoom Webinar

**Subject:** 5 Year IAQ Report

The HVAC systems were inspected from 2/17 to 2/20 to evaluate operation with emphasis on ventilation. This report summarizes the systems and describes the ventilation operation as found and reviewed on site. Observations cover outdoor entry paths, filters, and control system review.

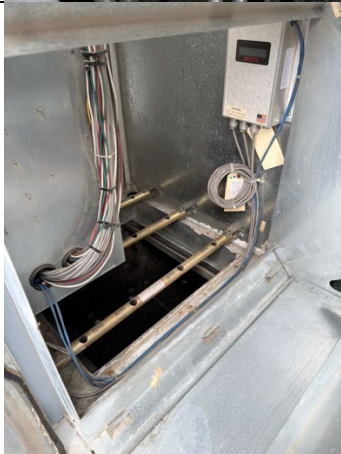
Return air flow measurement station

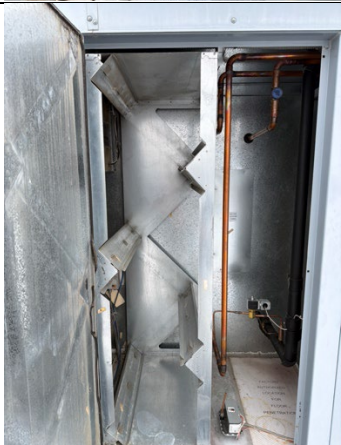
The DOAS unit is missing filters in both the outdoor air stream and the exhaust stream. It is supplying unfiltered outdoor air to the classrooms. The exhaust filters are meant to be installed upstream of the desiccant wheel heat exchanger to protect it from fouling and losing heat transfer effectiveness. The supply filters do the same with the added task of filtering the outdoor air supplied to the classroom. Without filters the wheel has some self-cleaning capability as supply air enters in one direction through half of the wheel as exhaust air passes through the other half of the wheel in the other direction.

Return air empty filter rack

Air flow velocity measurements at supply and exhaust registers in a sample of classrooms show an average of 147 cfm of outdoor air and 99 cfm of exhaust per classroom. This calculation assumes a 75% free area in the 5x12 inch grill and that the supply is the side with the highest air flow. Applying the average to 12 classrooms in the E-wing the total outdoor air should total at least 1,800 cfm. There are also supply grilles for the corridors. The DOAS unit is providing outdoor air to the E-wing and should be put into the regular maintenance schedule to install and replace filters.

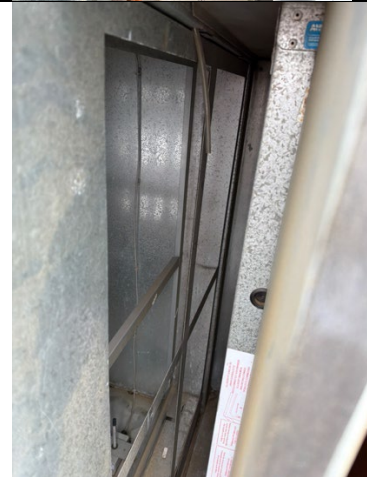
- The W-wing dedicated outdoor air system is missing filters on both the outdoor air intake and exhaust intake to the heat exchanger wheel that tempers the air. This unit supplies outdoor air directly to each classroom in the E wing. Currently the air is unfiltered.

<p>Outdoor supply empty filter racks</p>

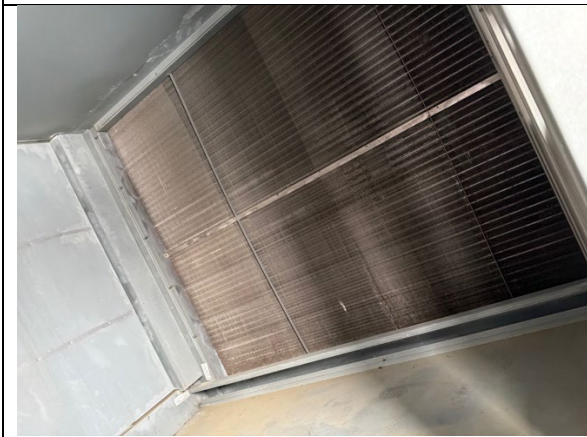
Coil inlet face. Some debris building up especially at bottom

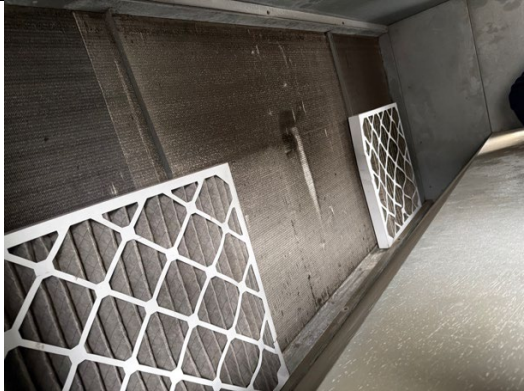
RTU-3	Mixed air temperature suggests 43% outdoor air when the damper is commanded to only 5% open. Airflow increases with more open damper. Is damper actually closing to 5%?
RTU-3	AFMS wiring is looped around OA damper blade.
RTU-3	Found filter blown out from rack and dirty coil inlet face.
RTU-6	The AFMS and mixed air temperature calculation suggest that the damper position has no effect on the outdoor air. Is damper actuating? Suspect damper is stuck about halfway open.
RTU-6	AFMS wiring is loose and sticks through OA damper opening.
RTU-6	Found filter blown out from rack and dirty coil inlet face.
RTU-8	No issues.
RTU-9	Data suggest that the outdoor dampers are mostly open when commanded closed.
RTU-9	Coil inlet face is dirty.
Auditorium	No design data. Mixed air temperature suggests 24% outdoor air with damper commanded 5% open.
HV-1	Mixed air temperature suggests 50% outdoor air with damper commanded 5% open.

Found filter blown out of rack and dirty coil inlet face

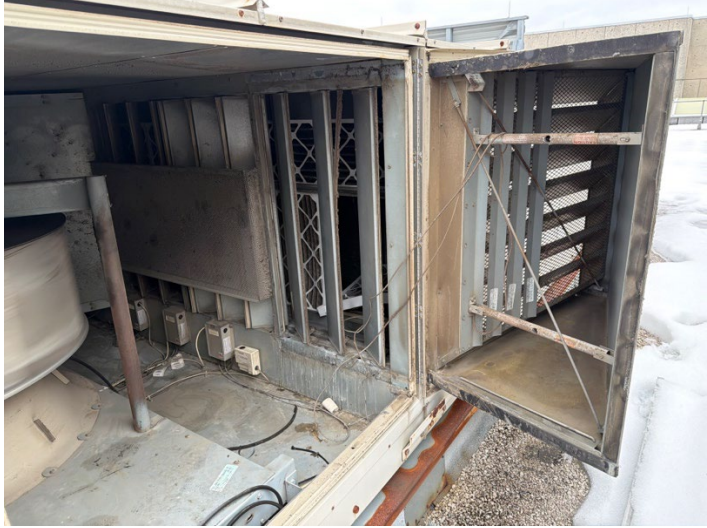
Priority	Medium
Tag	RTU-6
Location	H-wing Roof
Service	Gallery
Type	Single Zone Constant Volume RTU
Outdoor Air Filters	AFMS in door with intake louver 2 inch MERV-8. Two filters blown out of rack.

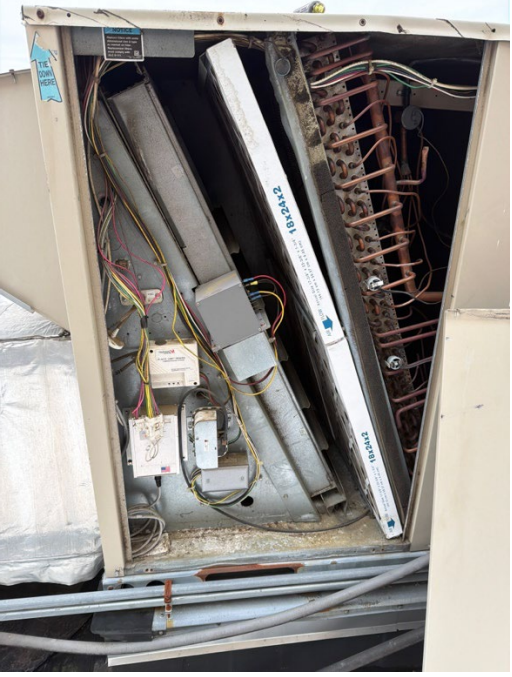
Outdoor damper on slant at top. Return air damper on slant at bottom

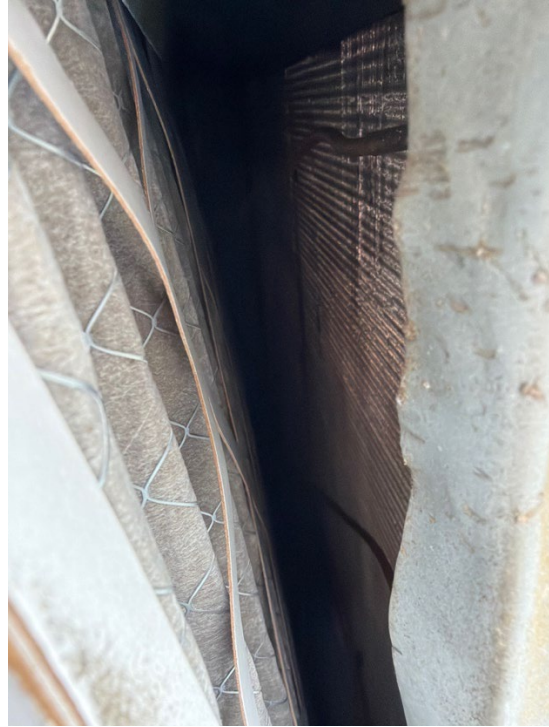
Mixed air temperature sensor in gap between filters and coil

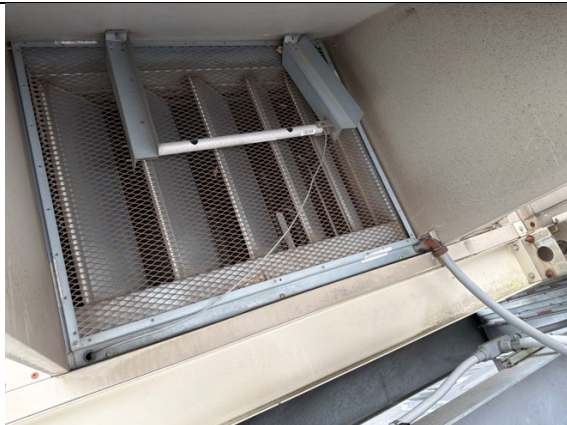
AFMS outside under shroud.  
Damper did not close when unit was off,

- RTU damper actuation should be verified. Observations noted some dampers open when the units are off or not closing completely. A relief damper that is erroneously open could contribute to the observed reduction in system air flow by exhausting excess return air.

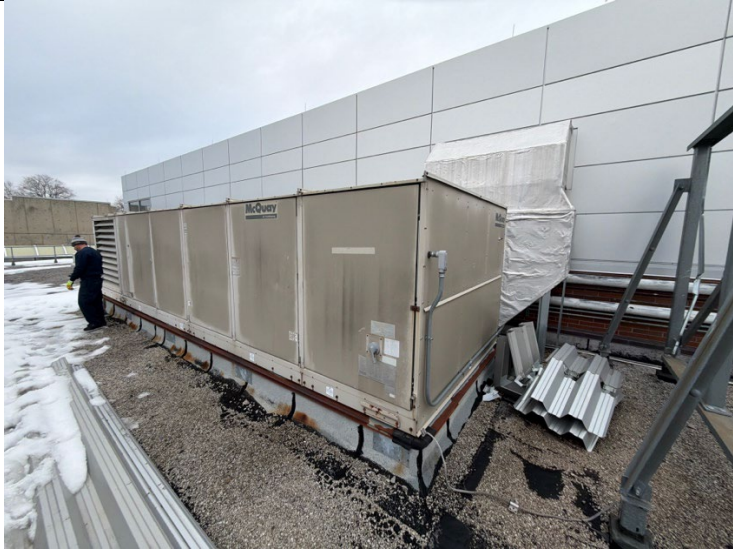
Unit Overview

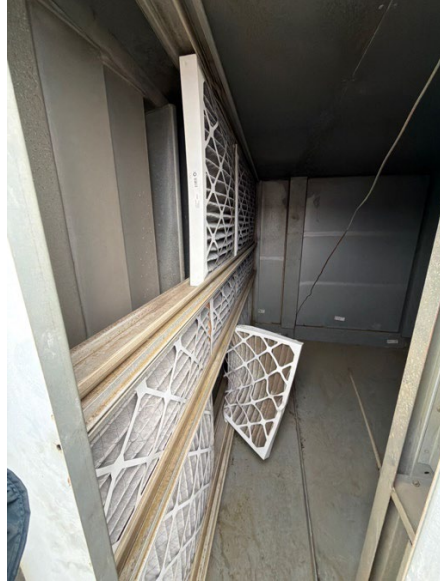
Priority	Medium
Tag	HV-1
Location	Roof
Service	Gym
Type	Single Zone VAV RTU
Outdoor Air	AFMS in door with intake louver
Filters	2 inch Merv-8. One found blown out

Lower center filter blown out

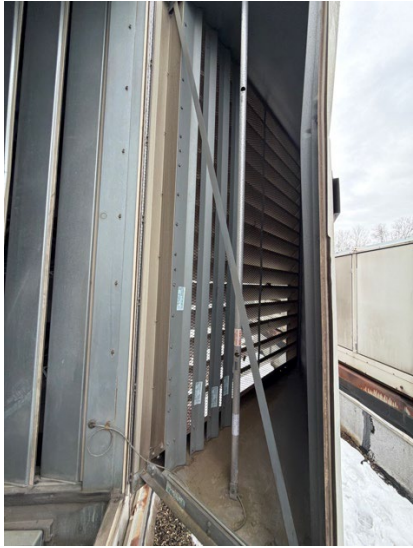
Return air section with outdoor air dampers – right AFMS in door with intake louver OA dampers do not close completely with unit off

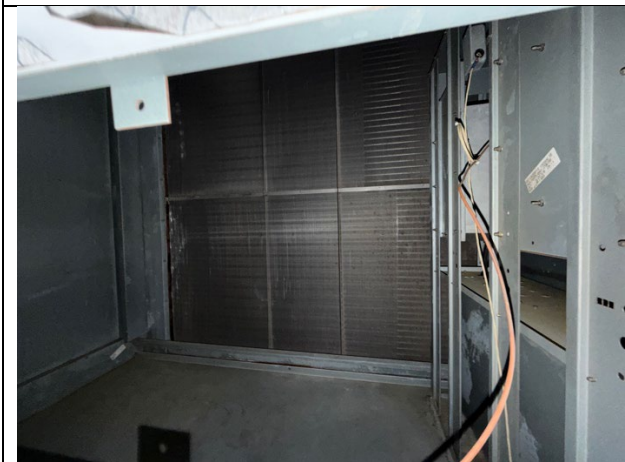
Filters lack blank off panels at end allowing dirty air to bypass filters

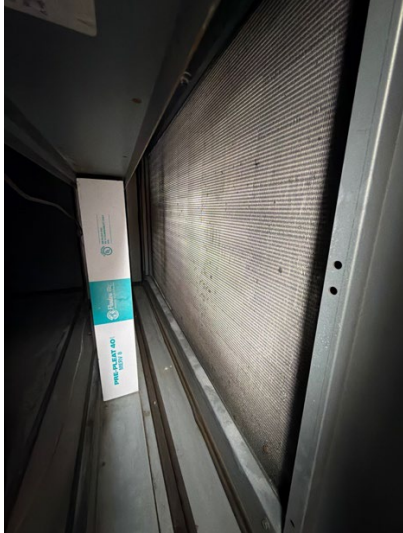
Mixed air temperature sensor across filter inlet. Part of sensor is near outdoor air intake,

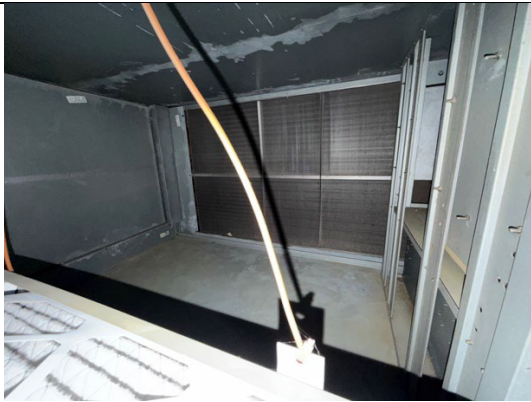
Coil inlet face. Some dirt at bottom of coil.

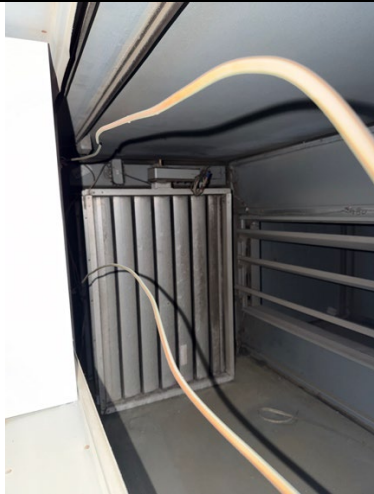
Mixed air temperature sensor at filter inlet. Part of sensor is near outdoor air intake.

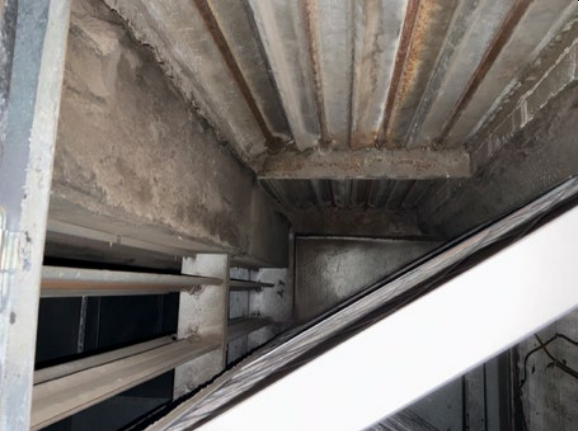
- OA damper closed – no outdoor air flow
- OA damper linkage and control actuator are disconnected
- Near side of coil covered in due to air blowing by filter. Missing blank off section to span gap from end of filter to door.

Damper control actuator is disconnected (on the floor) Damper blade linkage is disconnected

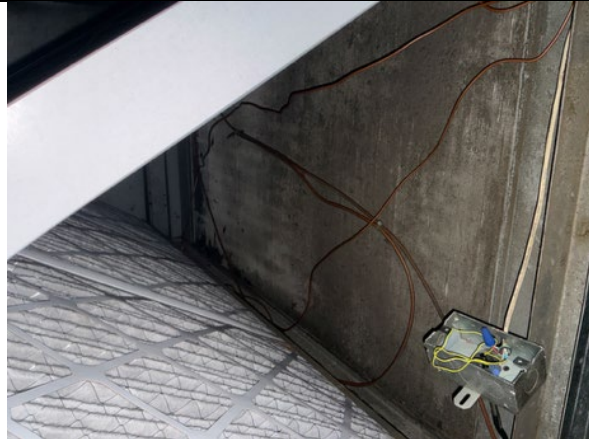
Outdoor air damper (top) is closed). Return air damper is open (left)

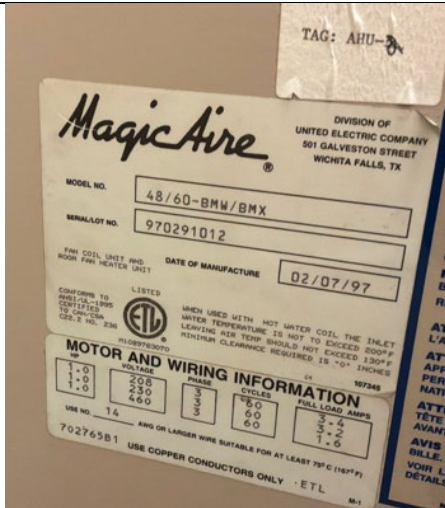
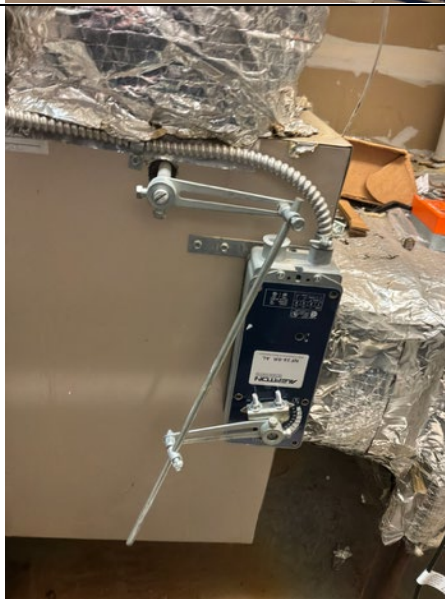
Priority	Medium
Tag	AHU-2
Location	Core Mezzanine
Service	Hallways
Make	Magic Aire
Outdoor Air	Control actuator is connected tightly to damper linkages No access to damper blades without disassembly panel
Filters	No access to filter without disassembly of panel

Outdoor and return air damper linkage is tightly secured to the control actuator

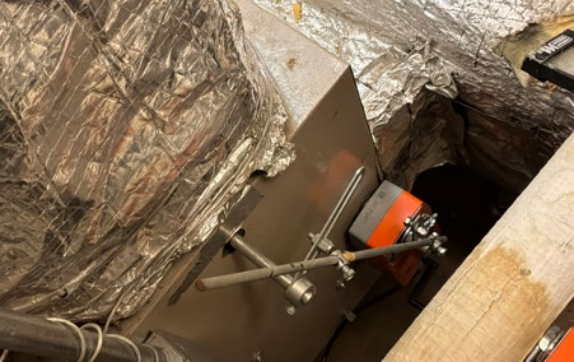
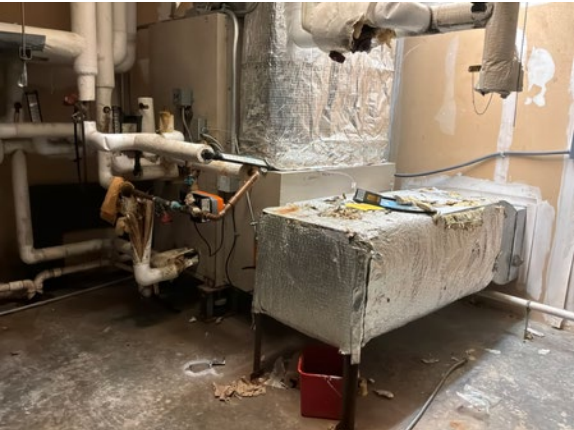
Priority	Medium
Tag	AHU-3
Location	Core Mezzanine
Service	Computer Room
Make	Magic Aire
Outdoor Air	Control actuator is connected tightly to damper linkages No access to damper blades without disassembly panel
Filters	No access to filter without disassembly of panel

Outdoor and return air damper linkage is tightly secured to the control actuator

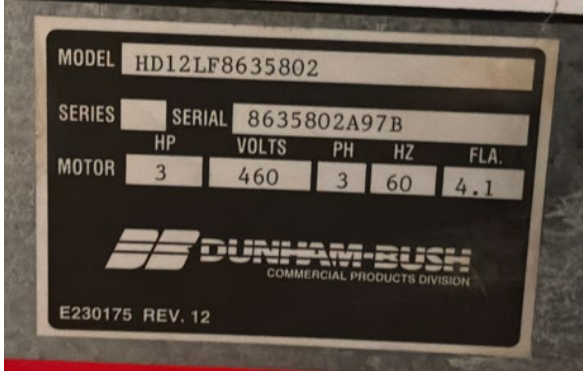
Priority	Medium
Tag	AHU-4
Location	Core Mezzanine
Service	Offices
Make	Dunham Bush
Outdoor Air	Damper linkages are disconnected Control actuator is disconnected OA is closed RA is loose and easily moved – found closed
Filters	Dirty coil from blow by through gap between filter end and door

Return damper linkage connection to actuator is loose. Outdoor damper linkage is disconnected

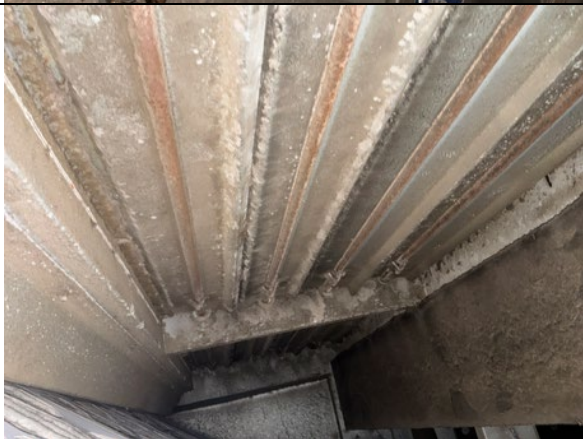
Outdoor air damper (top) is closed

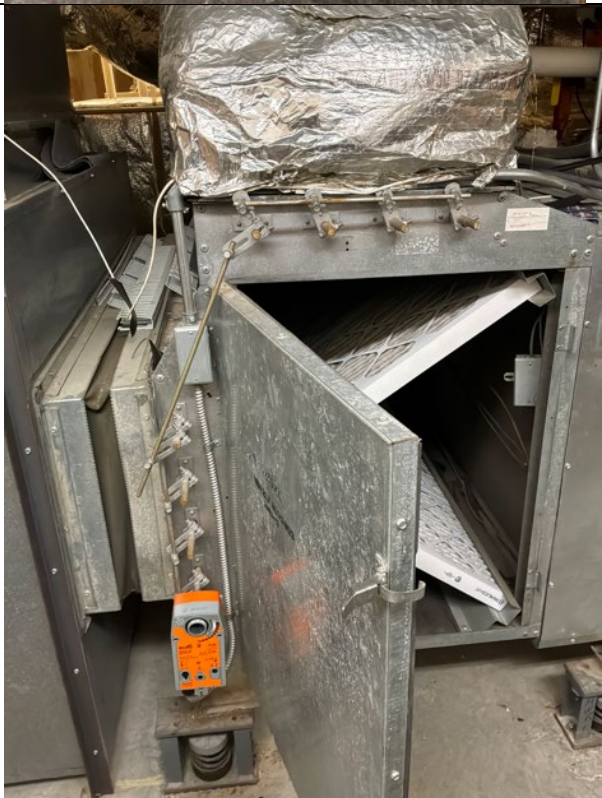
Priority	Medium
Tag	AHU-5
Location	Core Mezzanine
Service	Art and Nurse
Make	Dunham Bush
Outdoor Air	Control actuator is connected tightly to damper linkages RA is closed OA is open
Filters	Dirty coil from blow by through gap between filter end and door

Control actuator is connected tightly to damper linkages

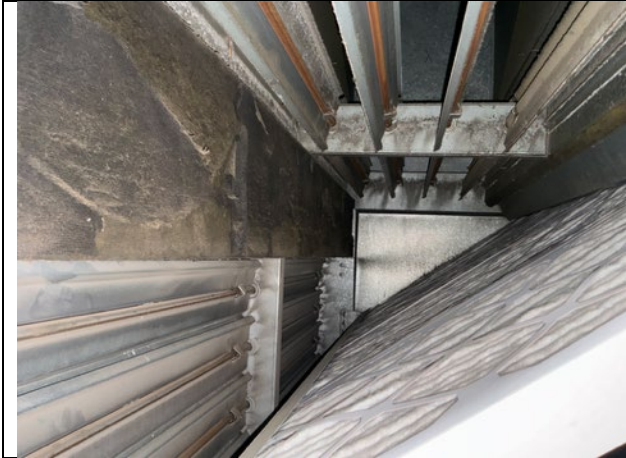
Outdoor air damper (top) is open  
Return air damper (left) is closed

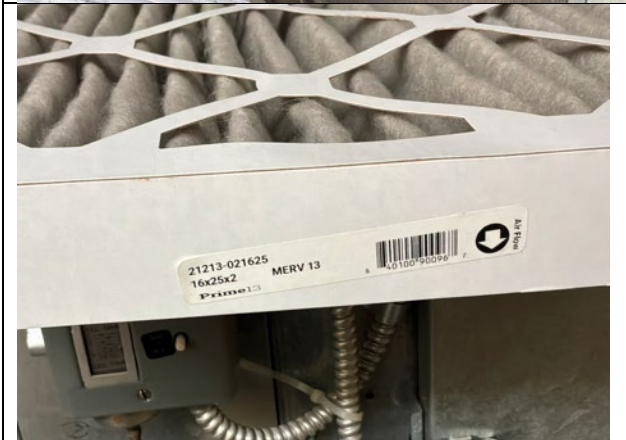
Example filter  
MERV 13 rating

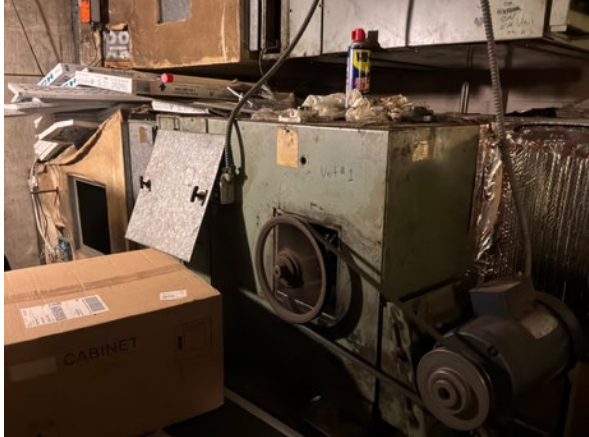
The gym is ventilated by two dedicated constant volume air handlers. The upper unit contains a cooling coil and is inoperable. The lower unit contains a heating coil with outdoor air and return air dampers to control the outdoor air fraction provided to the space. The dampers are not operational. The control system actuator is disconnected, and the outdoor damper is fixed in a closed position with one blade slightly cracked open. Little to no outdoor air is being provided to the gym.

Priority	Medium / High
Tag	--- GYM AHU
Location	North Fan Room
Service	Gym
Make	---
Outdoor Air	Damper linkages are disconnected Control actuator is disconnected OA is closed RA is open
Filters	Clean (all filter replaced every three months)

Unit overview

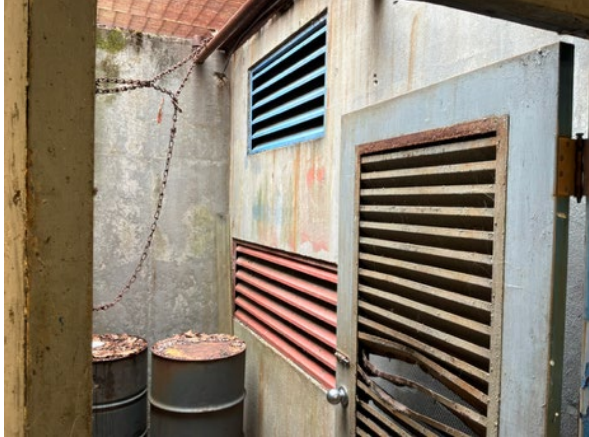
Outdoor air louver (lower)

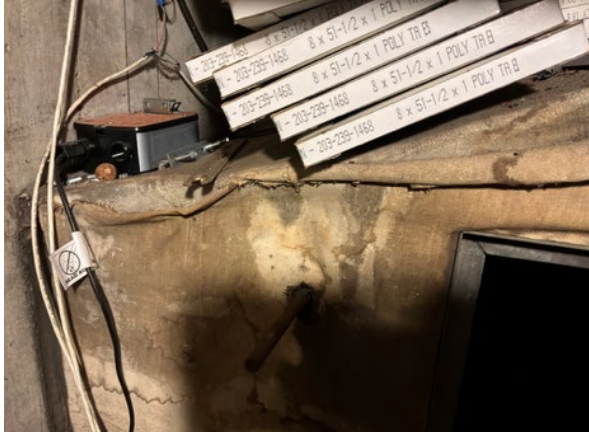
Four units are controlled through the BAS. They are noted to be operating as occupied which would expect to keep the fan continuously operating, but three of the four units were off when inspected. The outdoor damper position is noted with a log of changes over the years. If the fans are allowed to cycle during the occupied period, they will not introduce any outdoor air while off. Note that the Gym AHU outdoor air controls are not connected to the damper.

Damper actuator disconnected and set on top of unit

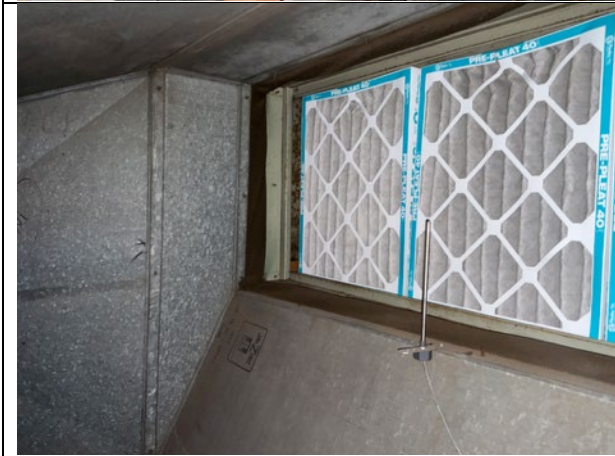
Filter section with single point mixed air temperature sensor in front of filter

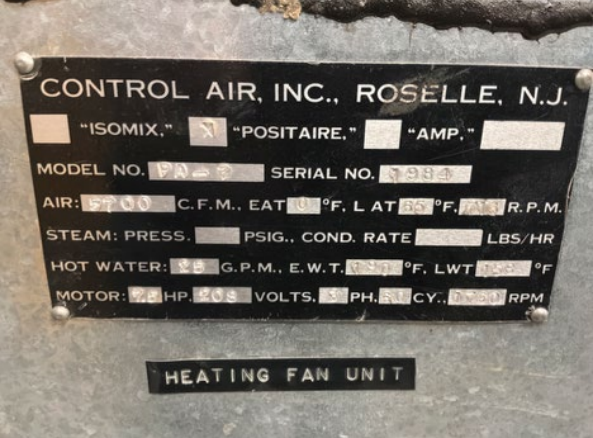
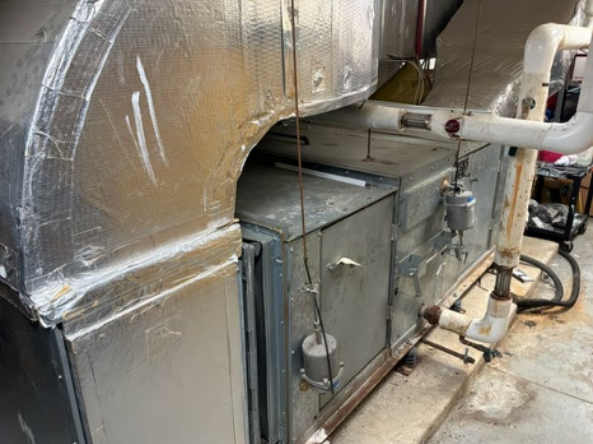
- Unit is 100% outdoor air with single inlet duct
- Coil state is not viewable due to clamshell style face/bypass dampers
- Controls are pneumatic
  - Inlet isolation damper
  - Heating coil face and bypass damper
- BAS shows damper control at 20%
  - Is it possible this is the inlet isolation damper rather than a return damper as suggested on the BAS graphics?
  - Unit is scheduled to operate 5 am to 10 pm Monday through Friday providing 70F air.
- BAS shows supply temperature controlled by Room NH-16 space temperature rather than maintaining a neutral discharge temperature as typically found on dedicated outdoor air units.
- No test ports were found on the unit to insert an air velocity probe. Unit air flow could be confirmed as well as room distribution flows confirmed from supply register measurements typically performed by a testing and balance contractor.

Priority	Low
Tag	--- Make-up Air Unit
Location	North Basement
Service	Corridors and classrooms without UVs
Make	Control Aire
Outdoor Air	100% OA unit Isolation damper at inlet to unit
Filters	Clean (all filter replaced every three months) 5,700 cfm 0F inlet / 65F outlet air temperatures

Unit overview Pneumatic damper actuator

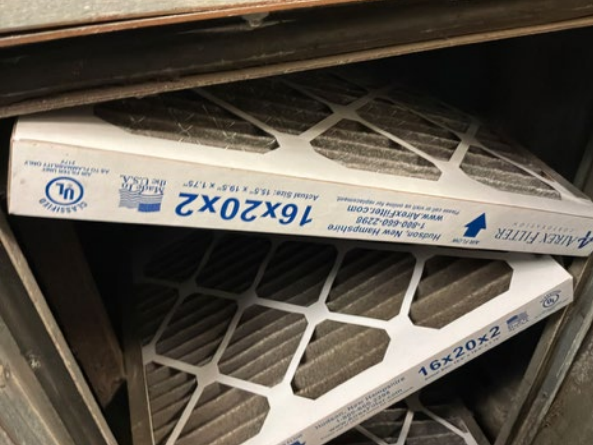
Example filter MERV-8 rating

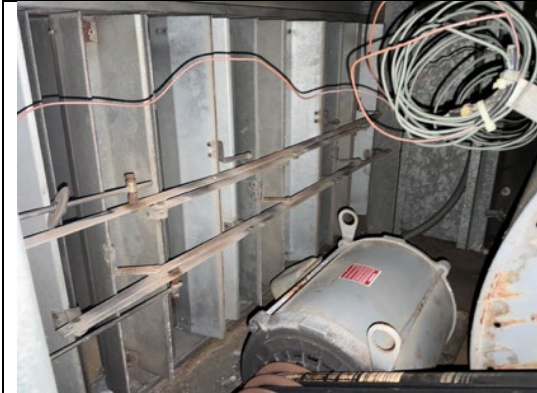
Downstream of heating coil. Clam shell damper blocks view of coil.

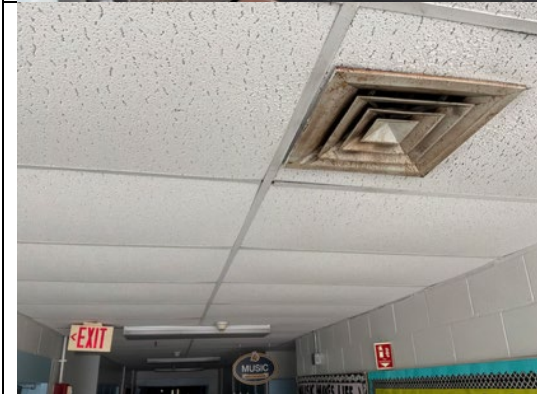
Example supply register in corridor

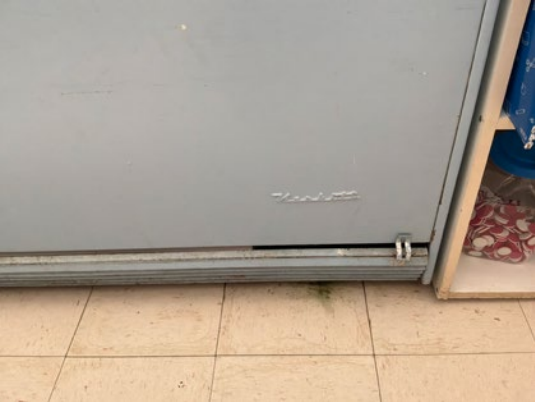
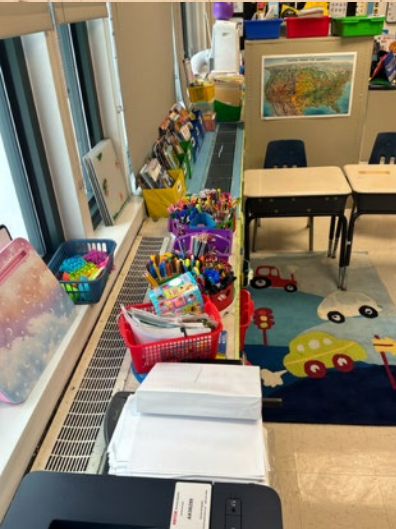
Priority	Medium / High
Tag	--- Unit Ventilator
Location	Classroom
Service	Classroom
Make	Nesbitt (oldest units)
Outdoor Air	Outdoor louver beneath window
Filters	At bottom inlet

Unit heater (blue background) Baseboard heat (foreground)

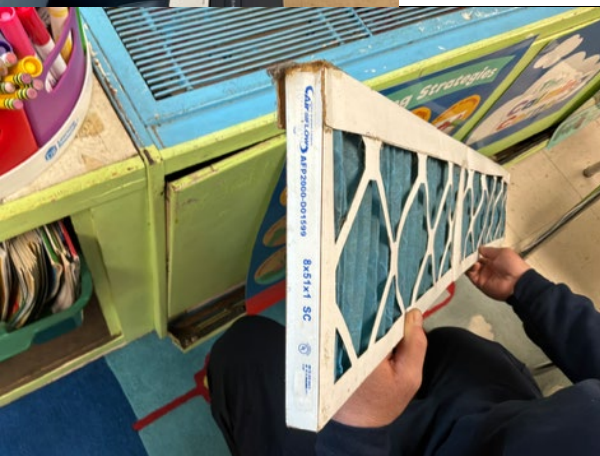
Example filter at inlet at base of unit

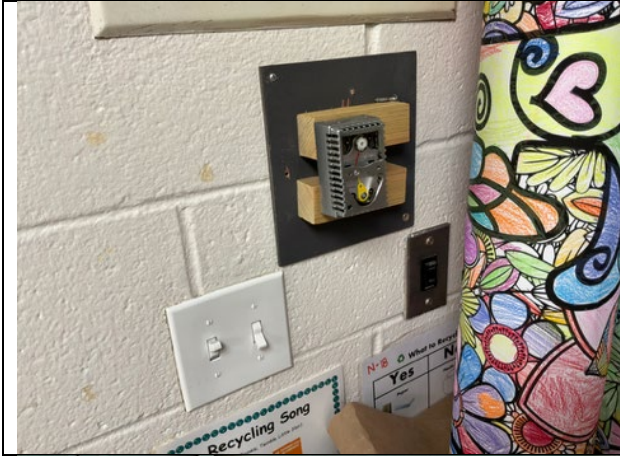
Pneumatic control of heating valve in unit

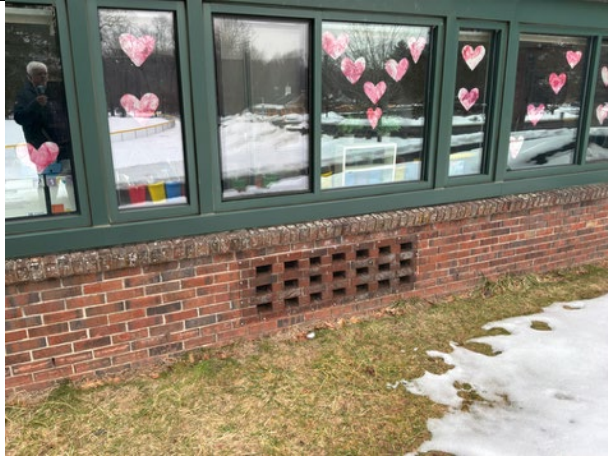
Outdoor air inlet

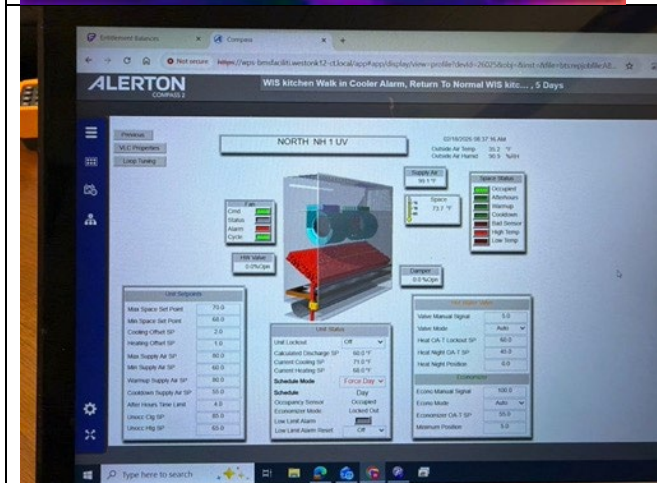
BAS graphics screen (newer units circa 1996)
