Bethel Board of Education Special Meeting - HVAC Feasibility

Bethel High School Mechanical Upgrades Study

June 3, 2022

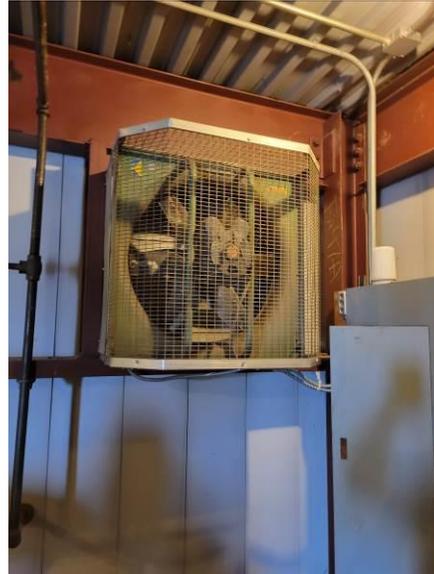
Penthouse Exhaust Fan

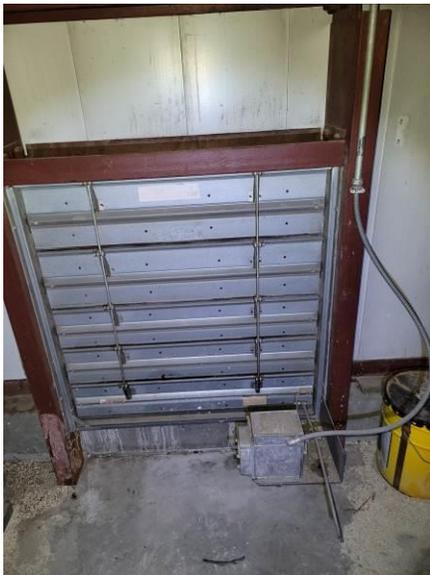
Penthouse Intake Damper

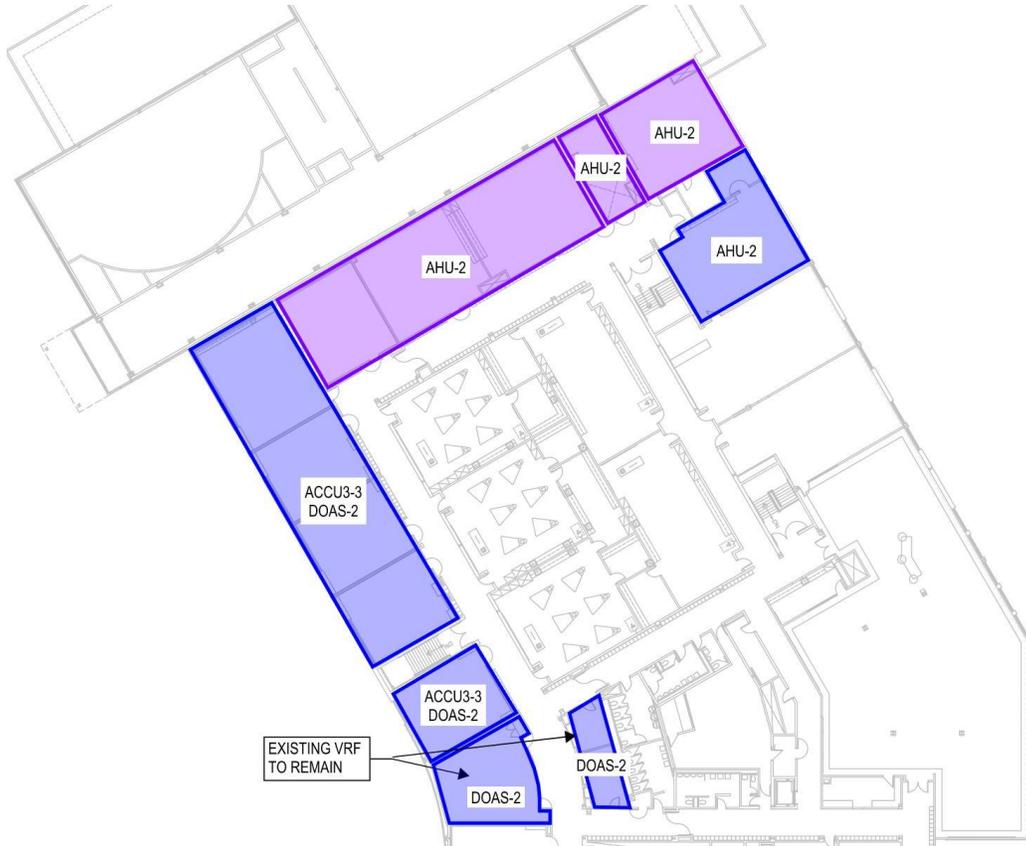
Option 1- AHU-2 & VRF (ACCU3-3) – Third Floor

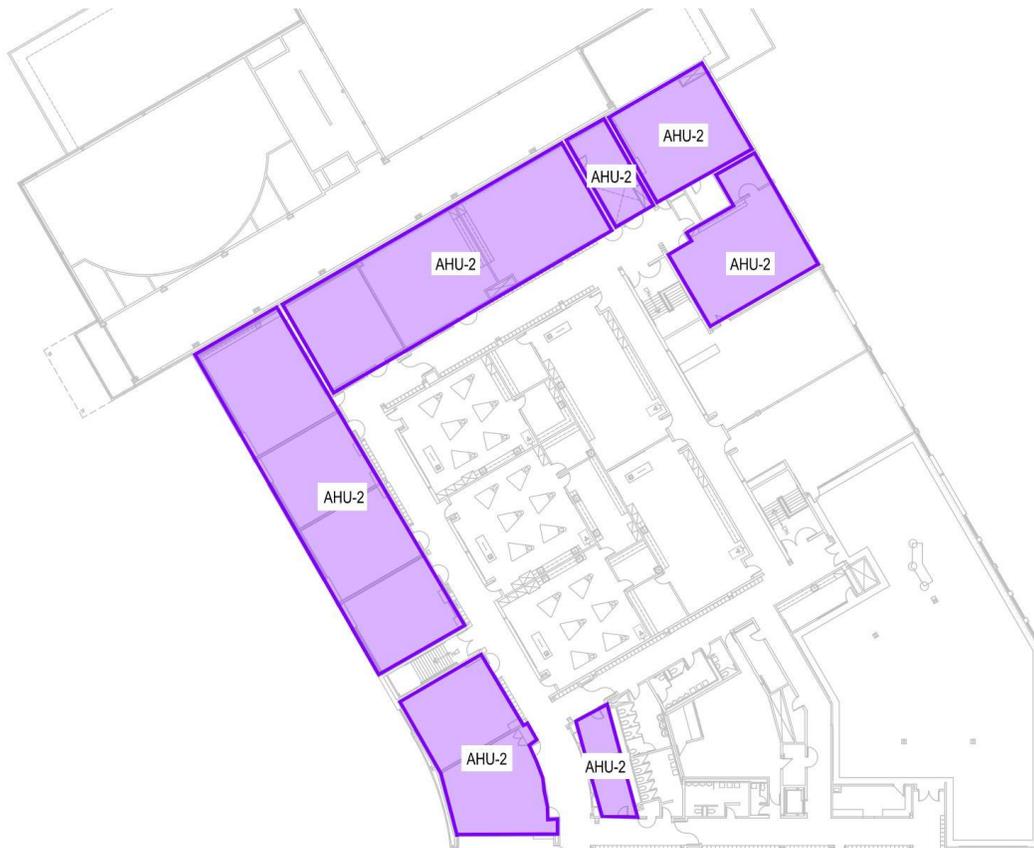
Option 2 – Larger AHU-2 – Third Floor

Option 2: Remove and replace AHU-2 with a new variable air volume gas fired / DX packaged rooftop unit similar to a Trane model IPAK sized for 50 tons of cooling, 688 MBh of heating, 4,800 CFM of ventilation air, and 12,000 CFM of total supply air. Connect to existing supply and return air risers. Provide new roof mounted supply and return air mains to new roof penetration serving history and special education classrooms on the third floor that do not currently have cooling. Outfit these rooms with new VAV boxes complete with hot water reheat coils. Provide (1) VAV box per classroom. Extend hot water from nearby mains serving radiation. Existing VAV boxes shall be reused and shall have their reheat coils inspected and cleaned. Re-balance all existing

VAV boxes. All existing ductwork serving AHU-2 to remain shall be cleaned, pressure tested and sealed as needed. New AHU-2, VAV boxes, and reheat coils shall be controlled by the BMS.

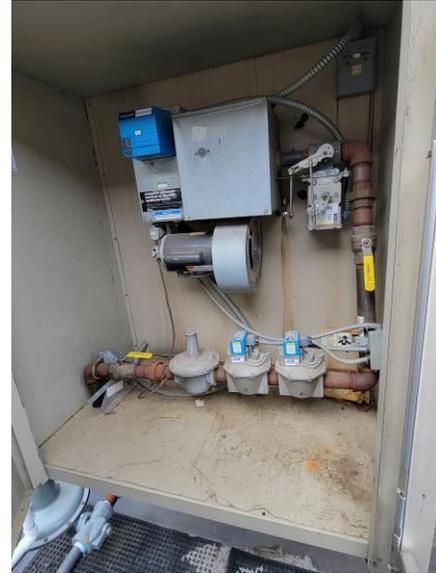
AHU-4 Natural Gas Train

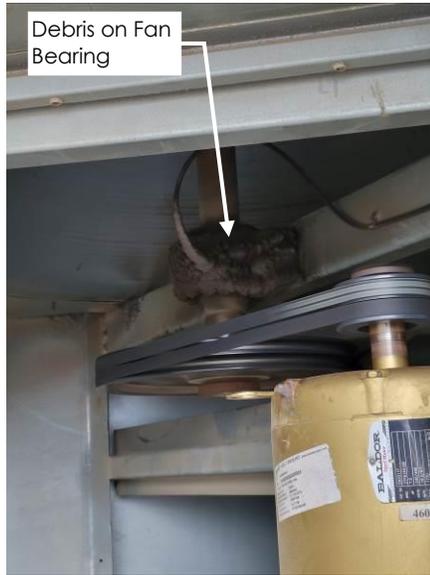
AHU-4 Debris on Fan Bearing

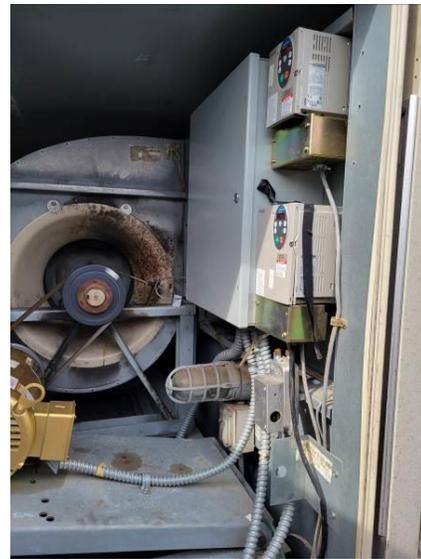
AHU-5 Supply Fan

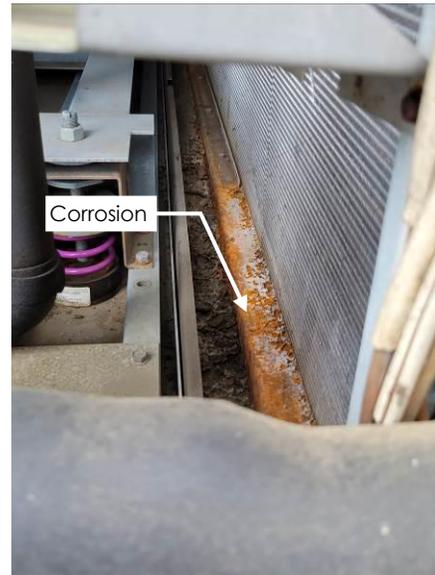
AHU-7 Cooling Coil Drain Pan

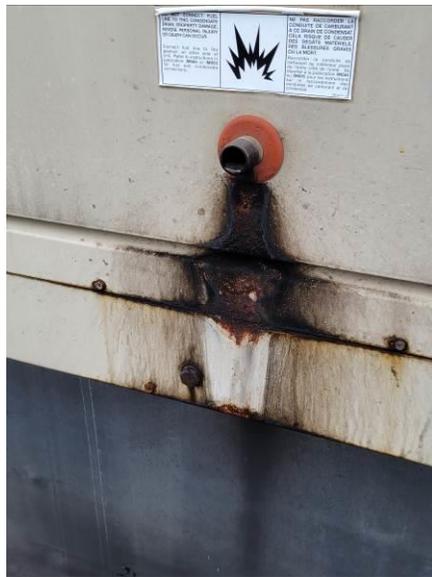
AHU-7 Heat Exchanger Condensate

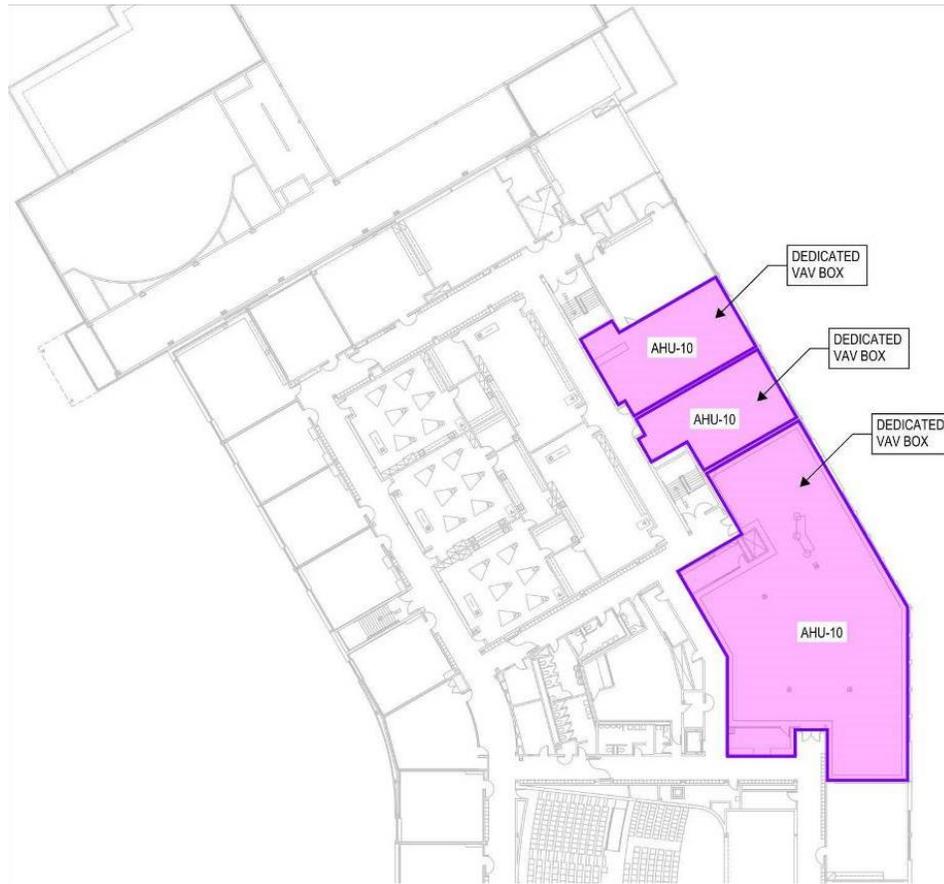
AHU-10 Proposed Correction – Second Floor

Remove and replace AHU-10 in kind with a new variable air volume gas fired / DX packaged rooftop unit similar to a Trane model IPAK sized to match the existing unit airflows and capacity. Provide a new adaptor curb and reconnect to the existing supply and return air mains on the roof. All existing rooftop ductwork shall be reinsulated with a closed cell product such as polyisocyanurate or flexible elastomeric insulation. Exterior insulation shall be protected with a self-adhesive aluminum jacketing. A new supply air main shall be routed to the (2) computer labs adjacent to the media center. Each computer lab shall be furnished with a new VAV box. The existing supply air main serving the media center shall be furnished with a slip in retrofit VAV box. New space mounted thermostats and CO2 sensors shall be installed to control temperature and ventilation. All existing ductwork serving AHU-10 shall be cleaned, pressure tested and sealed as needed. New AHU-10 and VAV boxes shall be controlled by the BMS.

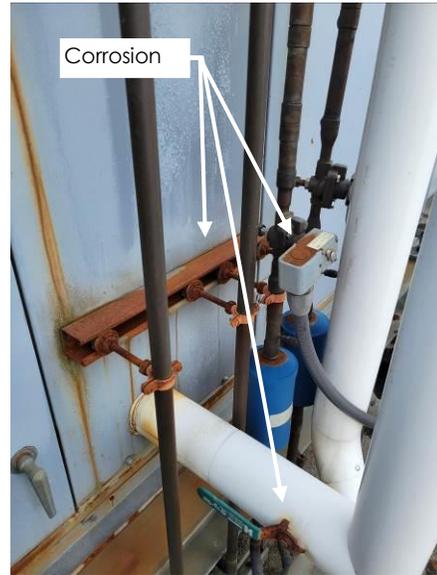
ERU-1 Exterior Pipe Hanger and Valves

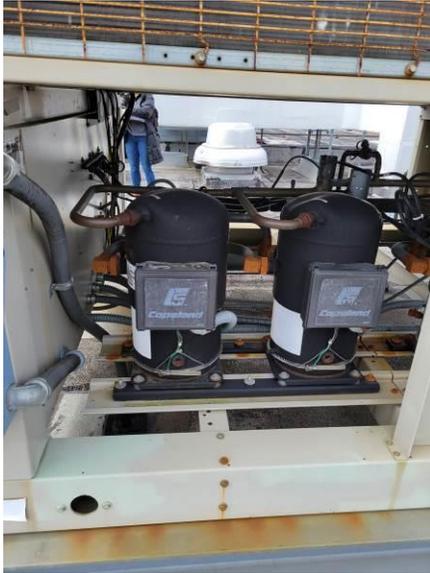
ERU-1 Compressors

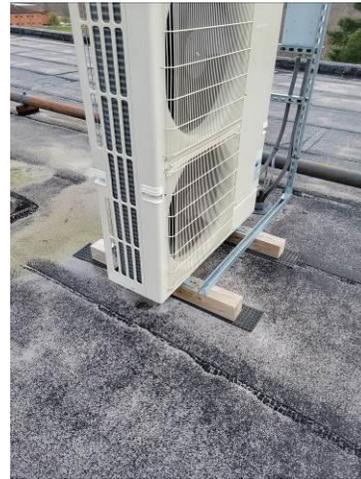
Roof Mounted Condensing Unit On Wood Blocks

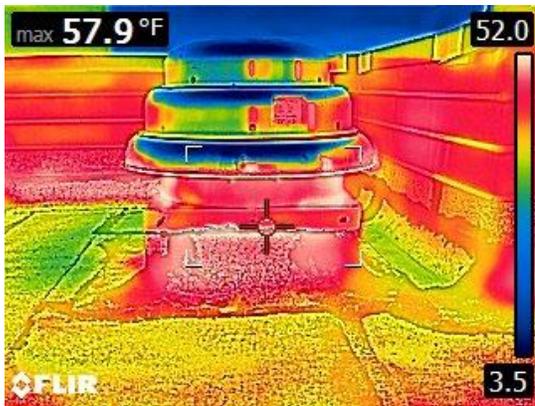
EF-41 Thermal Image without Leakage

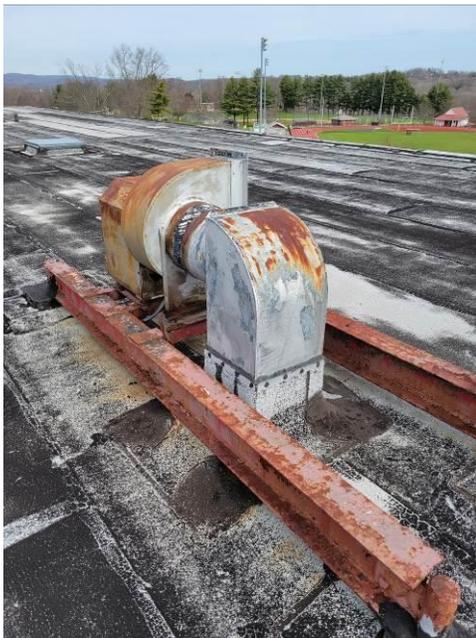
Example of Abandoned Fan

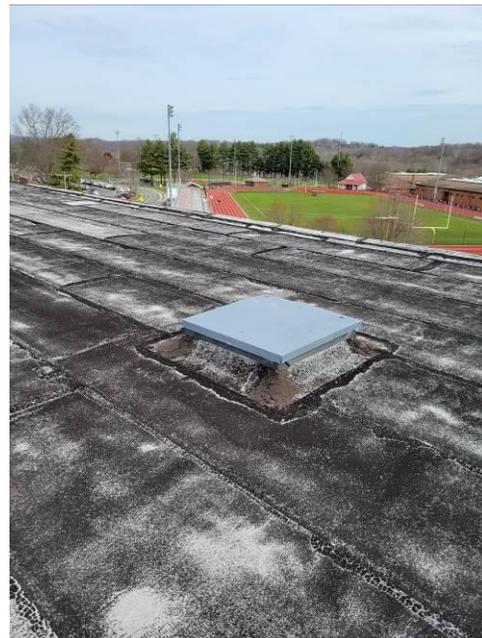
Example of Capped Fan Curb

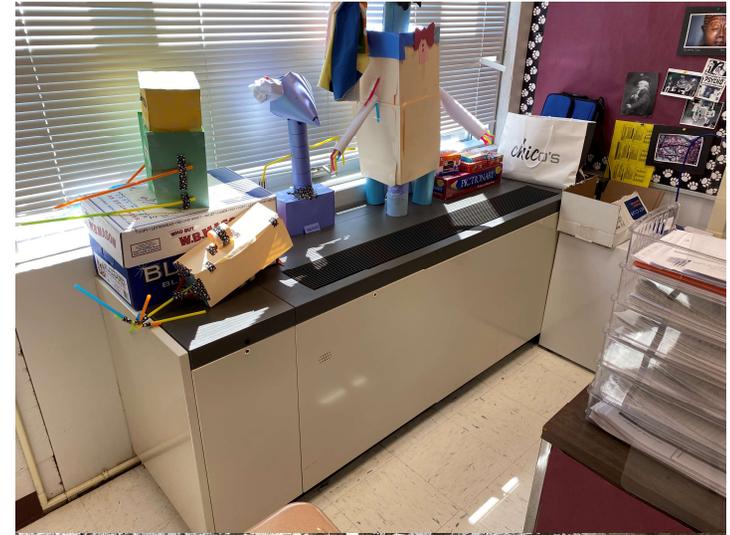
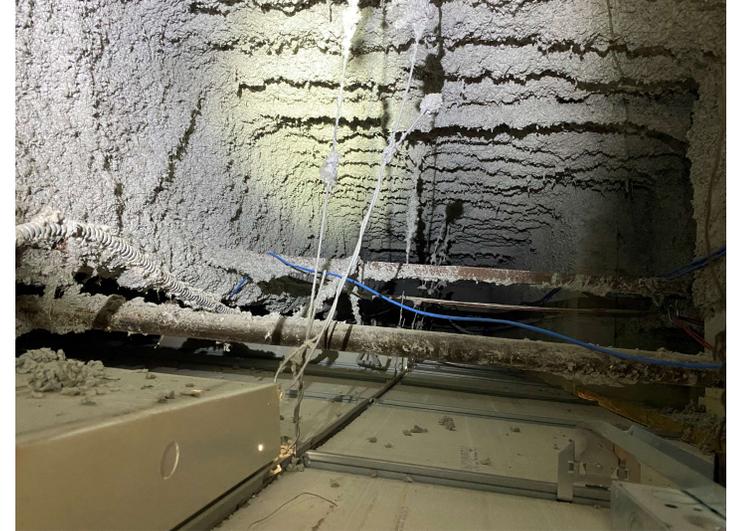
Findings

- Classroom Air Conditioning
 - Units have either unit ventilators only, radiation only or combination of both.
 - Exhaust fans with ducts to classrooms are inconsistent. Some grilles capped above ceilings or not connected to duct.
 - Abandoned rooftop relief penthouses.
 - Unit ventilators are noisy. Do not comply with ANSI classroom sound standards.
- Issues:
 - Noise.
 - No air conditioning.
 - Lack of ventilation in some non-air-conditioned and air-conditioned spaces (mini-splits).
 - Tight conditions.
- Recommendations:
 - Option 1/Priority 1 and 2 with VRF and Dedicated Outside Air System (DOAS)

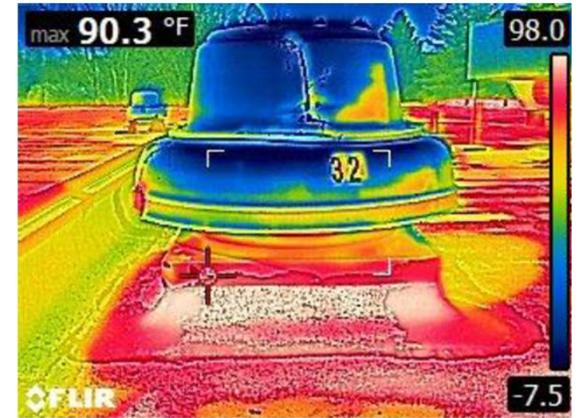
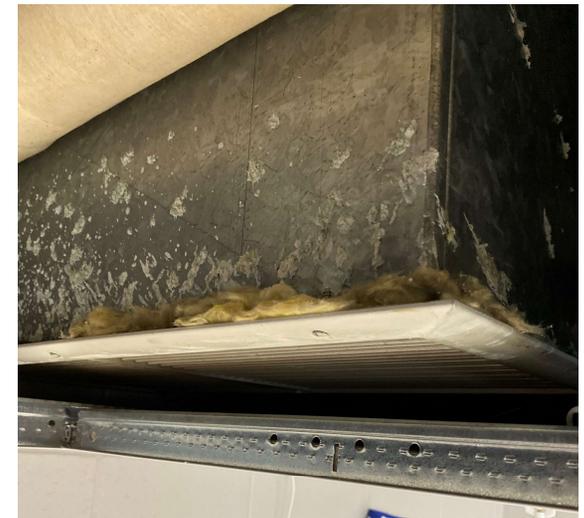
- Lots of abandoned ducts from the 2007 renovation that were supposed to be removed.
- Direct opens to the exterior. I.e., open louvers.
- Mold on ceiling tiles in kitchen area.
- No means of ventilation in corridors throughout.
- Natural gas issues to rooftop units.
- Plugged outside air louver to kitchen make up unit.
- Abandoned equipment on roof and above ceilings.
- Dead systems with controlled heating coils.
- Misc. exhaust ductwork capped above ceiling with plastic
- Some pneumatic control valves on radiation (nurses' area).
- Exhaust grilles located above ceilings, not in space served.
- Some plenum areas with PVC drain piping.
- Inoperable exhaust fans.
- AHU-8 open grilles in egress corridor.
- Windows too small for natural ventilation without operable exhaust.
- Fire proofing throughout
